PG&E Responds to CAL FIRE's Report on 2021 Dixie Fire in Butte, Lassen, Plumas, Shasta, and Tehama Counties

CALIFORNIA DEPARTMENT OF FORESTRY AND FIRE PROTECTION

INVESTIGATION REPORT

On Tuesday July 13, 2021 at approximately 5:07 PM, the Dixie Fire was reported in a remote area above the Cresta Dam in Plumas County, CA, near the community of Pulga. The fire ignited below the Pacific Gas and Electric (PG&E) Bucks 1101 12KV distribution circuit, between pole number 120772797 and an unmarked pole approximately 300 feet east. The fire ignited as a result of a 65' tall, damaged and decayed Douglas-Fir tree when it fell and contacted conductors at approximately 6:48 AM. Two of the three fuses blew (opened) upon initial contact with the conductors, but the third fuse remained closed and kept a line energized. The tree being in contact with energized conductors and the ground created a high impedance fault. The high impedance fault energized the tree, which caused heat and arcing to ignite a dry and receptive fuel bed over the course of 10 hours. Because PG&E had an excessively delayed response to the fault, the fire was not discovered until a PG&E troubleman W-1 arrived at scene at app

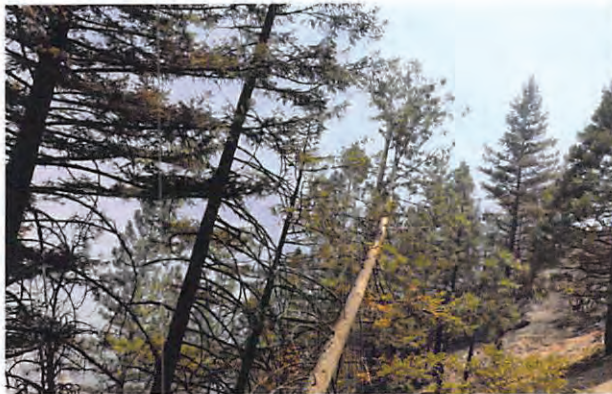
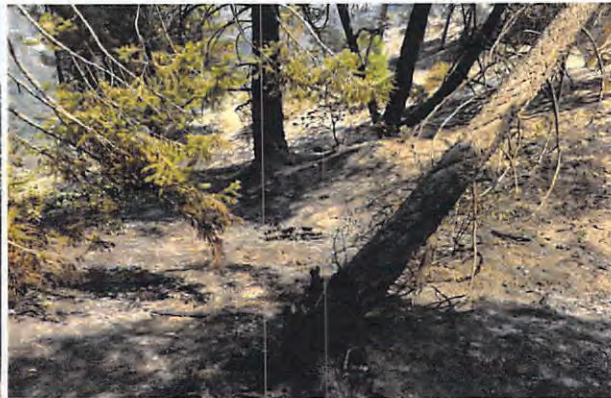
1 Creek and Dixie Road. At approximately 11:45 AM, we arrived at the origin and found it
2 to be undisturbed. At approximately 12:30 PM, BERRY, THOMPSON and I started
3 conducting the origin and cause investigation by first walking the edge of Camp Creek
4 Road and identifying the flanks of the fire that I had witnessed the evening of July 13,
5 2021. Next, we walked around the fire in a clock wise and counterclockwise direction
6 starting with the south flank where power pole 120772797 intersects with Camp Creek
7 Road and Engine 2183's hand line began. We observed macro fire pattern indicators
8 such as angle of char, foliage freeze, and protection that indicated the general origin
9 area (GOA) to be between power pole 120772797 and an unmarked pole approximately
10 300 feet east and downhill toward Cresta Dam. Between these two poles and nearest
11 the unmarked pole was a tree (subject tree) approximately 65 feet in length laying

12 across all three conductors. This section of line was later determined to be identified by
13 PG&E as the Bucks 1101 circuit.

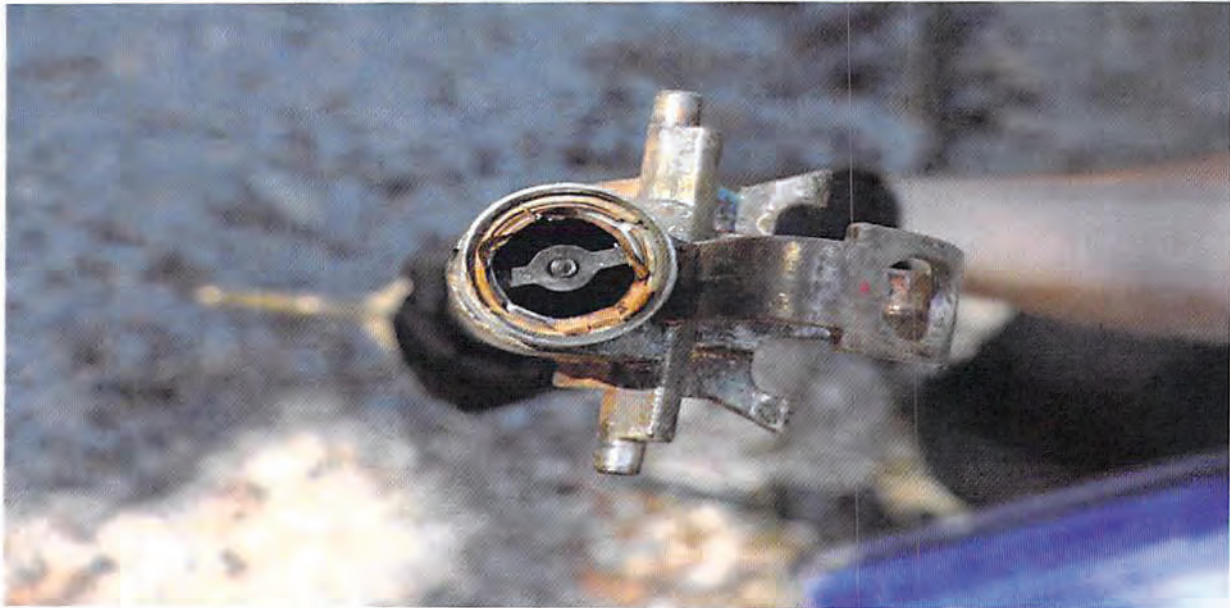
- 1 and did not have any continuity. Conductor 3 was not blown and did have continuity.
2 After HILTON examined the fuses, BERRY photographed while I packaged and labeled
3 them as evidence.
4
5 Fuse from conductor #1 (southern conductor) or far right conductor looking downhill
6 from Camp Creek Road was labeled E-1.

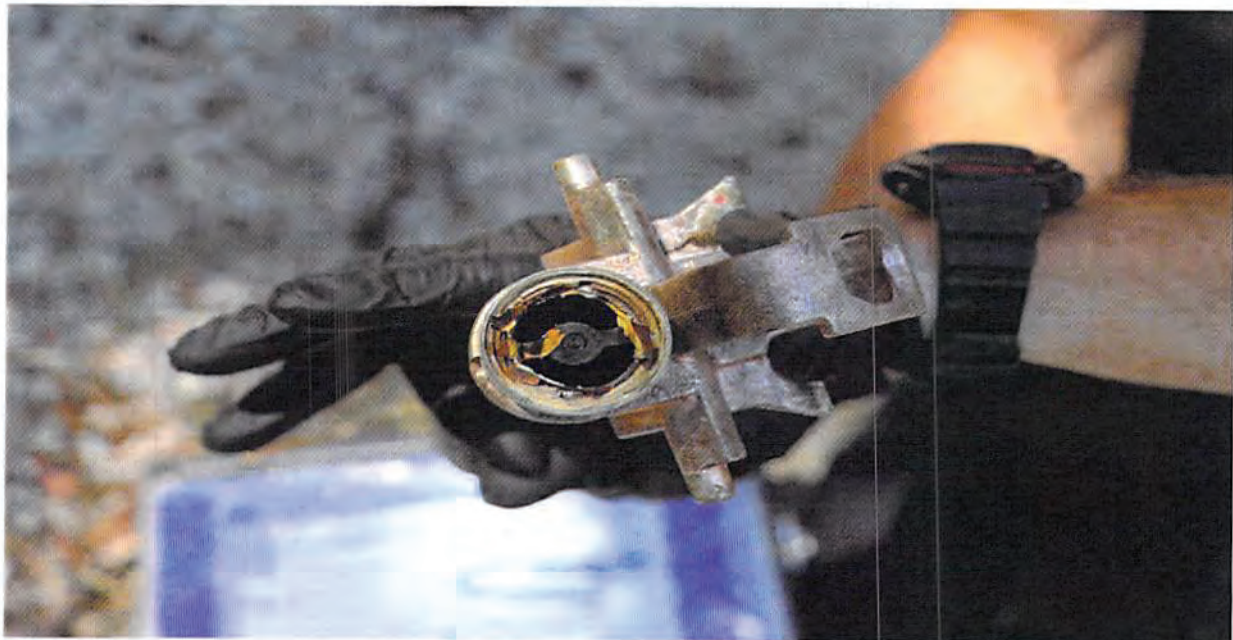
- 7
8 Fuse from conductor #2 (middle conductor) was labeled E-2.

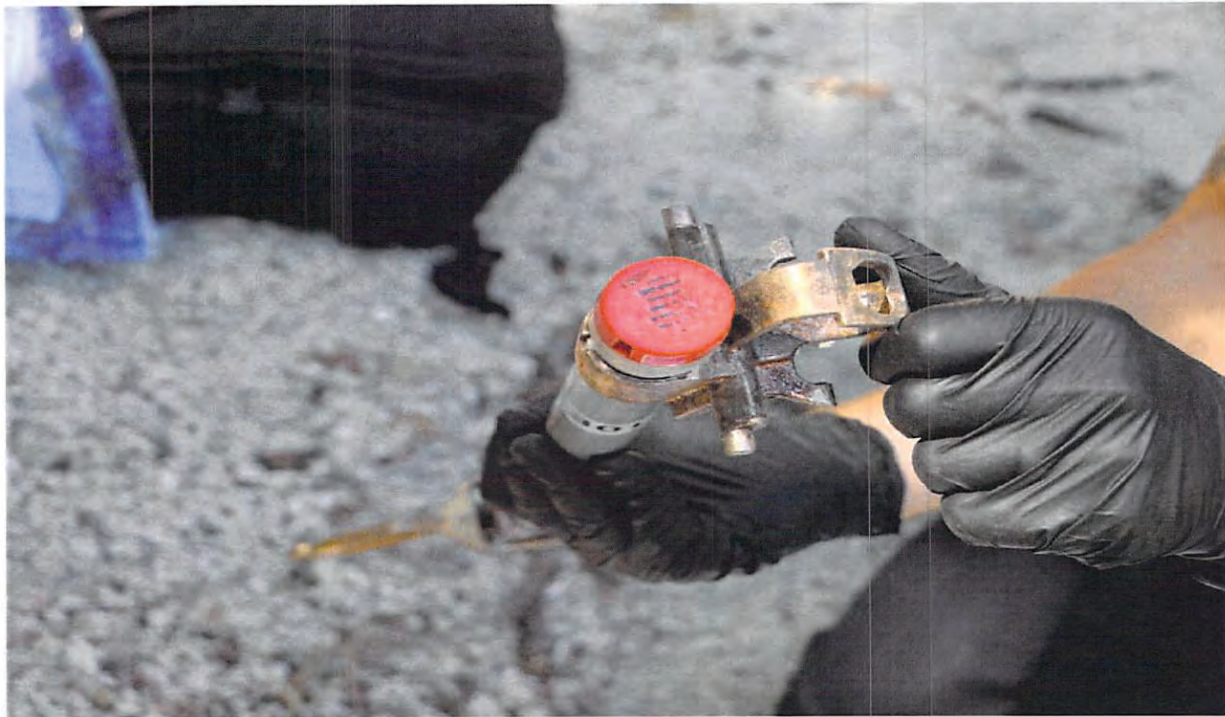
- 1 Fuse from conductor #3 (northern conductor) or far left conductor looking downhill from
- 2 Camp Creek Road was labeled E-3.

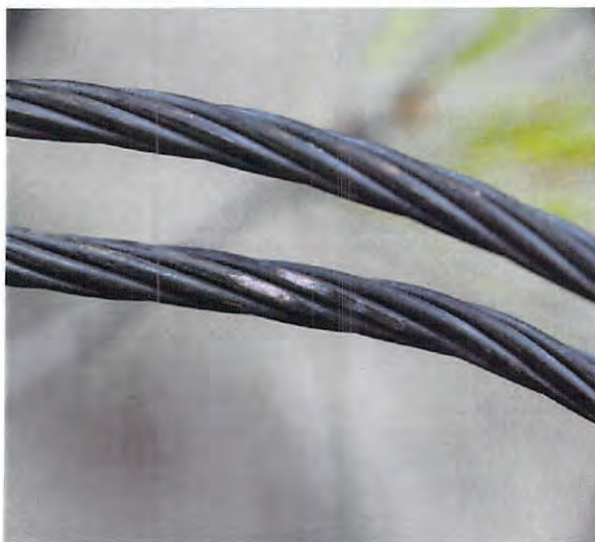
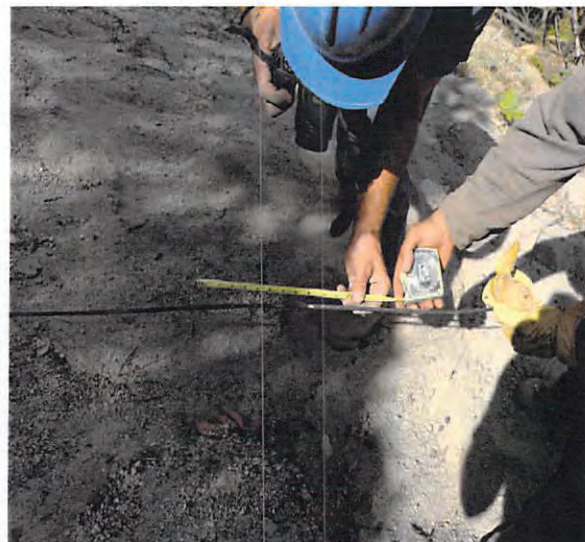
2
3
4 **Conductor #1** (southern conductor) Approximately 5 feet of conductor was removed
5 and packaged as evidence labeled E-6. This conductor showed remnants of tree bark
6 and materials transfer approximately 4-5 feet uphill (west) from the insulator on the
7 unmarked pole and within 16 inches from the insulator where the tree came to rest. This
8 section of conductor also showed signs of deformation, arcing, and flattening where the
9 tree contacted the conductor.

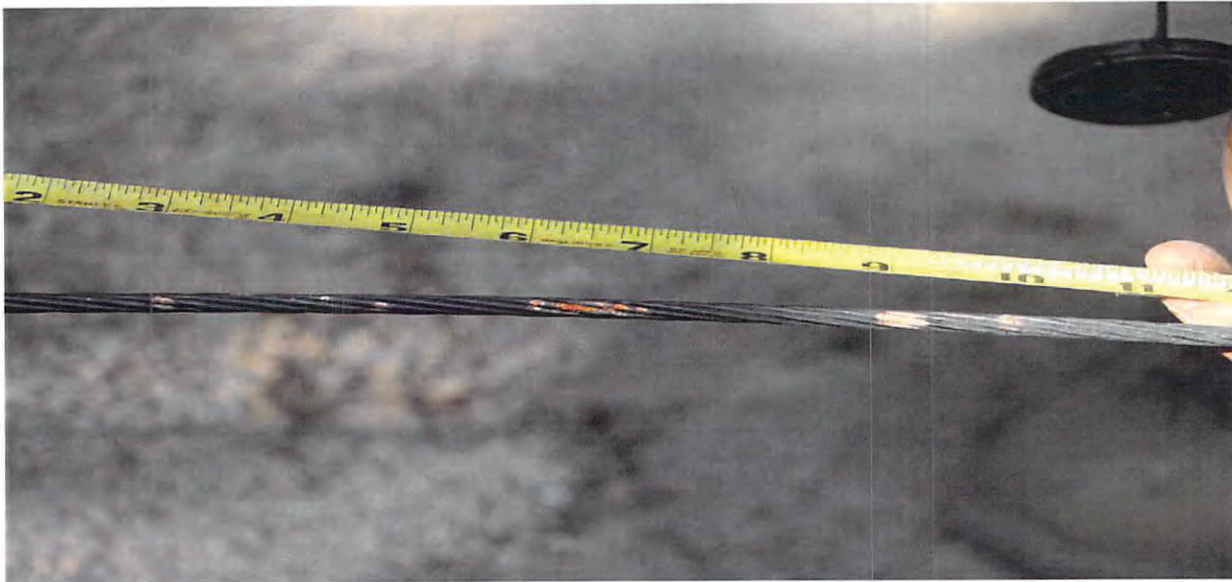
- 1 **Conductor #1** (southern Conductor) Approximately 34 feet uphill (west) from the
2 insulator on the unmarked pole. Approximately 12 inches of conductor was removed
3 and packaged as E-7. This section of conductor showed signs of fresh arcing and
4 beading in multiple spots over the approximate 12-inch section.

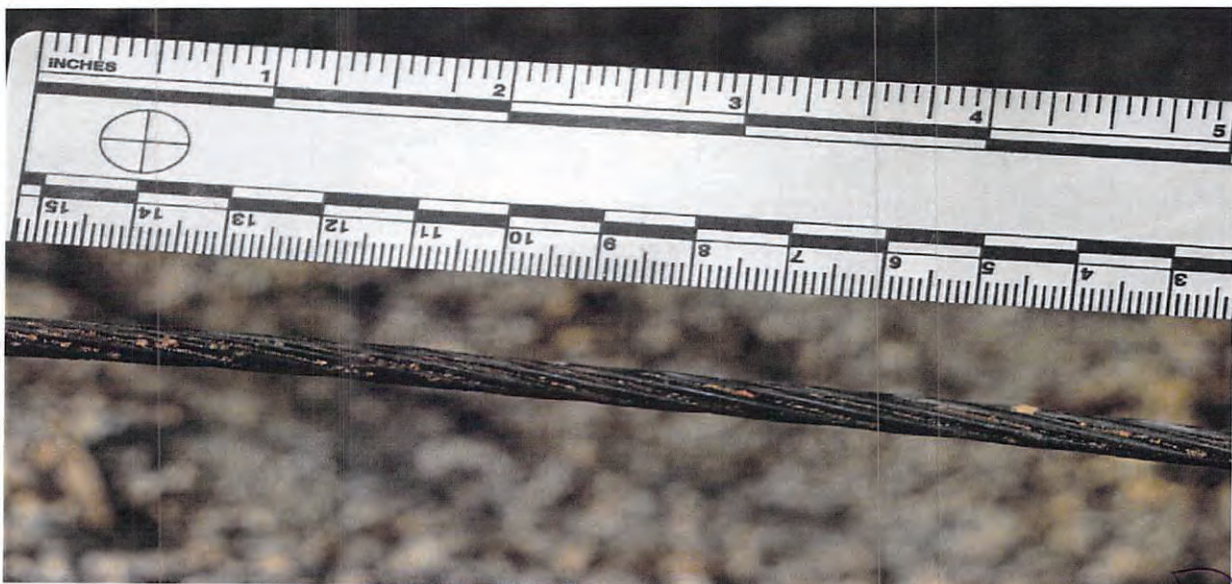
- 7 **Conductor #2** (middle conductor) Approximately 5 feet of conductor was removed and
8 packaged as E-8. This conductor showed remnants of tree bark and materials transfer
9 from approximately 6 feet uphill (west) and up to 16 inches from the insulator on the
10 unmarked pole.

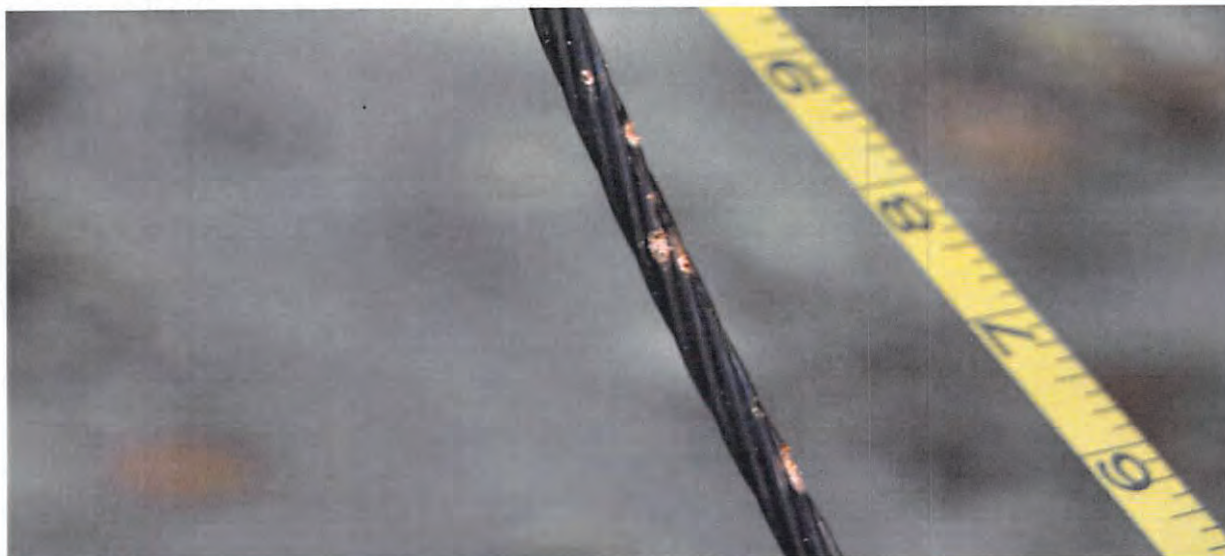
1
2 **Conductor #2** (middle conductor) Approximately 12 inches of conductor was removed
3 and packaged as E-10. This section of conductor was located approximately 32 feet
4 uphill from the insulator on the unmarked pole. This section of conductor showed signs
5 of fresh arcing and beading in multiple spots over the approximate 12-inch section.

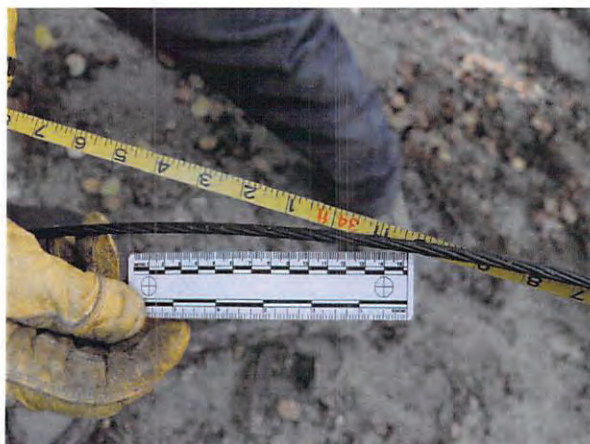
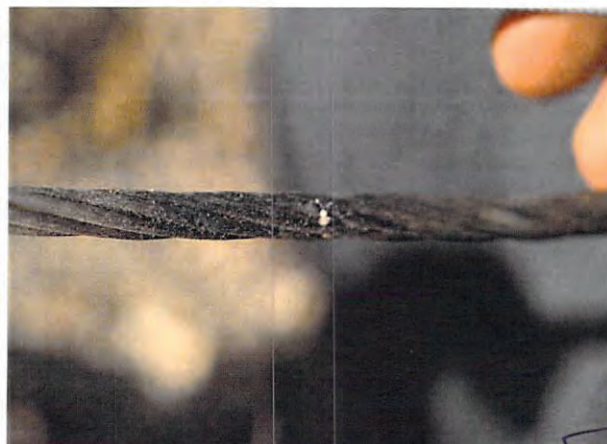
6
7
8 **Conductor #3** (north conductor) Approximately 4 feet of conductor was removed and
9 packaged as E-9. This section of conductor showed signs of tree bark and material
10 transfer from approximately 34 feet uphill of the unmarked pole to within approximately
11 12 inches of the insulator on the unmarked pole. It also showed black remnants where
12 the tree trunk made constant contact after coming to rest. This area was located
13 approximately 33 inches uphill from the insulator.

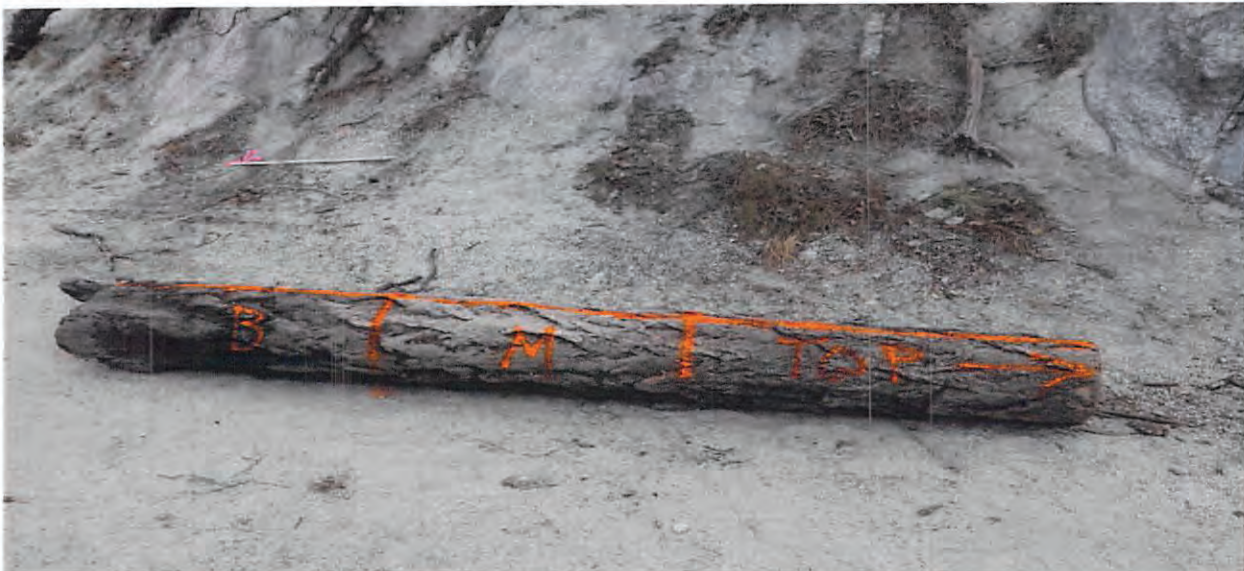
10
11 "Bottom" was marked as E-11-1

12 "Middle" was marked as E-11-2

13 "Top" was marked as E-11-3

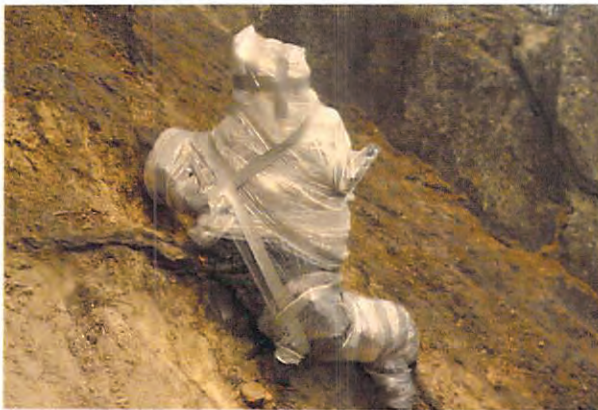
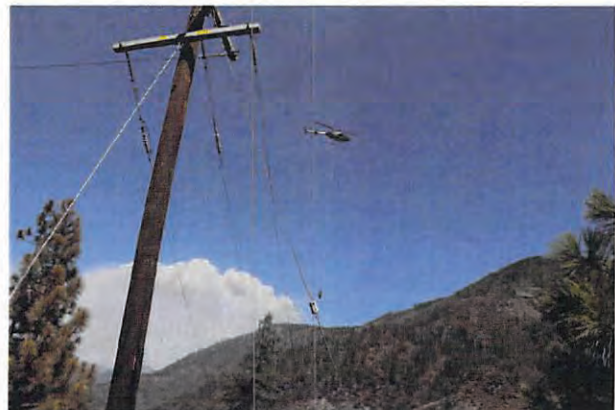
6
7 After exposing the root system below the soil level, the stump and a large portion of the
8 root were photographed and cut loose. The stump and root were then packaged in
9 protective bubble wrap and loaded into a cargo net and flown by long line below the
10 Butte County Sheriff's Department helicopter to the Shady Rest Area along Highway 70.
11 The stump and root were then loaded into a CAL FIRE flatbed vehicle and driven to a
12 secure CAL FIRE evidence storage facility. The flatbed was followed by BERRY during
13 transport. The tap root was labeled as E-12 and the stump was labeled as E-13.

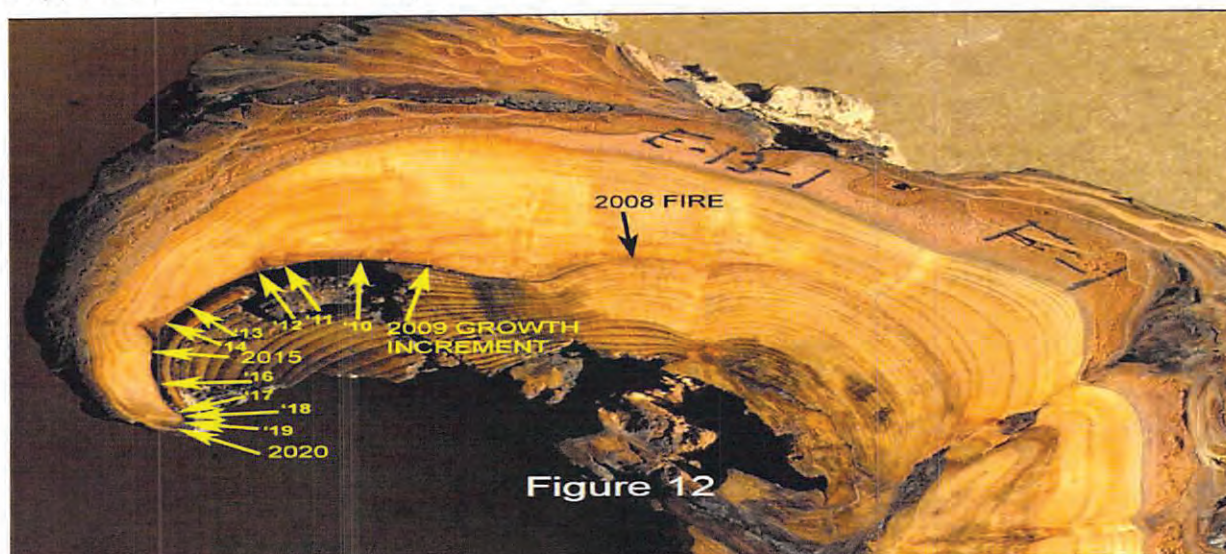
Based upon MCNEIL's evaluation the tree was likely significantly injured by the Butte Lightning Complex Fire in 2008 and by an unidentified event between 2015 and 2016. These injuries caused the live cambium (growing part of trunk) to be severely damaged.

1 and over time led to significant advanced decay at the base of the tree. MCNEILL' s
2 report also concluded the discovery of two "major buttressing and mechanically
3 supporting" roots had sustained damage from the 2008 Butte Lightning Complex which
4 killed a half to two thirds of the roots circumference. The south side of the lower trunk
5 burned in 2008, killed over half of the circumference, this would have formed a wound
6 with no bark cover, visible as exposed and decaying wood. MCNEIL concludes this
7 wound would have been visible from 18-38 inches above the ground. After the 2008 fire
8 the only live tissue keeping the tree canopy green was on the side away from the
9 conductors. After the unknown 2015/2016 event more than half of the tree in the lower
10 three feet was dead, open, and decaying. This left the tree with insufficient wood to
11 support the tree mechanically.

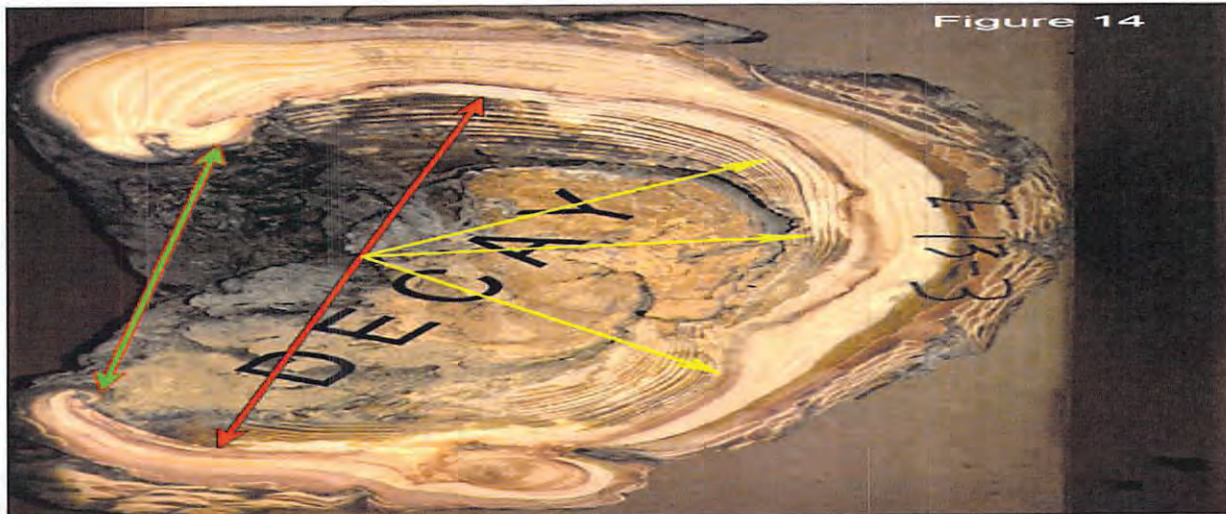
12
13 MCNEIL concluded that the degraded condition of the base of the tree was the primary
14 cause of the failure and that the defect would have been visible without extraordinary
15 discovery effort, from under the conductors. It would have been visible as a cat face, an
16 open injury to the trunk. A visual inspection around the base of the tree would have
17 revealed the poor mechanical condition of the tree. A pre inspector who was close to
18 the tree for a brief visual inspection should have discovered the decay.

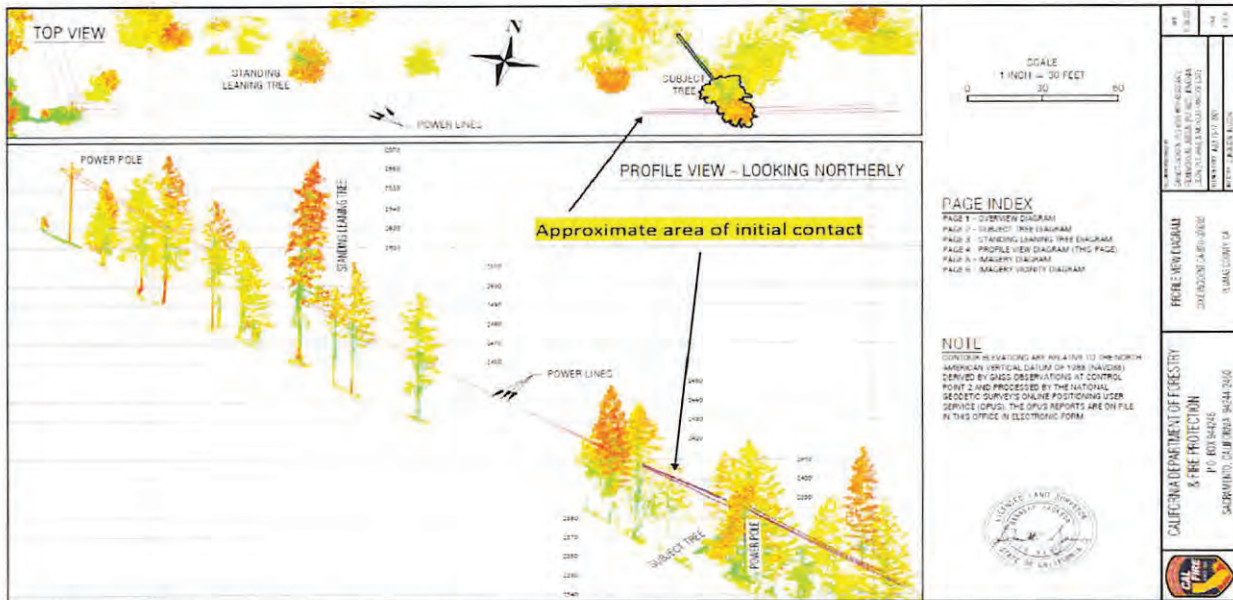
13
14 On November 29, 2021, I received a copy of HYLTON's report. HYLTON concluded the
15 most probable scenario, based upon pole location, subject tree location, fuse status,
16 SCADA data and markings found on conductors is the subject tree fell across the line
17 approximately 32 feet west (uphill) of its final resting place (up against the unmarked
18 pole) at approximately 6:48 AM on July 13, 2021. The subject tree contacted all three
19 conductors (12kV) and, because the line is built on a steep slope, it slid down the
20 conductors and came to rest next to the pole. Two of the three fuses blew upon the
21 initial contact (fuses 1&2). The third fuse (fuse 3) remained intact and kept the line
22 energized. All three conductors were energized through back feed by the transformers

- 1 at Cresta Dam. This caused the tree to remain energized until the line was de –
 2 energized by PG&E.

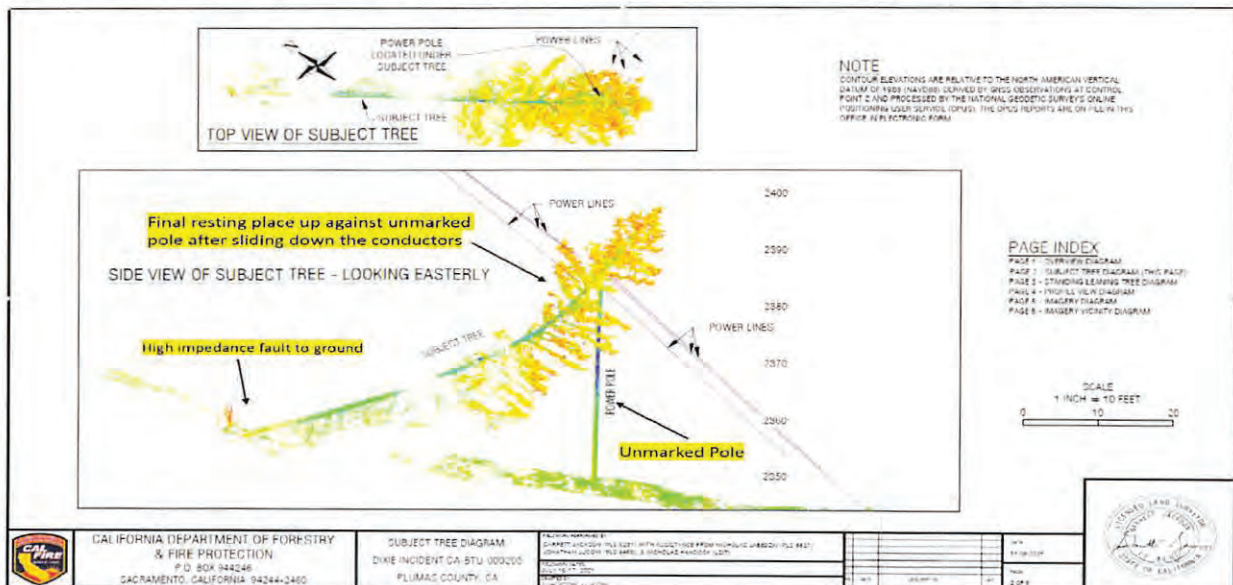
- 3
 4 HYLTON concluded the tree being in contact with energized conductors (prior to PG&E
 5 de-energizing) and the ground created a high impedance fault. The tree may have
 6 initially stayed connected to the stump; or it may have broken loose and came to rest on
 7 the ground. In either case, the connection to the earth would create a poor (high
 8 impedance) path to ground. Poor electrical connections, especially at high voltage,
 9 create heat and cause arcing. (See HYLTON'S full report attachment X)
