UNITED STATES DISTRICT COURT
NORTHERN DISTRICT OF CALIFORNIA
SAN FRANCISCO DIVISION

Case No. 14-CR-00175-WHA

**RESPONSE TO SIXTH REQUEST RE
DIXIE FIRE AND SUPPLEMENTAL
RESPONSE TO FIFTH FURTHER
REQUEST FOR RESPONSES RE
DIXIE FIRE**

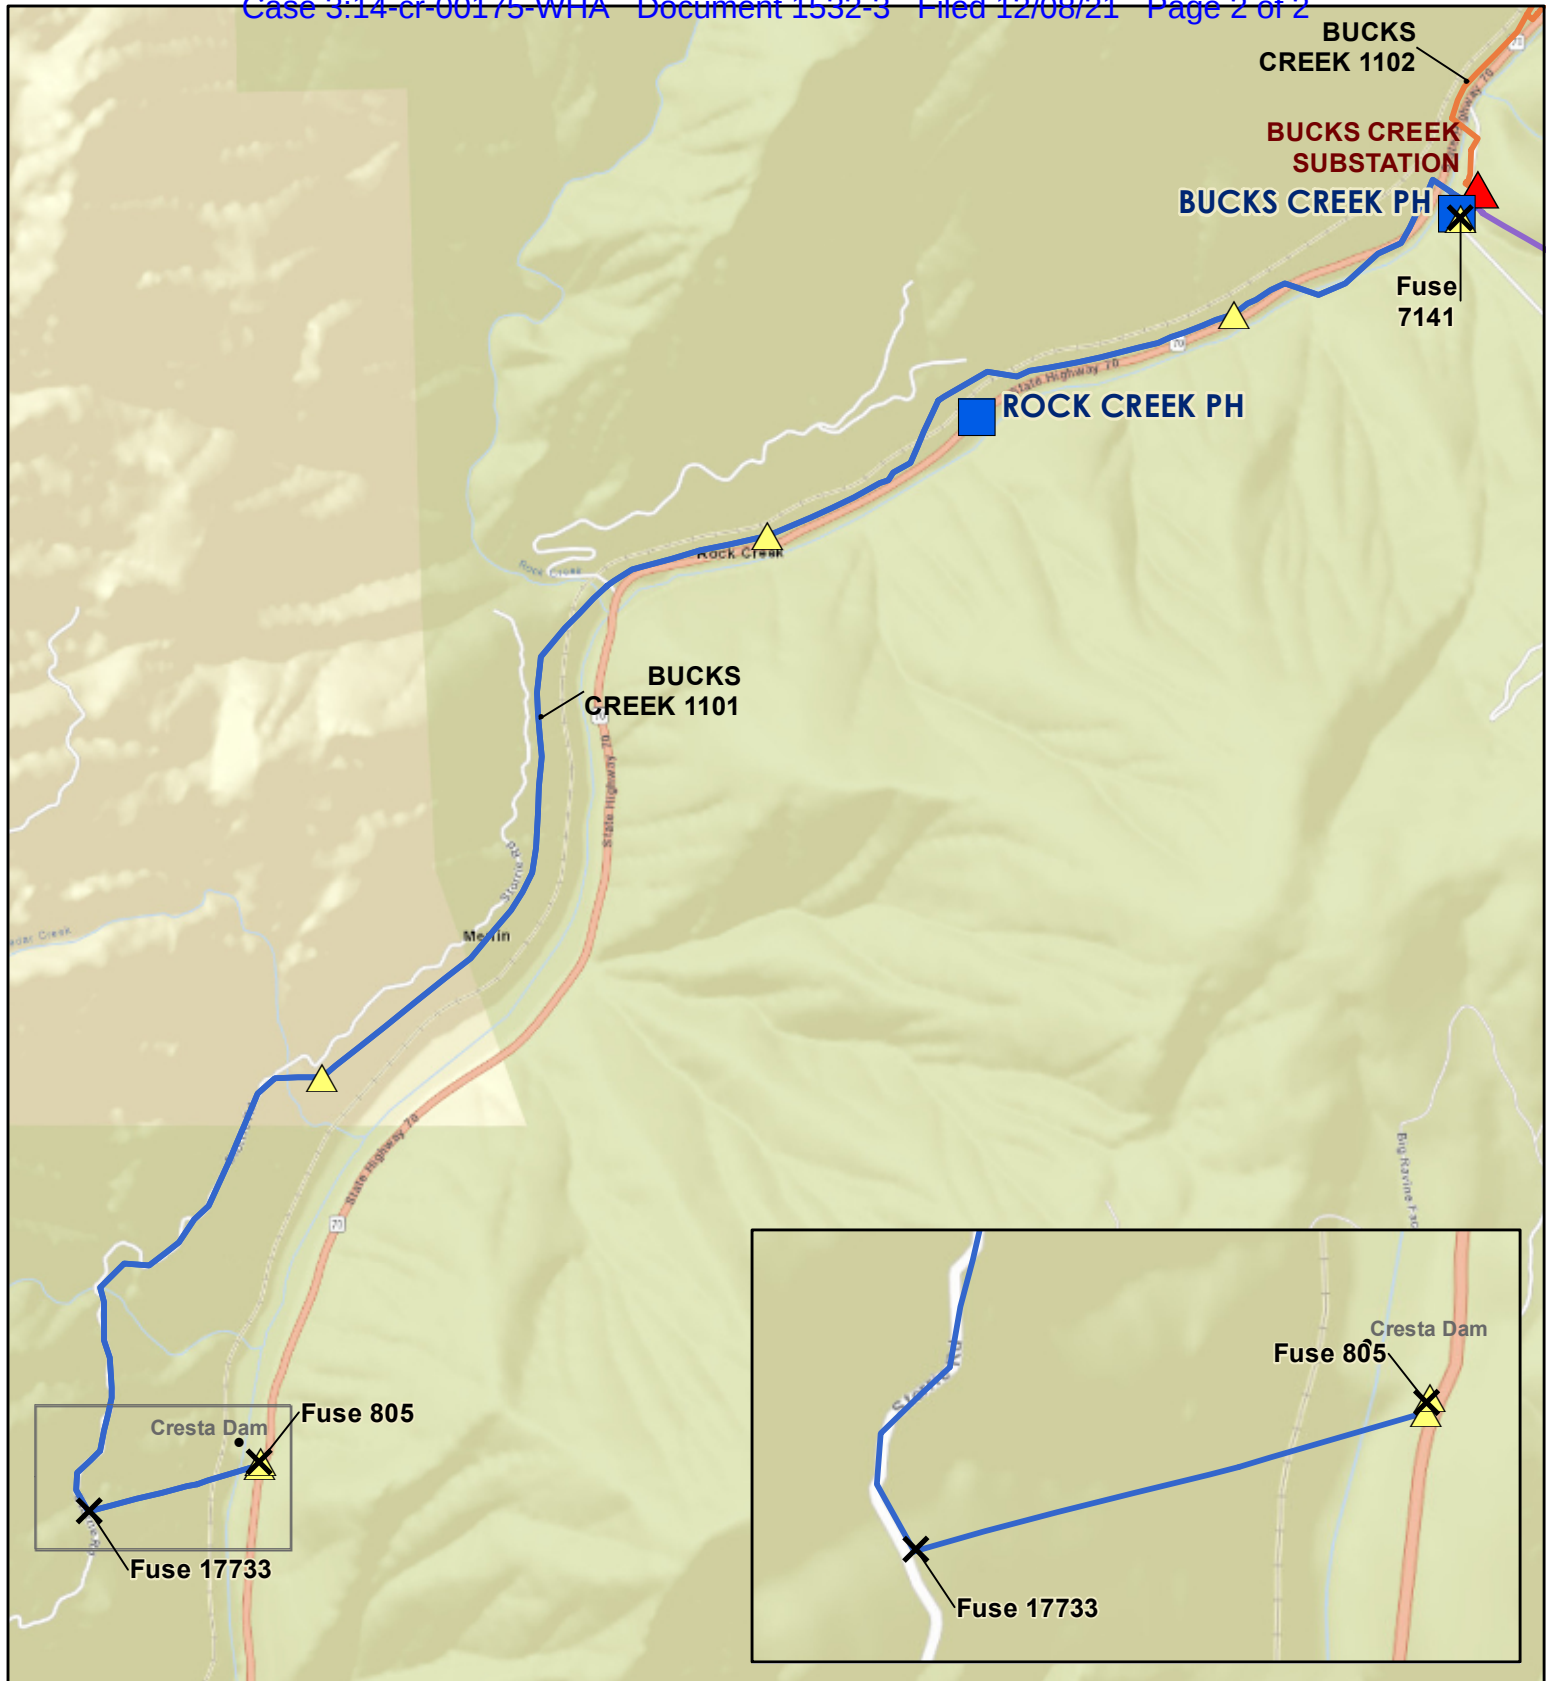
Exhibit TTT

the end of the circuit.² The approximate location of each of these transformers is shown on the map marked as Exhibit TTT, as is the location of Fuse 17733. As indicated on the map, the nearest transformers to Fuse 17733 were: (a) on the source side, the southern-most railroad connection and (b) on the load side, the transformers at the dam and the tunnel.

Getting to all the transformers on the Bucks Creek 1101 Line would take an appreciable period of time, as the transformers located at two of the railroad tie-ins (including the location closest to Fuse 17733) are not accessible from the highway; checking them prior to checking Fuse 17733 would have further delayed the Dixie Troubleman arriving at Fuse 17733 and reporting the fire.

*Approximate Locations of Transformers Connected to Bucks Creek 1101 on July 13, 2021
