KIRKLAND & ELLIS LLP

**PG&E Independent  
Monitor Report of  
November 19, 2021**

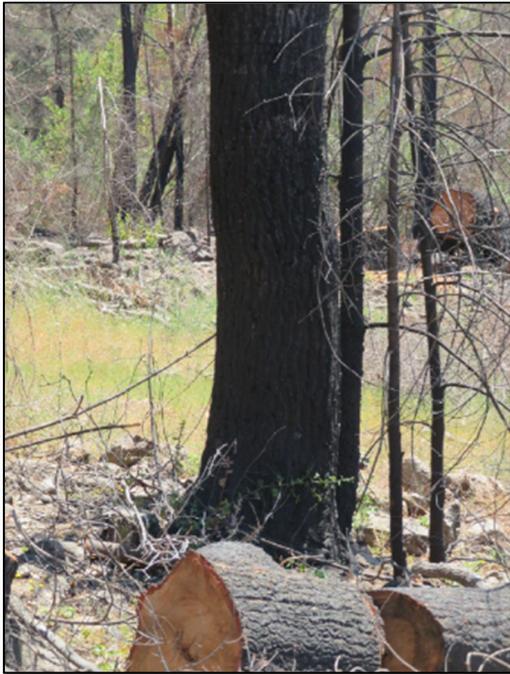
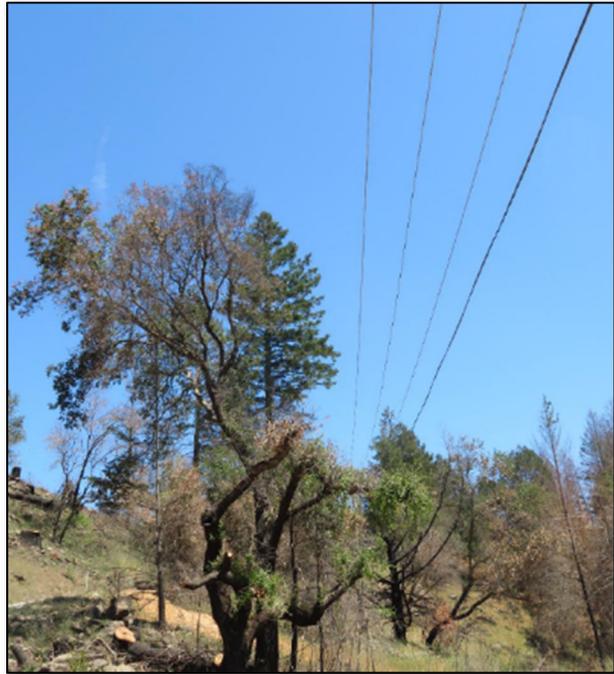
Below is a hazard tree with fire damage identified by the Monitor team.

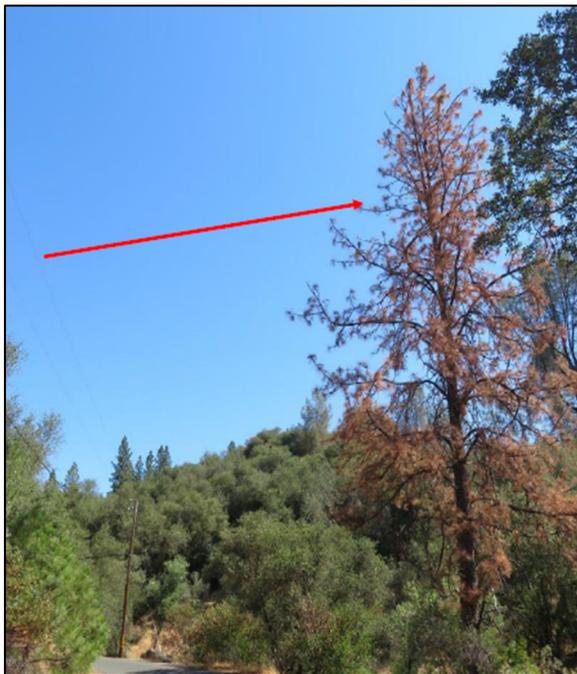
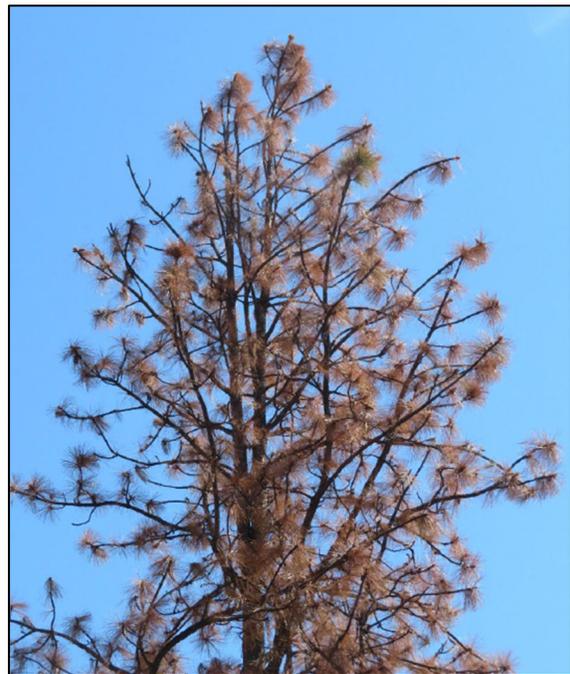
Below is a hazard tree that was dead or dying identified by the Monitor team.

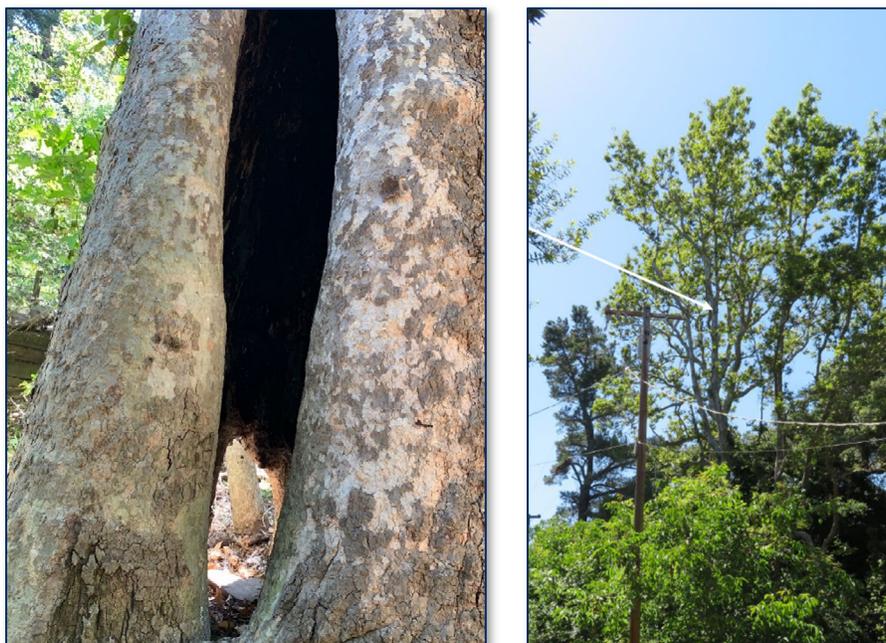
Below is a hazard tree with decayed cavities identified by the Monitor team.

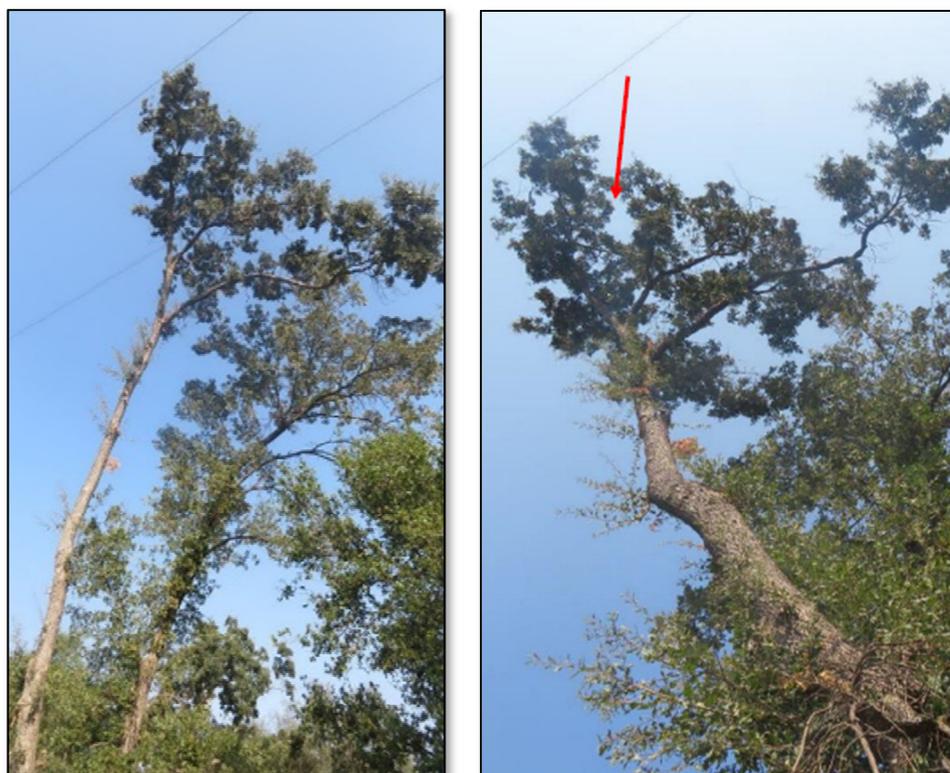
Below is a hazard tree with poor taper identified by the Monitor team.

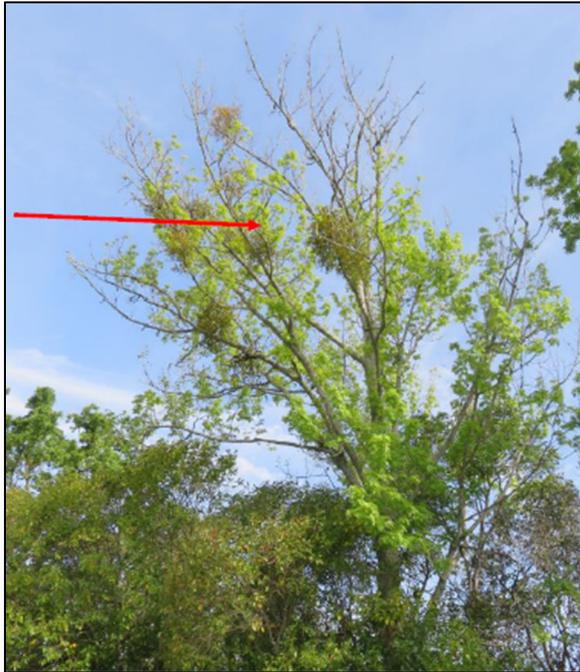
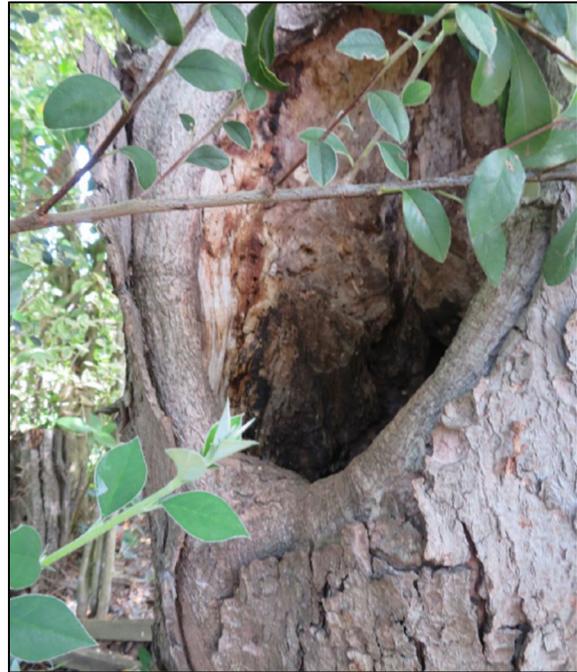
Below is a hazard tree with branch dieback and decayed cavities identified by the Monitor team.

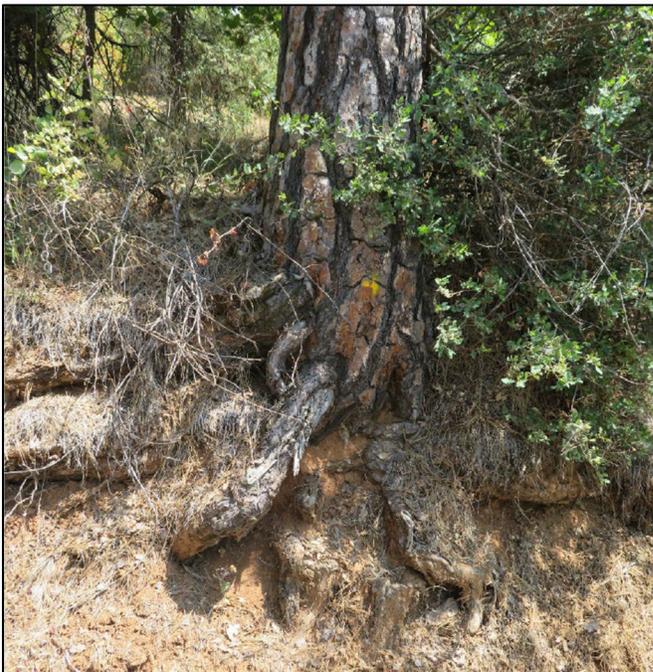
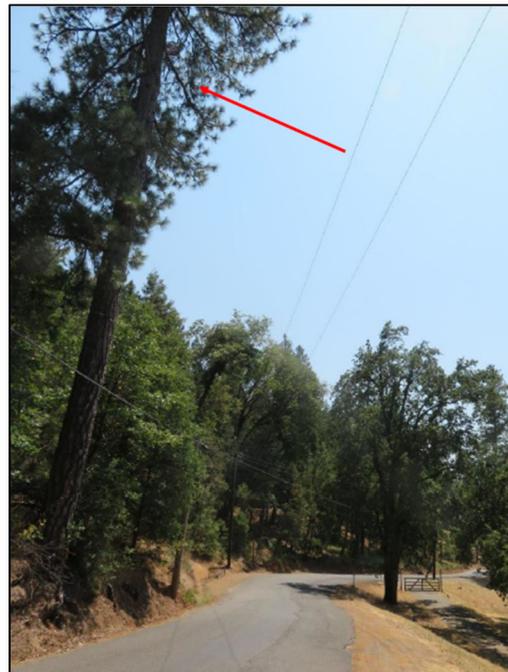
Below is a hazard tree with exposed roots identified by the Monitor team.

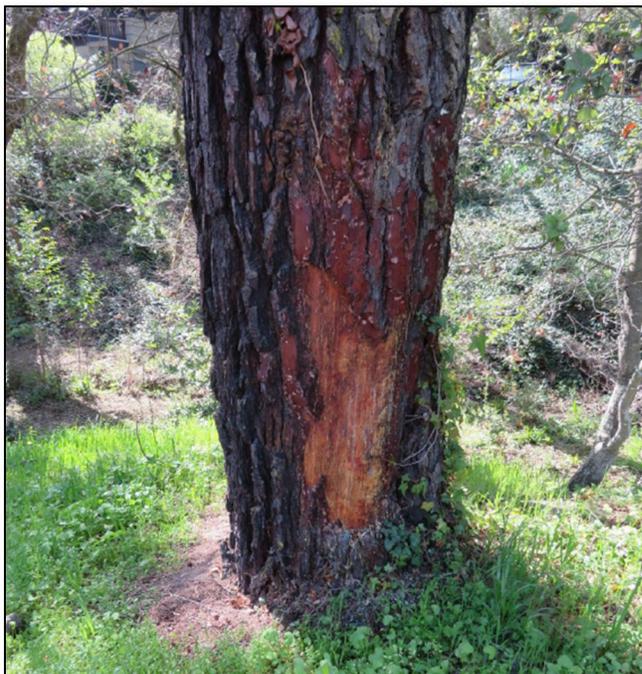
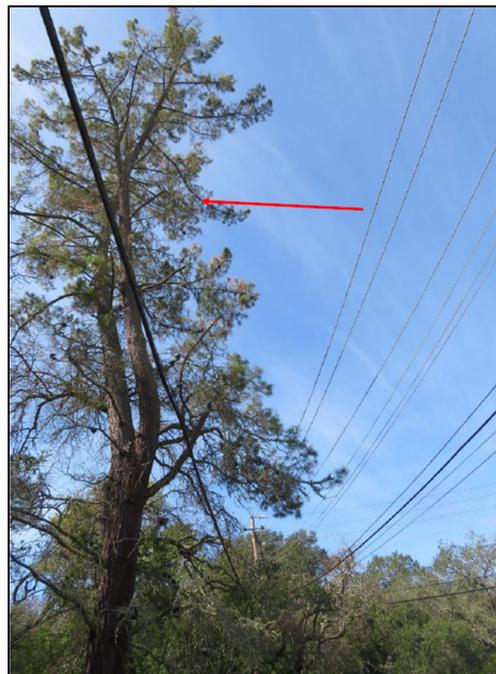
Below is a hazard tree with mechanical damage identified by the Monitor team

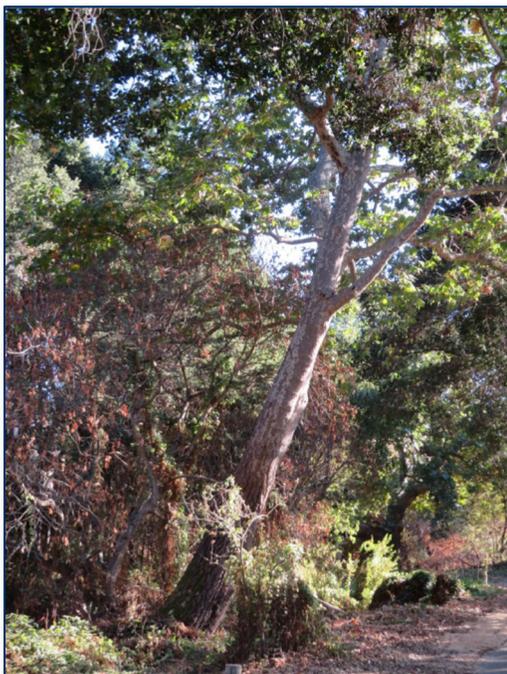
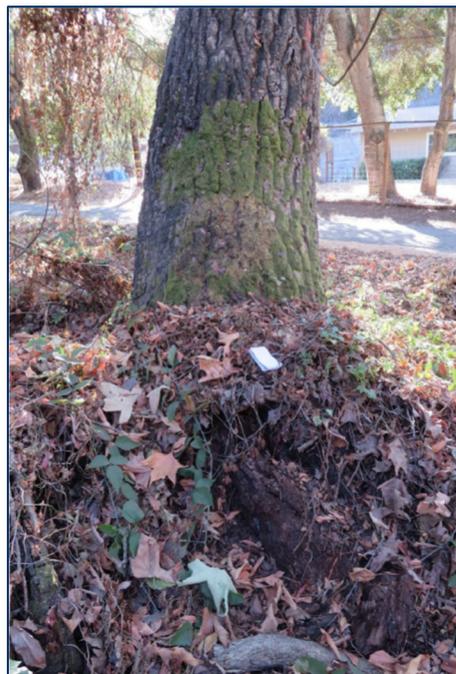
Below is a hazard tree uprooting at the base identified by the Monitor team.

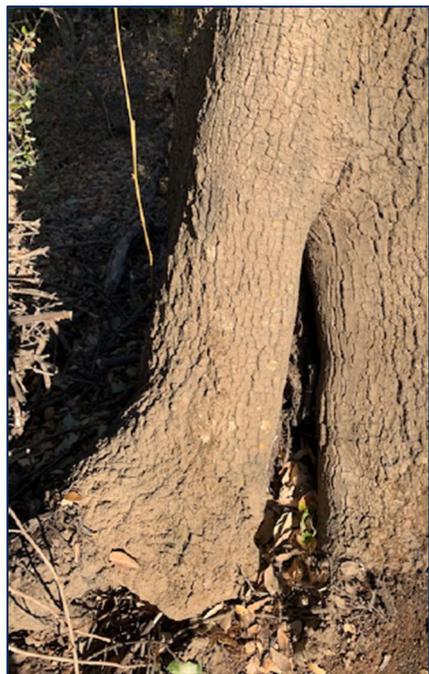
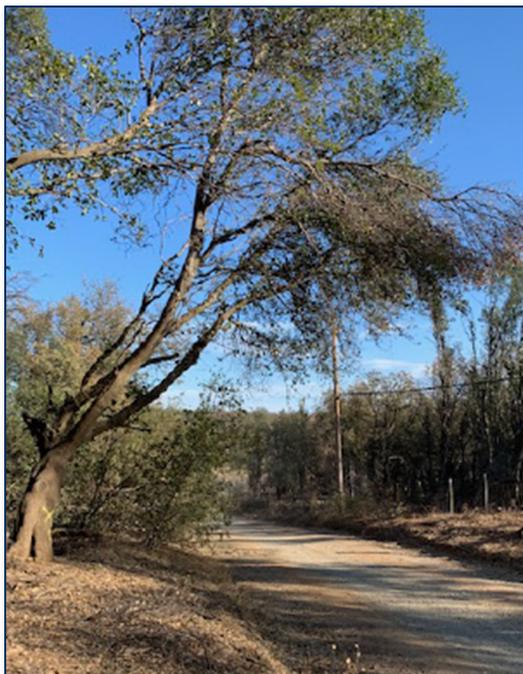
Below is a hazard tree with cavities, heart rot, and cracking identified by the Monitor team.

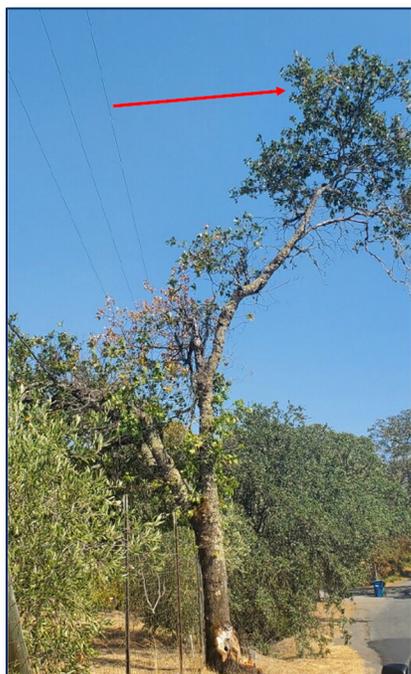
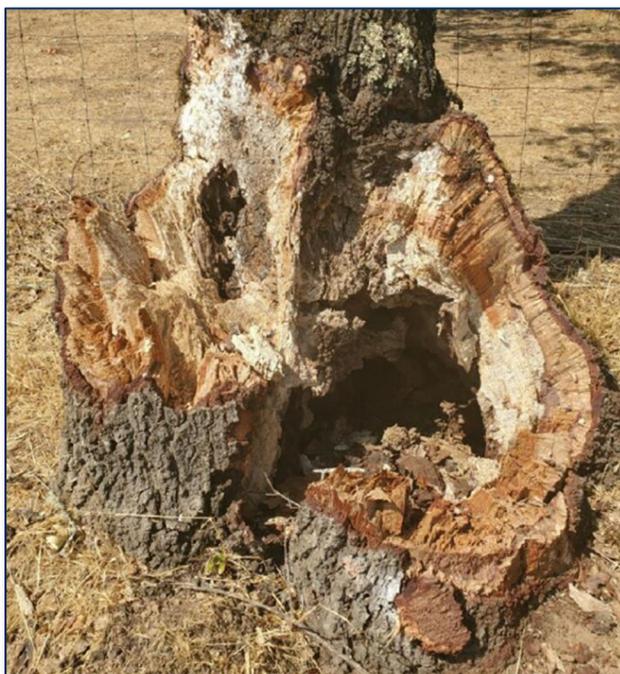
Below is a hazard tree with cavities and rotting identified by the Monitor team.

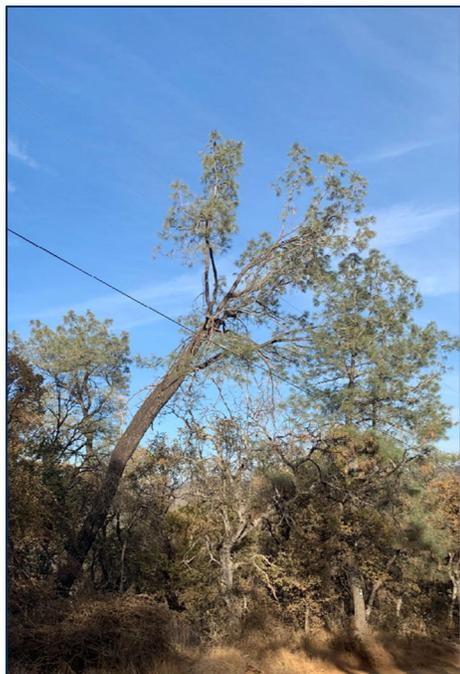
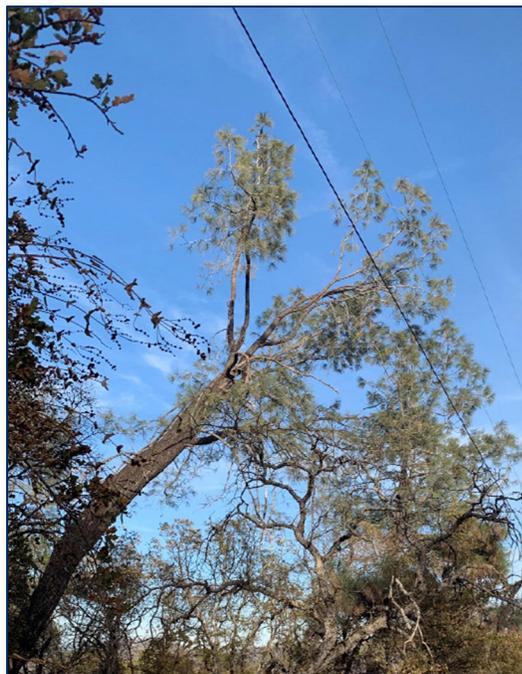
Below is a hazard tree with severe lean towards primary conductor identified by the Monitor team.

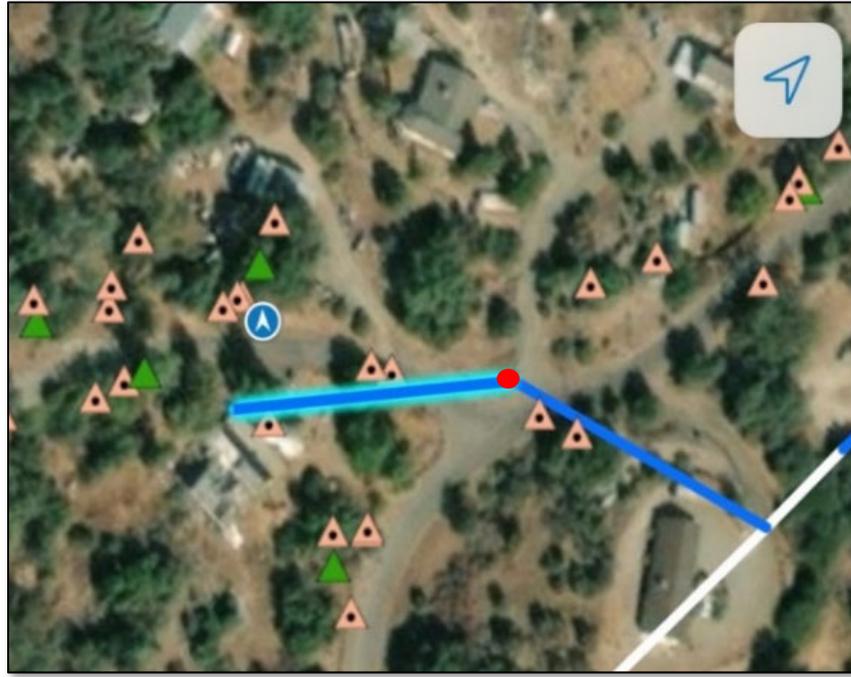
On CIP\_BF126-A14\_638206, the actual location of a pole (blue circle with white arrow) was ~200 feet away from the location of that pole on the Arc Collector map (red circle).

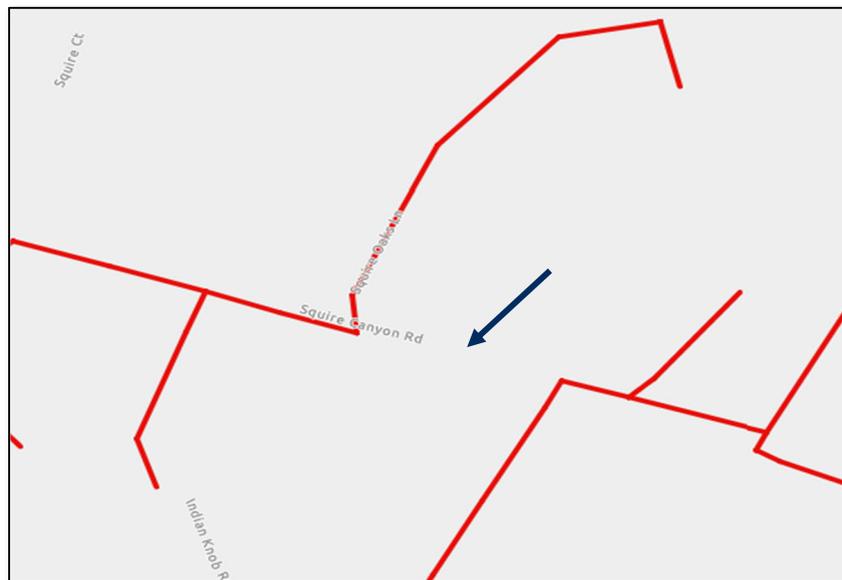
Near CIL\_AY138-L08\_143892, the Monitor team informed PG&E on 10/30/20 of a radial clearance issue on a segment that was missing from the Arc Collector map. That segment is still missing in 2021.

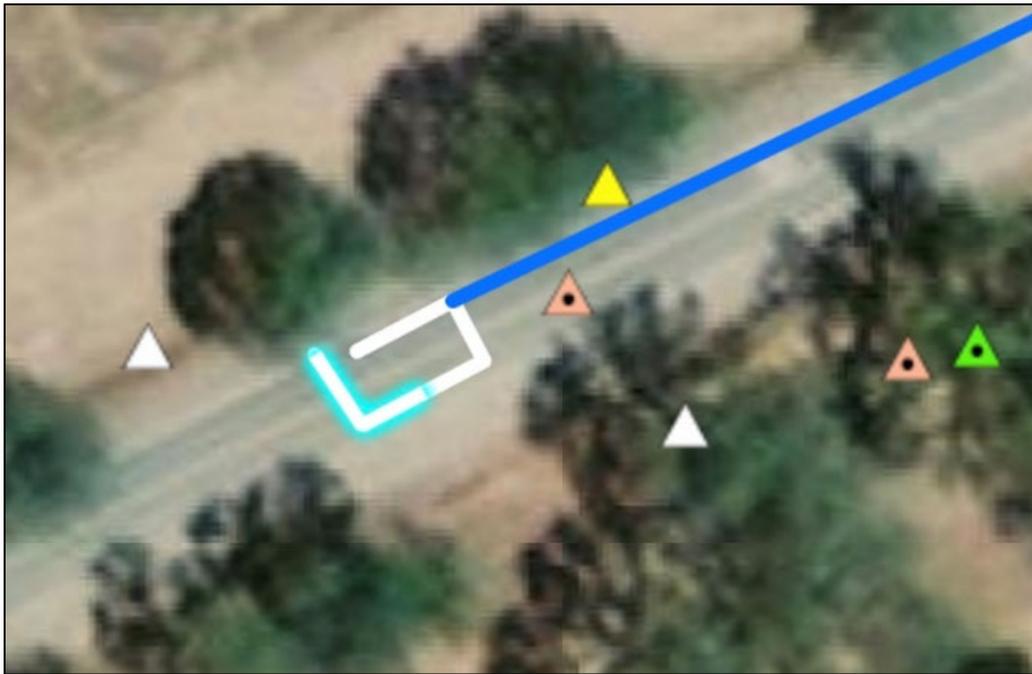
CIE\_AO108-B15\_1774125 (and the adjacent L-shaped segment) do not exist in the field.

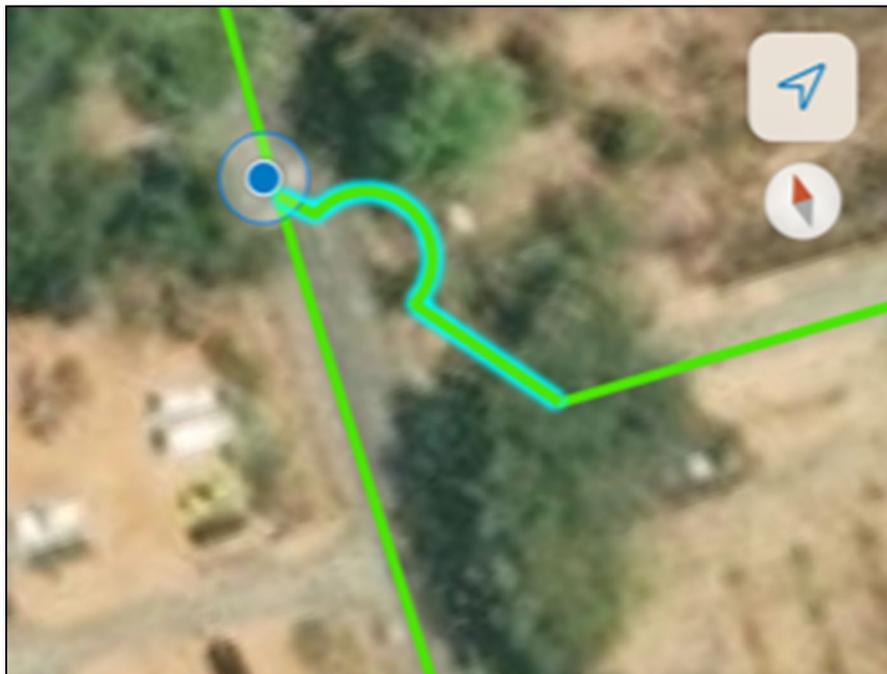
CIE\_AP120-K24\_1757184 appears curved on Arc Collector, but the segment is a straight line in the field.

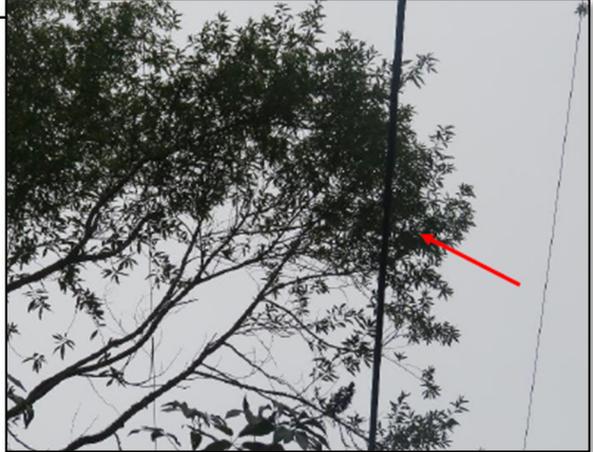
Near CIE\_AJ120-K23\_1744484, the Monitor team observed five trees that had been marked as “Tree Work Complete,” but the Monitor team observed that the prescribed tree work had not been performed.

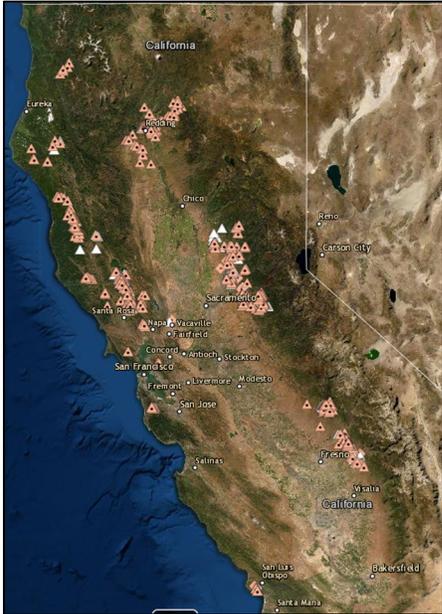
The below vegetation point record shows a tree with a Tree Assessment Tool result of “Abate” but a Status of “No Work Required Under EVM.” The map shows 1,541 vegetation point records in Arc Collector with the same discrepancy between the Tree Assessment Tool result and the Status.

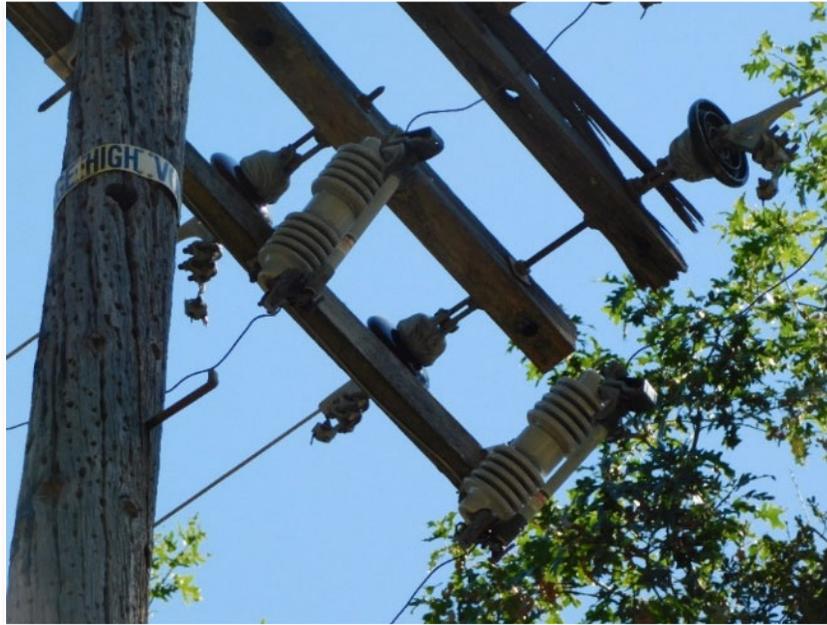
Below is a severely damaged crossarm the Monitor encountered in a Tier 3 HFTD. The Monitor team immediately reported this condition to PG&E, which then dispatched a field team that arrived on site within approximately two hours.

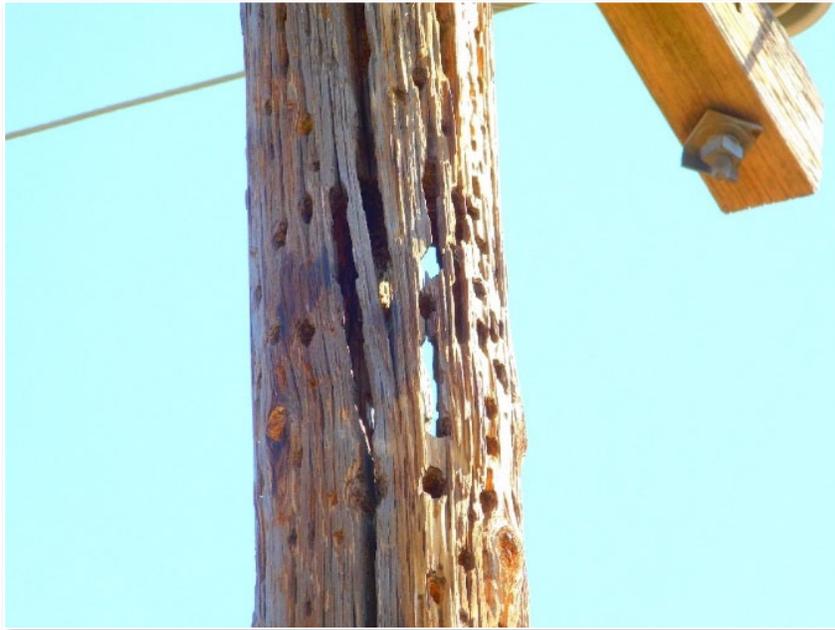
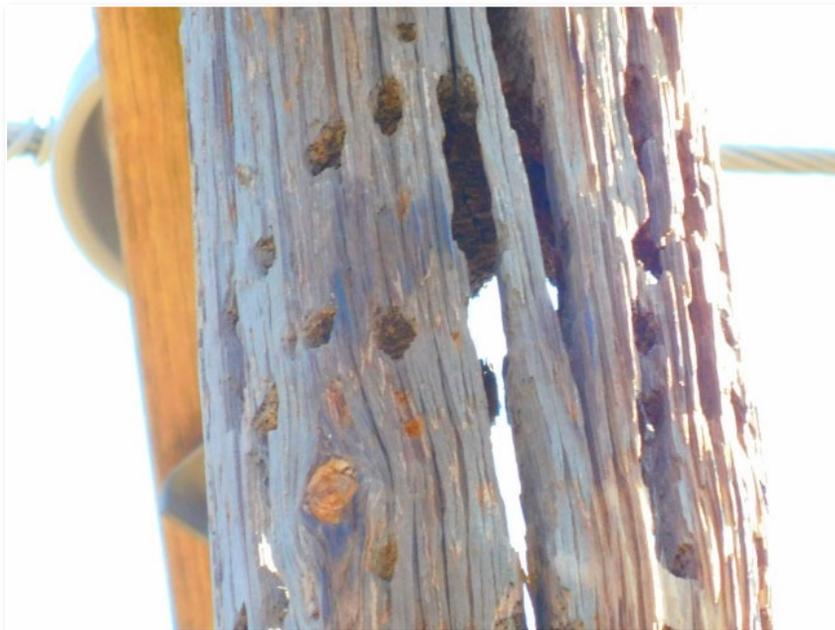
Below is a pole with severe cracking and decay that the Monitor team found in a Tier 2 area and immediately reported to PG&E. The Monitor team confirmed that PG&E replaced the pole the same day.

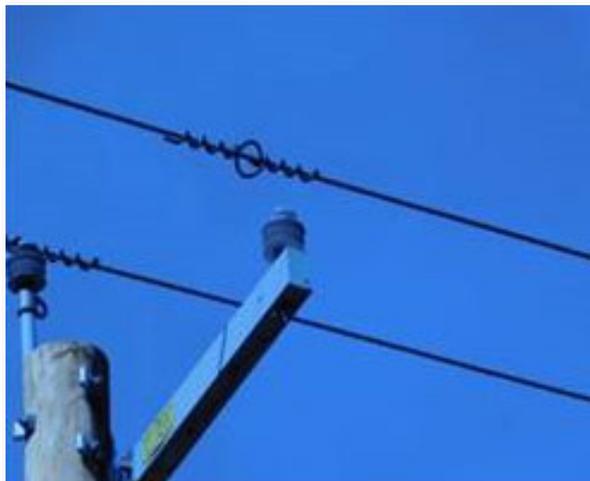
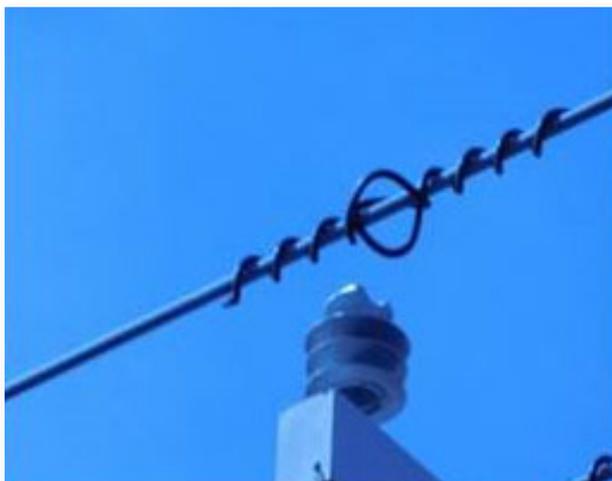
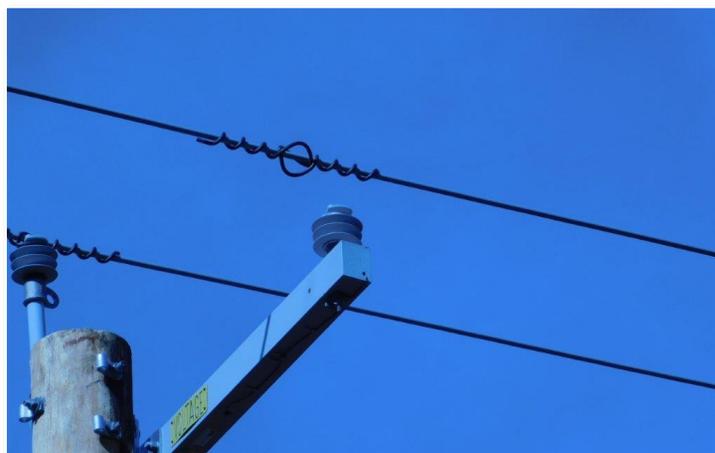
Below are floating conductors the Monitor team identified in Tier 3 areas and immediately reported to PG&E.

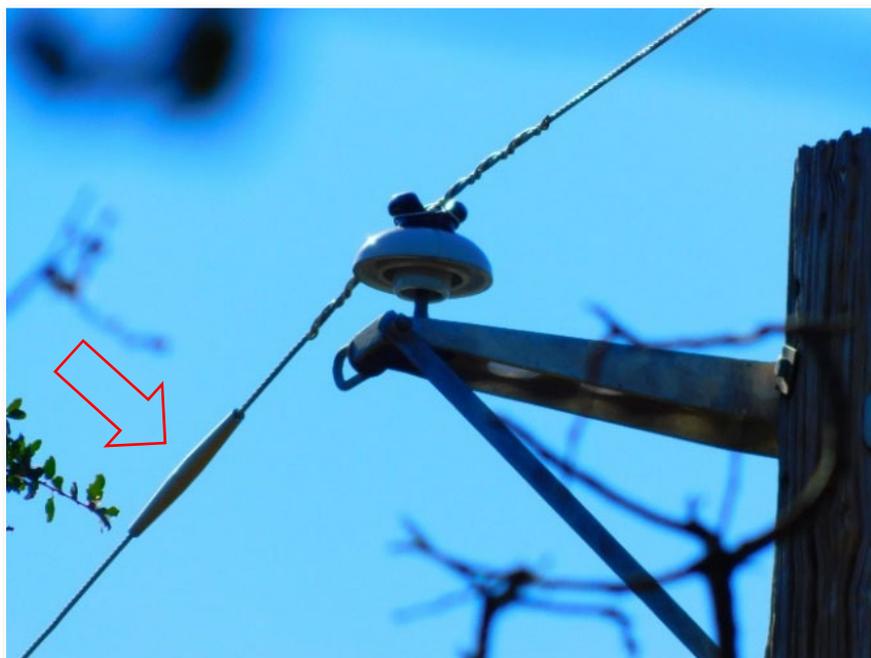
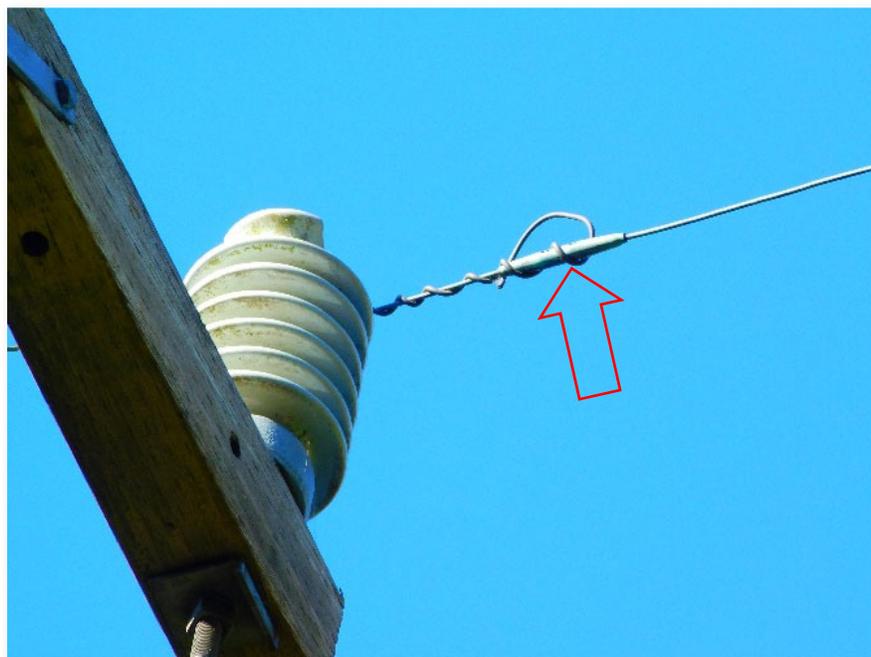
Below are conductors the Monitor team identified with splices tied in within 2' of an insulator.

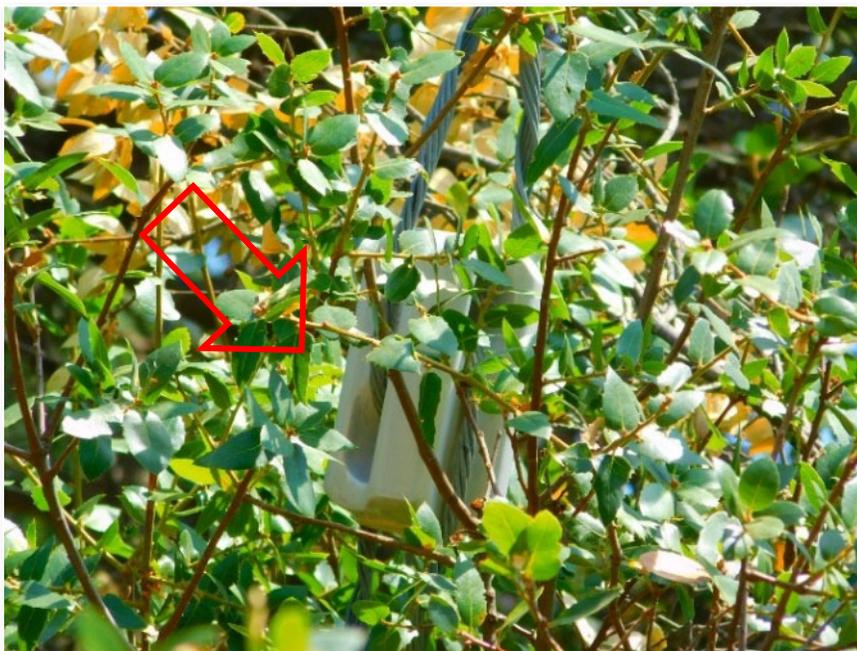
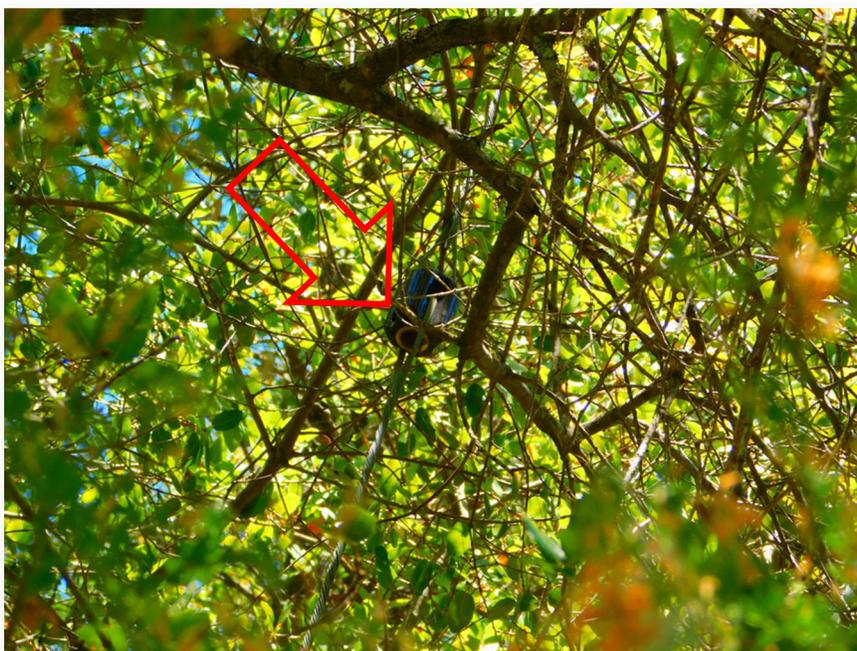
Below are examples found by the Monitor team where the guy wire was overgrown by vegetation.

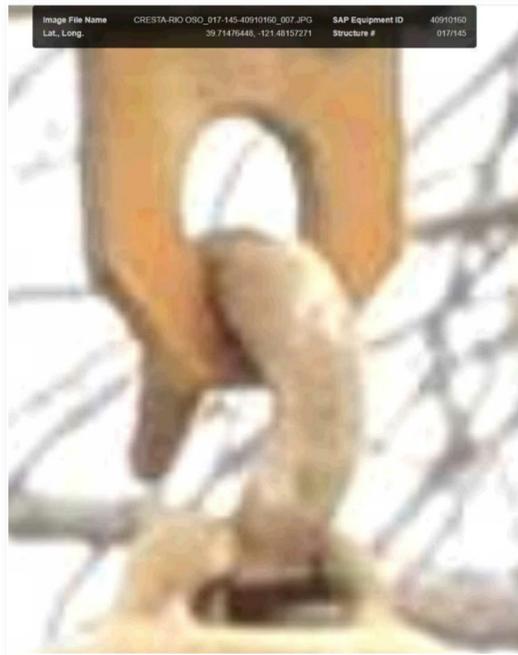
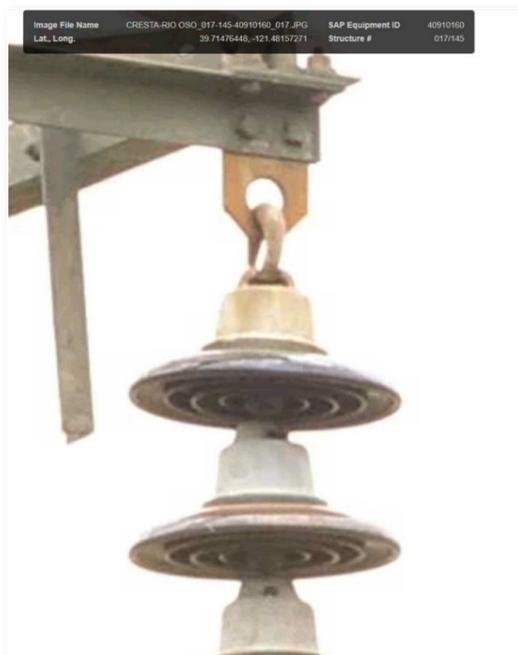
Below is a transmission structure on which the Monitor team observed a partially deteriorated C-hook and hanger plate.

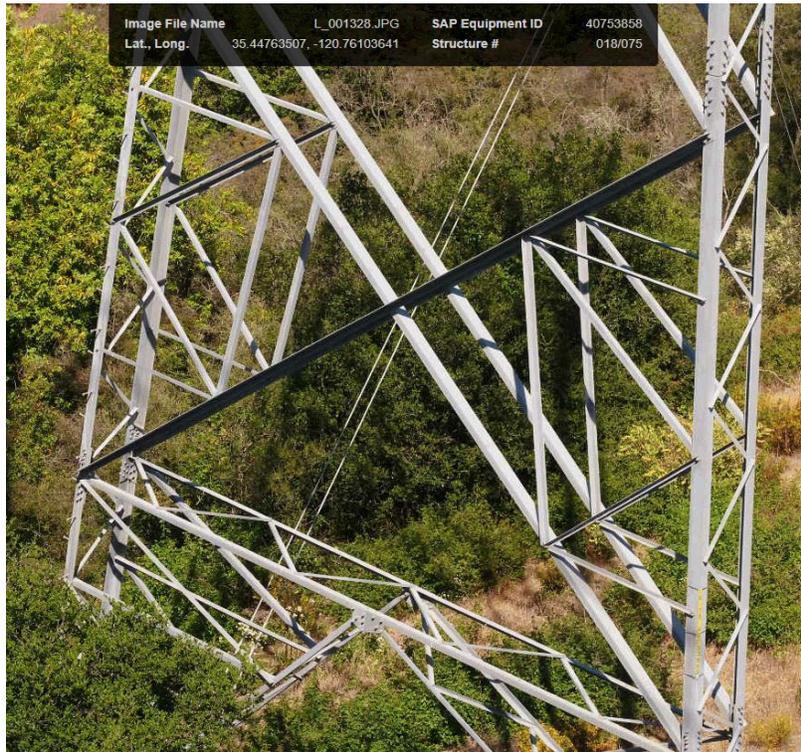
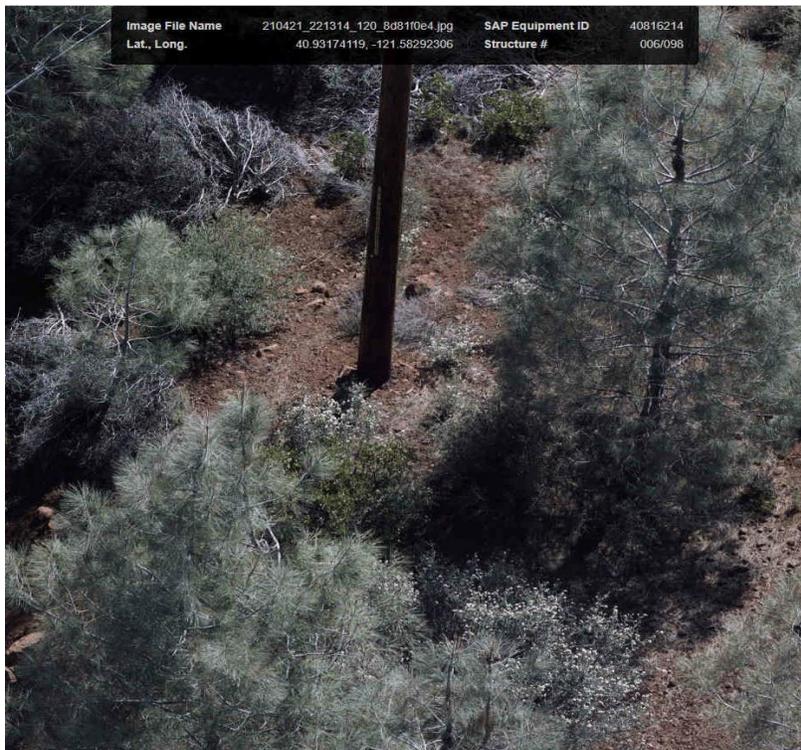
Below are structures the Monitor team identified that appeared to have vegetation present where PG&E inspectors did not note it.
