## **INVESTIGATION REPORT**

<b>CASE NUMBER:</b>	17CABTU015954
<b>CASE NAME:</b>	La Porte
<b>DATE:</b>	October 8, 2017
<b>INCIDENT TYPE:</b>	Vegetation Fire
<b>INCIDENT INVESTIGATOR:</b>	Tom Kluge – Fire Captain Specialist - BTU

# LA PORTE FIRE

17CABTU015954-103

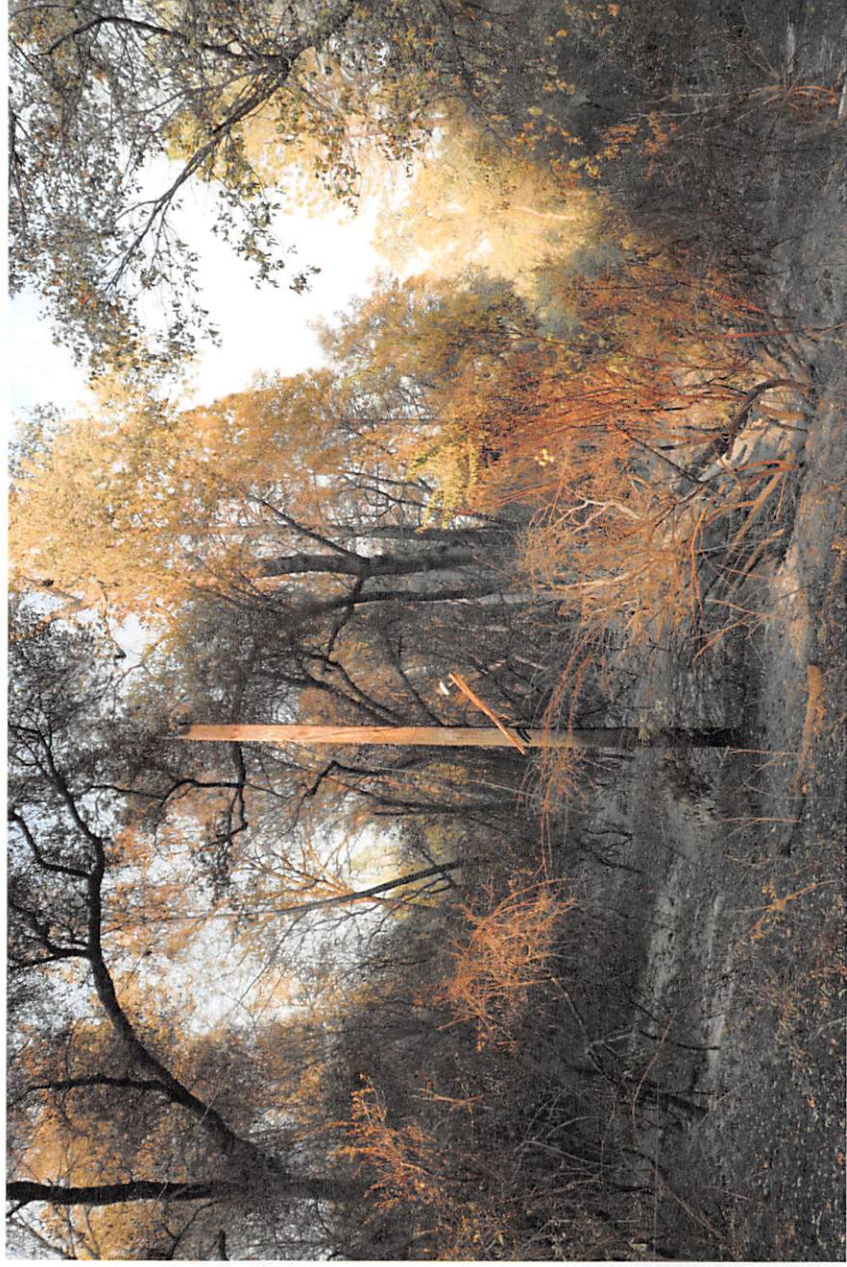
Photograph 1  
General Origin Area (GOA)

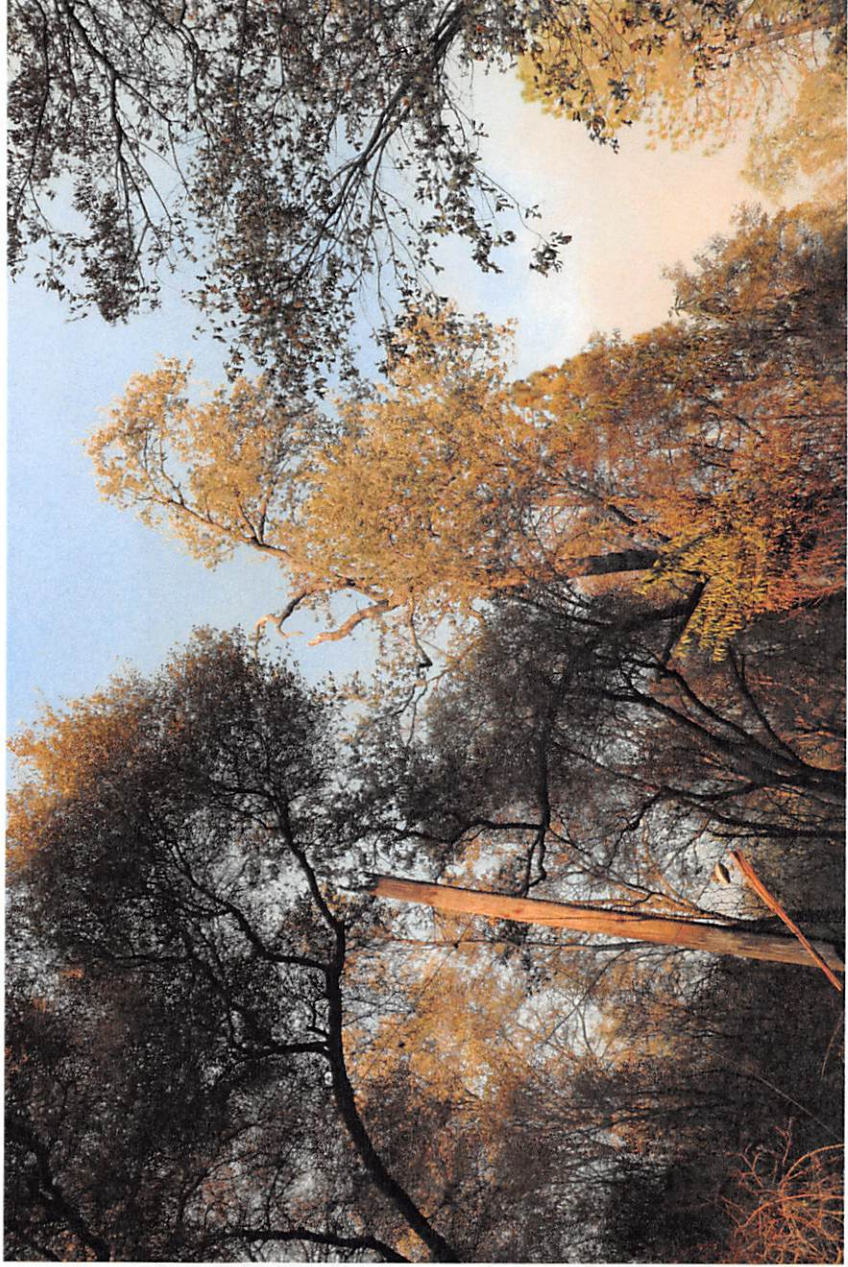
3  
4 The report provided by the contracted arborist, Mark Porter, stated the subject valley  
5 oak did show signs of decay. The arborist report stated there may have been a crack at  
6 the base of the limb. The arborist report stated it is possible there were no visible  
7 outward signs of failure or weakness that would have been discovered with a normal  
8 assessment.

Photograph 2  
Subject tree in GOA

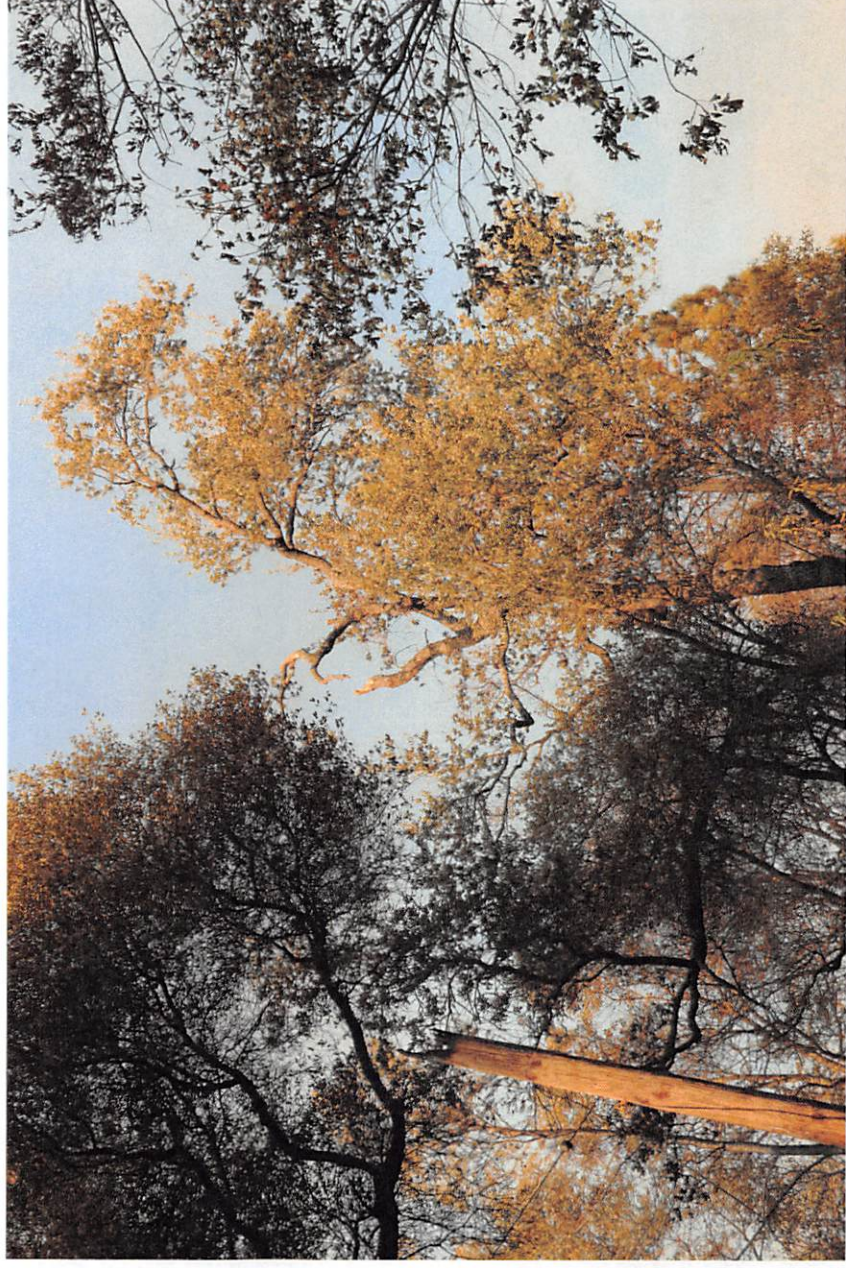
Photograph 3  
Closer view of subject tree in GOA

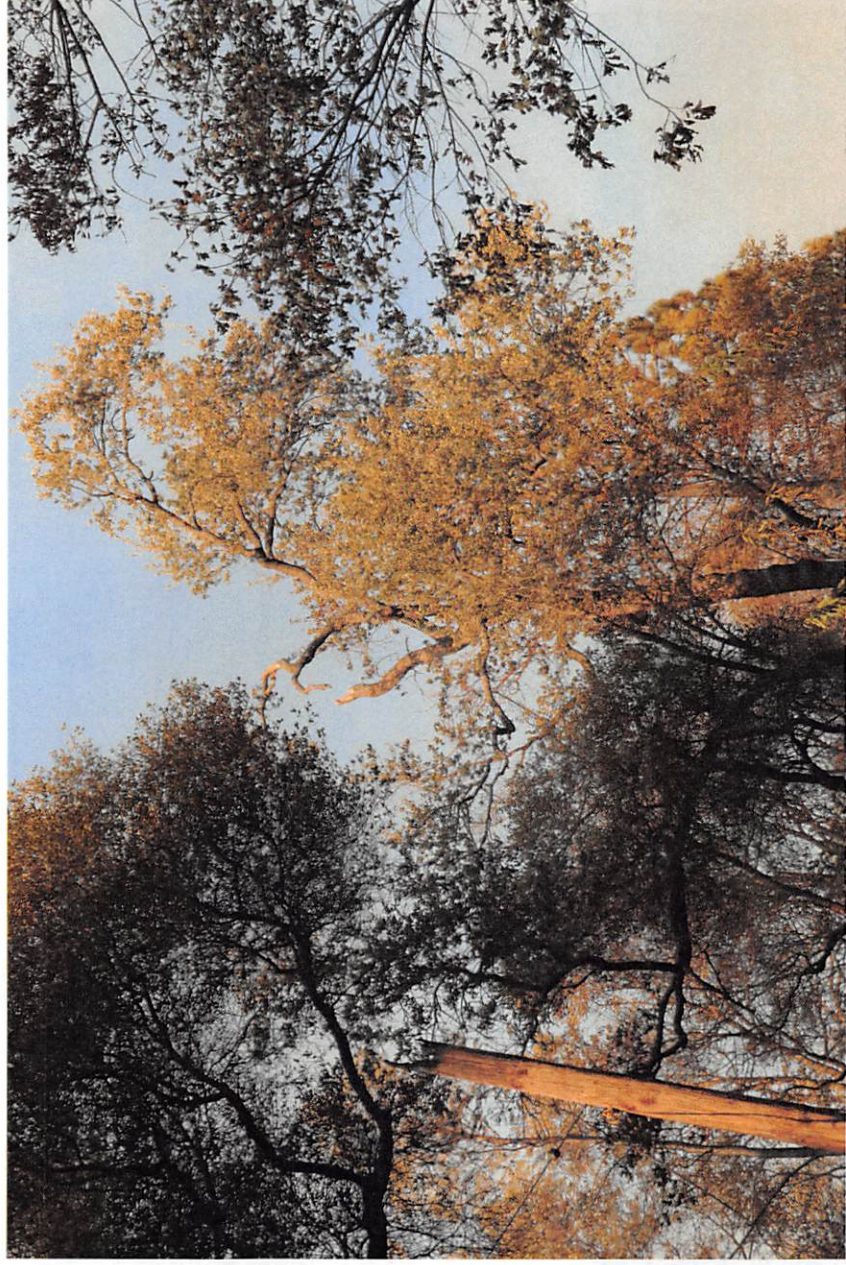
Photograph 4  
Closer view of subject tree in GOA

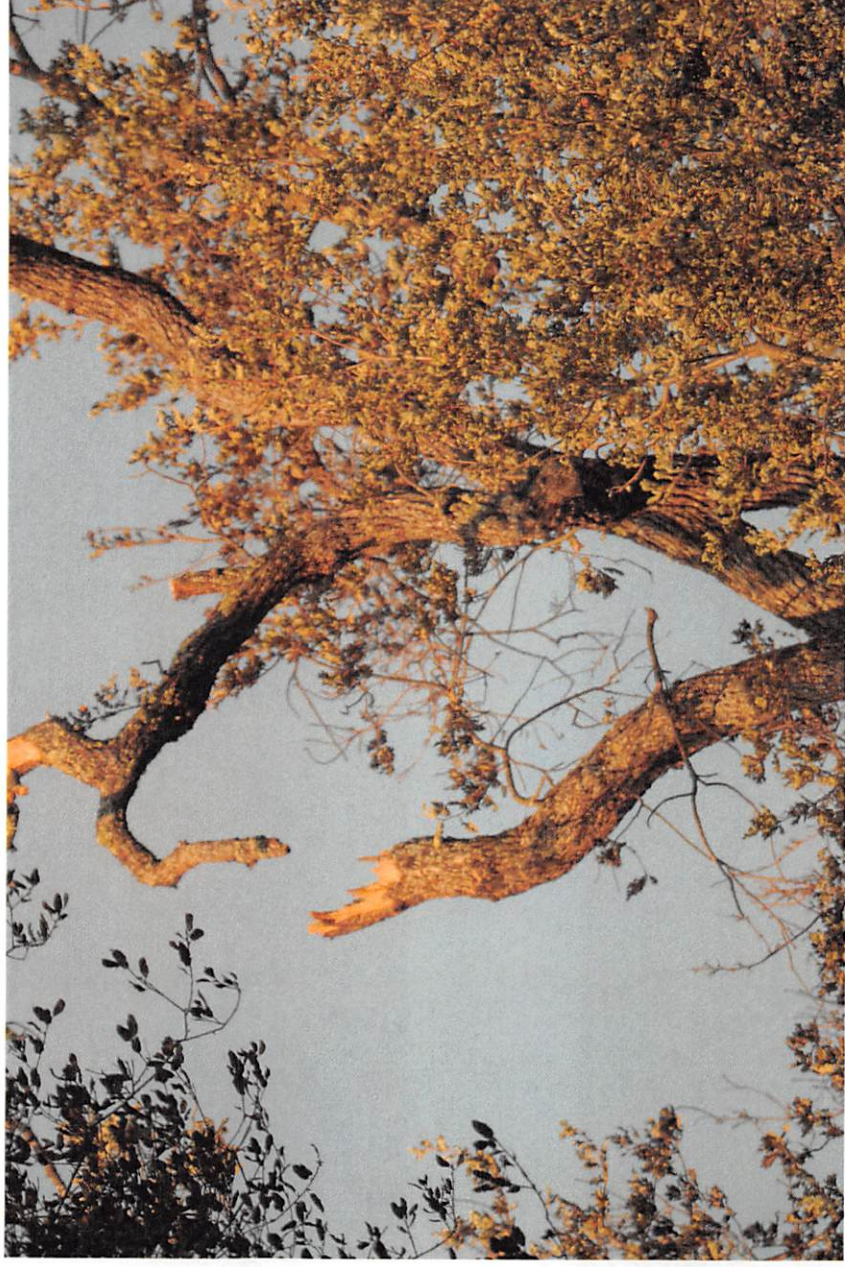
Photograph 5  
Subject limb break of subject tree

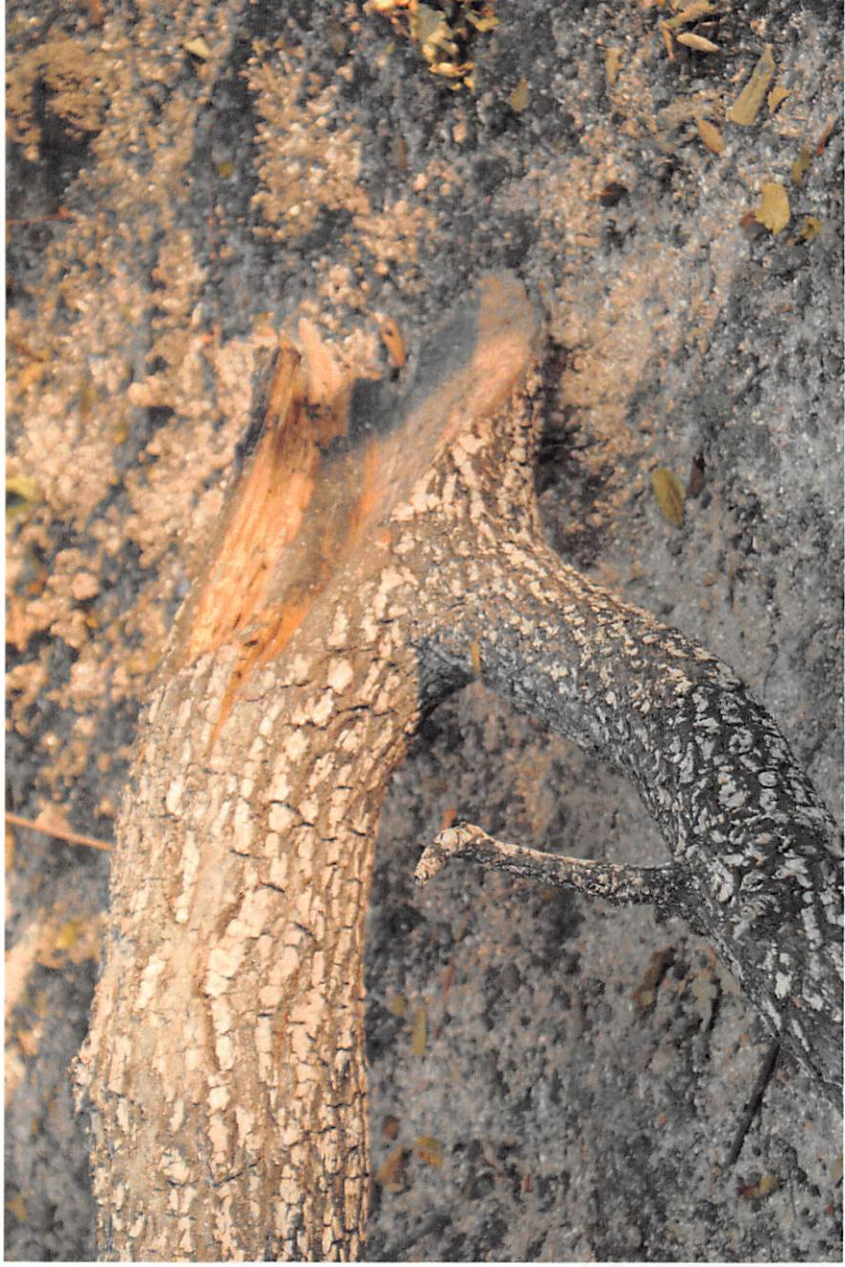
Photograph 6  
Close up broken limb

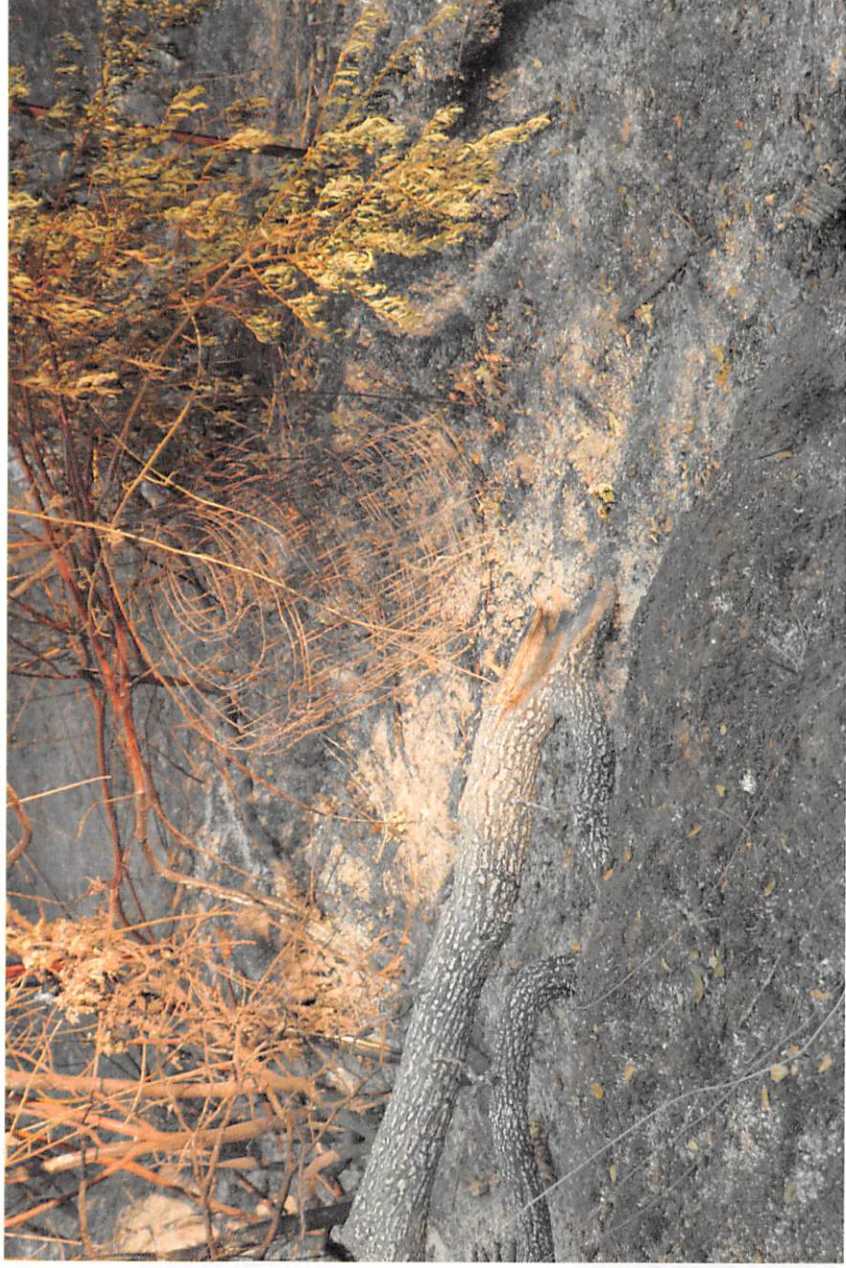
23 (photo 7). I observed the break in the branch did not appear to be weathered. The oak  
24 branch was partially scorched however mostly undamaged with leaf foliage still intact.  
25 The oak branch was positioned on top of the conductor wire that was observed in the  
26 SOA. I photographed the area and secured access to the GOA.

Photograph 7  
Broken oak limb in GOA

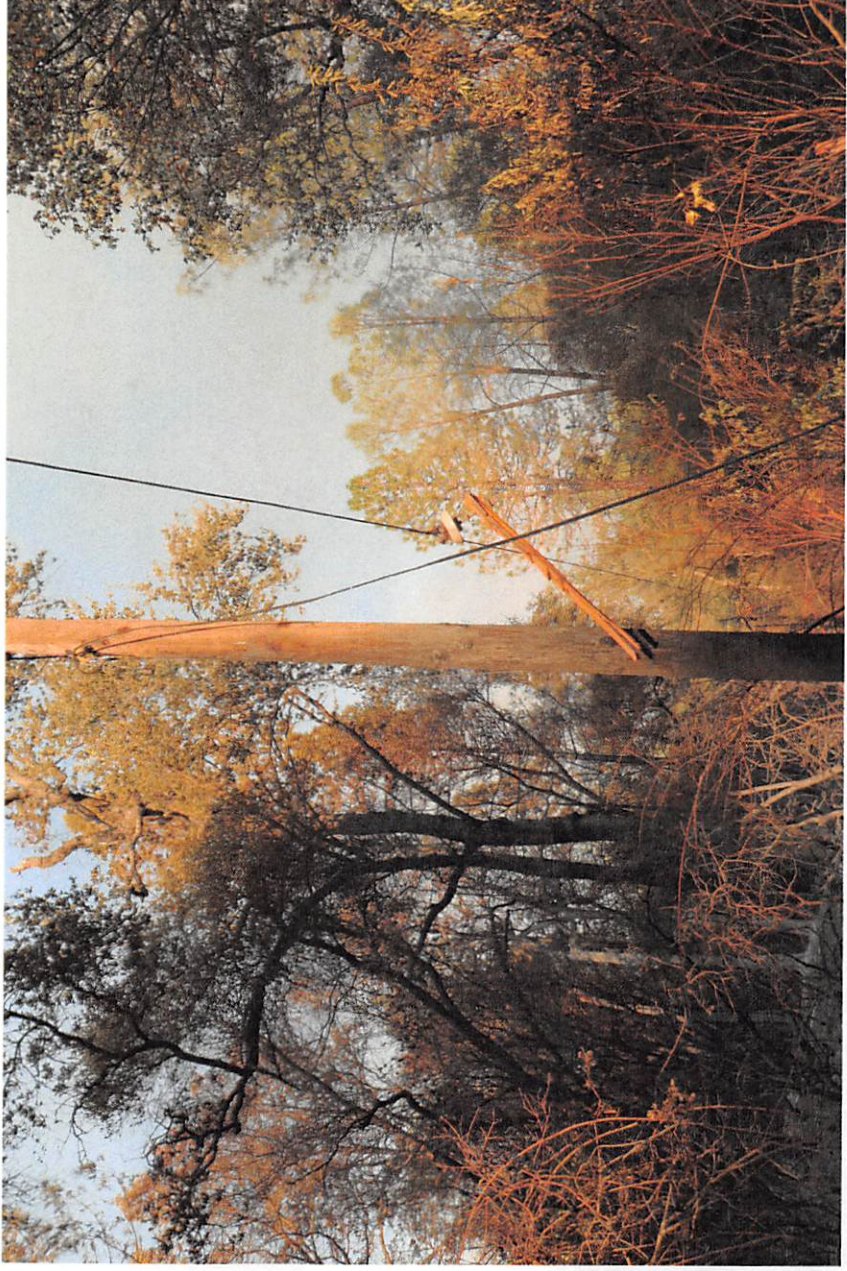
Photograph 8  
close up view of broken cross arm

There were powerlines that were down in the area. A power pole had been broken and burned. One of the metal supports for the cross beam was bent in an ell where it should have been straight. One conductor was broken. The insulators for one of the conductors was broken. The cross beam was split into two pieces at the point where the bolt holes were drilled through. There was a seven inch diameter oak branch laying on the broken conductor. The oak branch had most of it leaves still intact. There was a valley oak near the broken branch that had one of the top limbs broken off. The diameter and distinct features of the failed limb of the tree were very similar to the broken limb on the ground. There were signs of arcing on the broken conductor wire.
