**CALIFORNIA DEPARTMENT OF FORESTRY AND FIRE PROTECTION
NEVADA-YUBA-PLACER UNIT**

INVESTIGATION REPORT

INCIDENT NUMBER: 17-CA-NEU-026269

CASE NAME: CASCADE

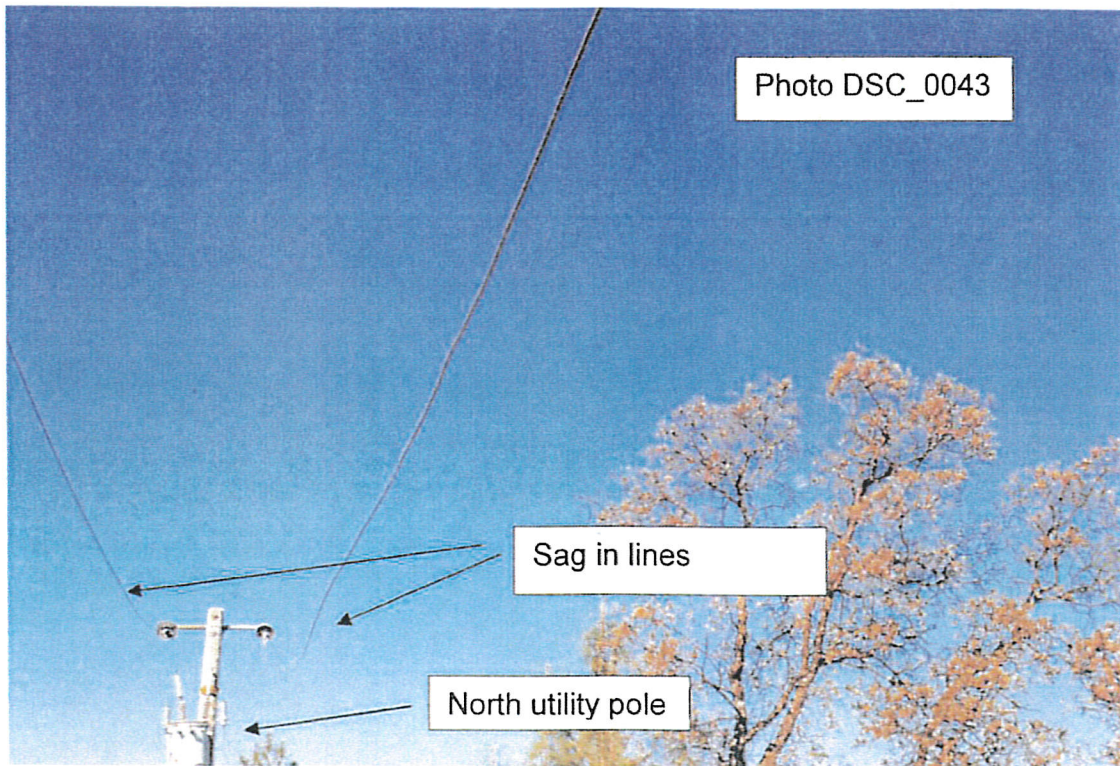
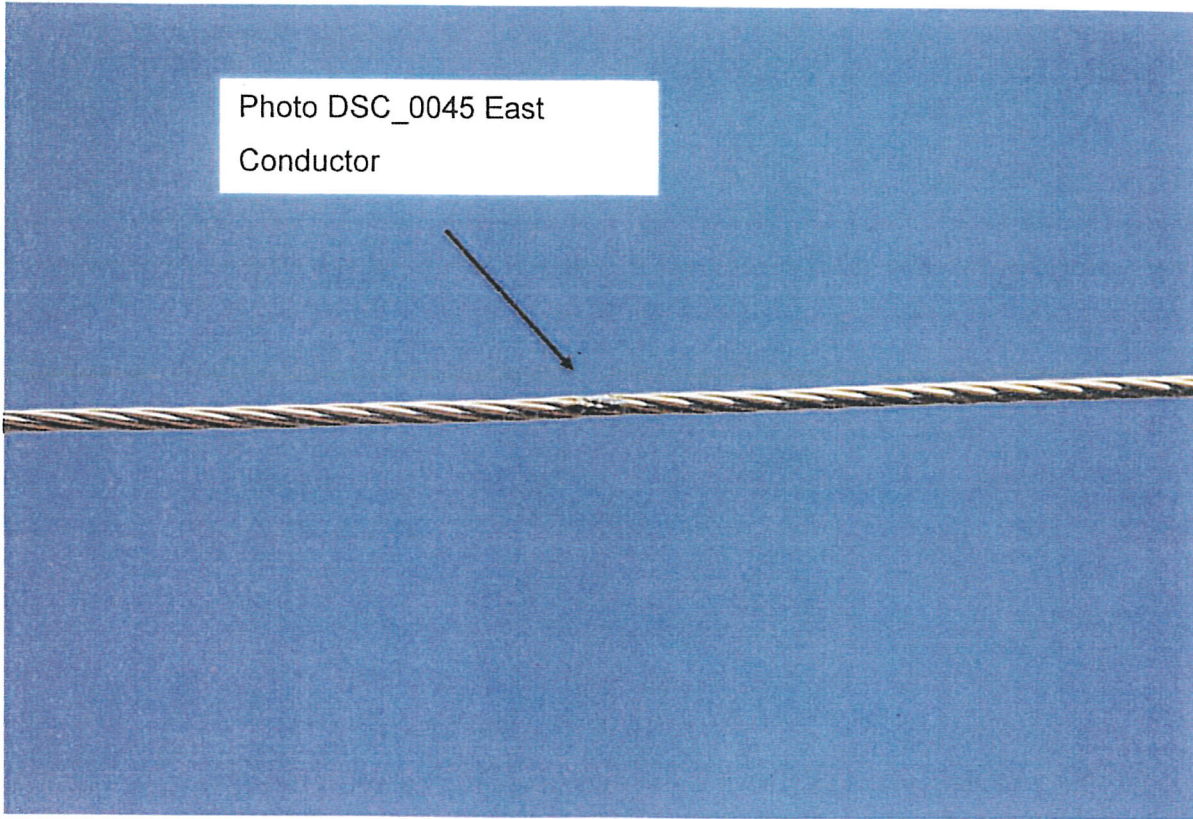
1 From the bucket truck, I observed and photographed an irregularity on both the east
2 and west conductors. The irregularities appeared to be damage to the lines. The
3 damage appeared to be close to the same distance between the north and south utility
4 poles. Jim NOLT completed an independent report of the electrical equipment at the
5 scene (Attachment -7).

2 Based on my knowledge, training, and experience, 911 audio, witness
 3 statements, and evidence from the Cascade Fire, I believe the cause of the Cascade
 4 Fire was due to line sag during the October 8, 2017 wind event. The wind in
 5 conjunction with the line sag on the two-conductors located on the property at 13916
 6 Cascade Way made contact creating an electrical arc. The electrical arc deposited hot
 7 burning or molten material on the ground in a receptive fuel bed causing the fire. I
 8 reserve the right to re-examine this report if additional information is discovered or
 9 provided to me that could amend or reinforce my opinions or conclusions.

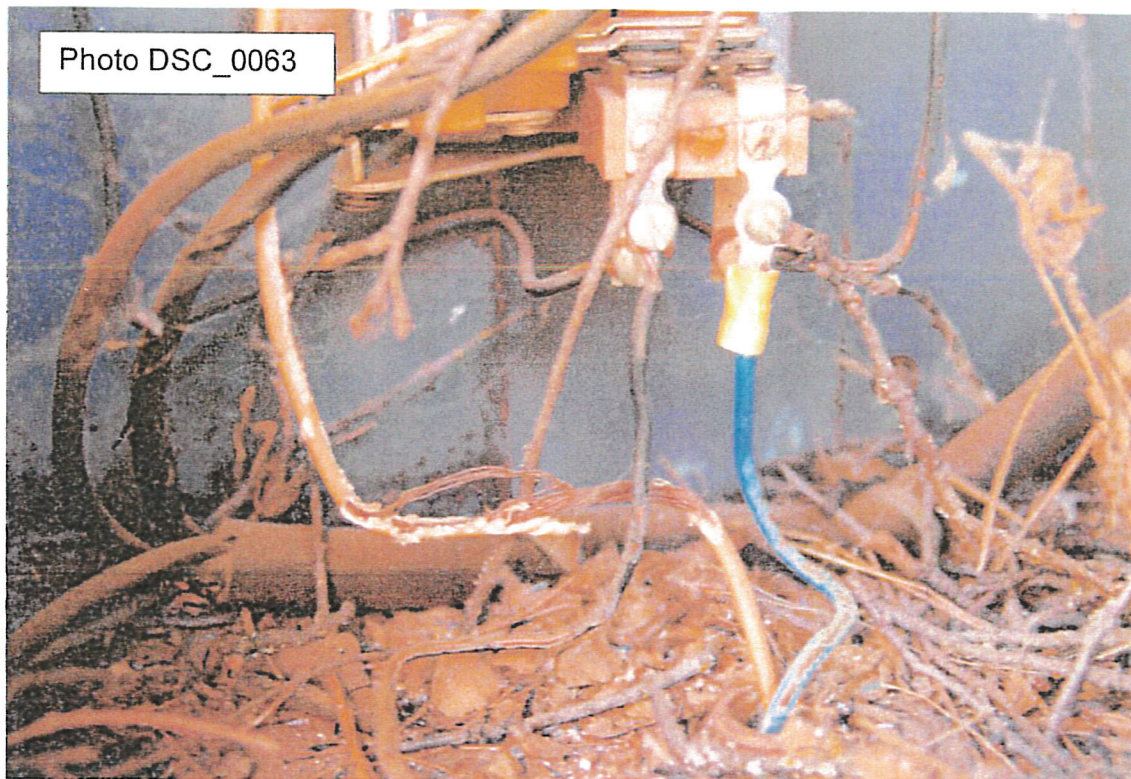
The electrical panel inside of the well house appeared to be weathered and damaged by rodents (see photo DSC_0063).

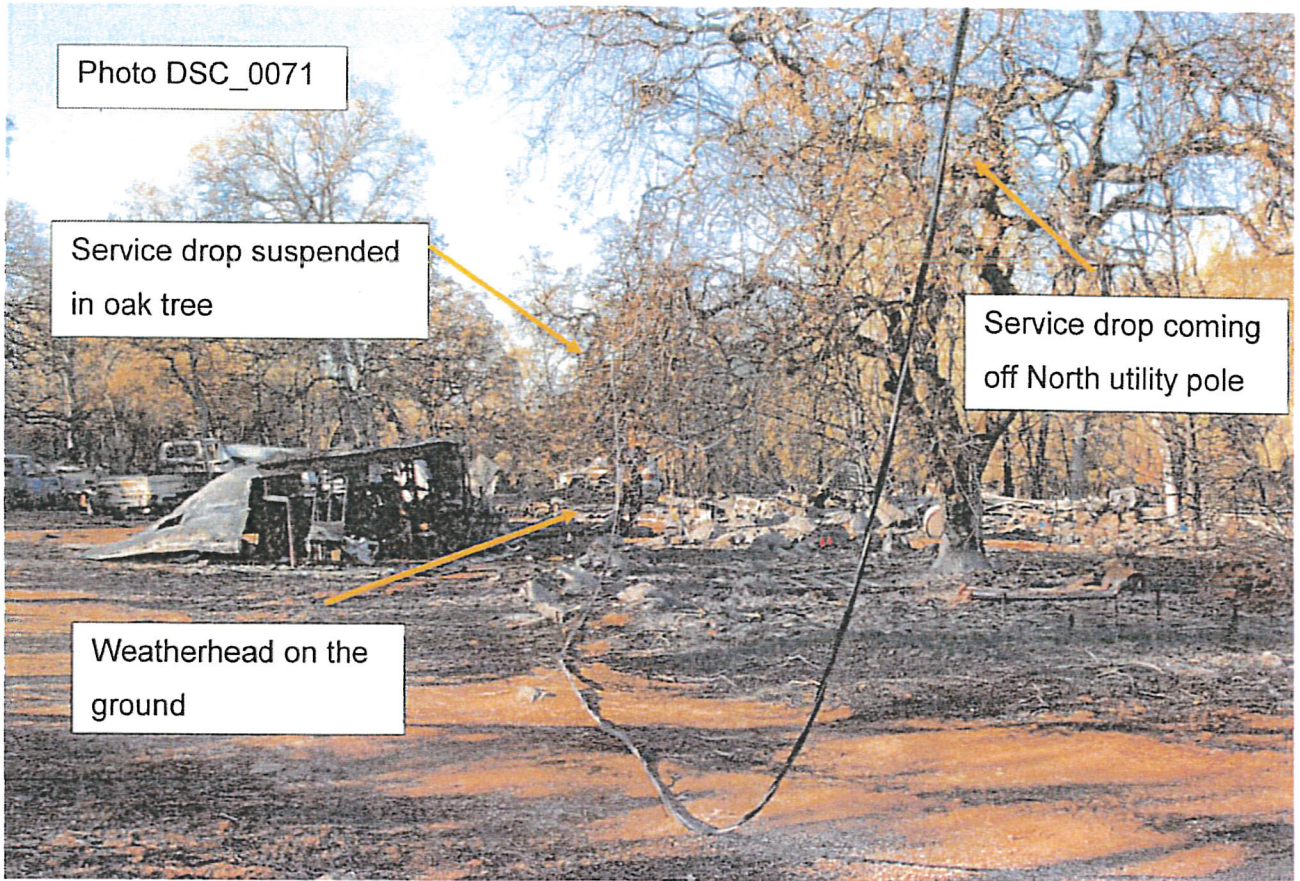
4 NOLT and I checked the drop line coming off the north utility pole going to the
5 weatherhead near the 5th wheel trailer. The service drop came off the pole and was
6 lying on the ground (See photo DSC_0071). From the ground, the service drop went up
7 off the ground held by an oak tree and was found near the weatherhead by the 5th
8 wheel trailer.

I was unable to locate any tree branches on the drop line which would suggest the tree caused the drop line to contact the ground. I was unable to locate any limb damage, charring, pitting, or staining on the tree which would have been indicative of a live conductor making contact with the tree. The weatherhead, electrical meter, and electrical panel to the 5th wheel trailer were collected as evidence and sent to Anamet Inc. for further laboratory testing due to the extent of fire damage to the equipment. NOLT also looked at this equipment for analysis (See NOLT report - Attachment 7).

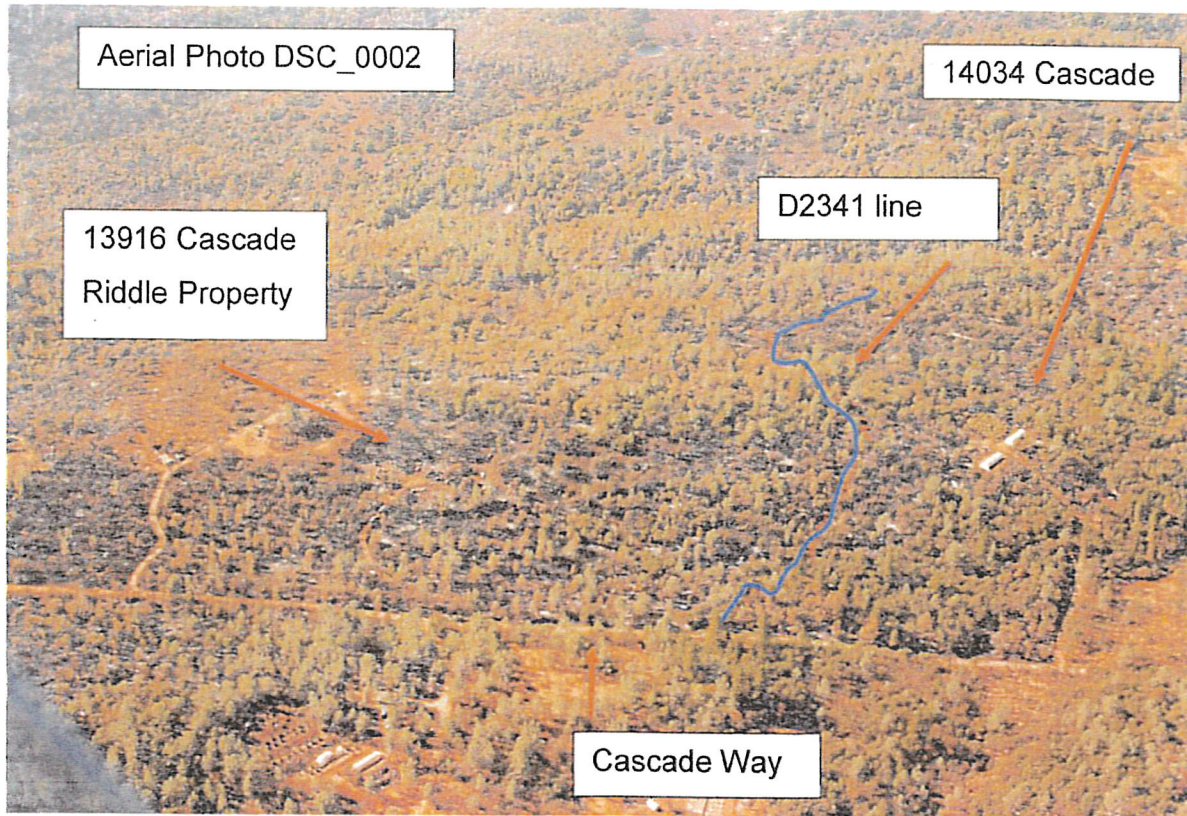
13 Marijuana cultivation buildings and power pole at 14034 Cascade Way were not
14 involved in fire until suppression crews arrived and used fire to improve the line (See
15 Aerial Photo DSC_0002).

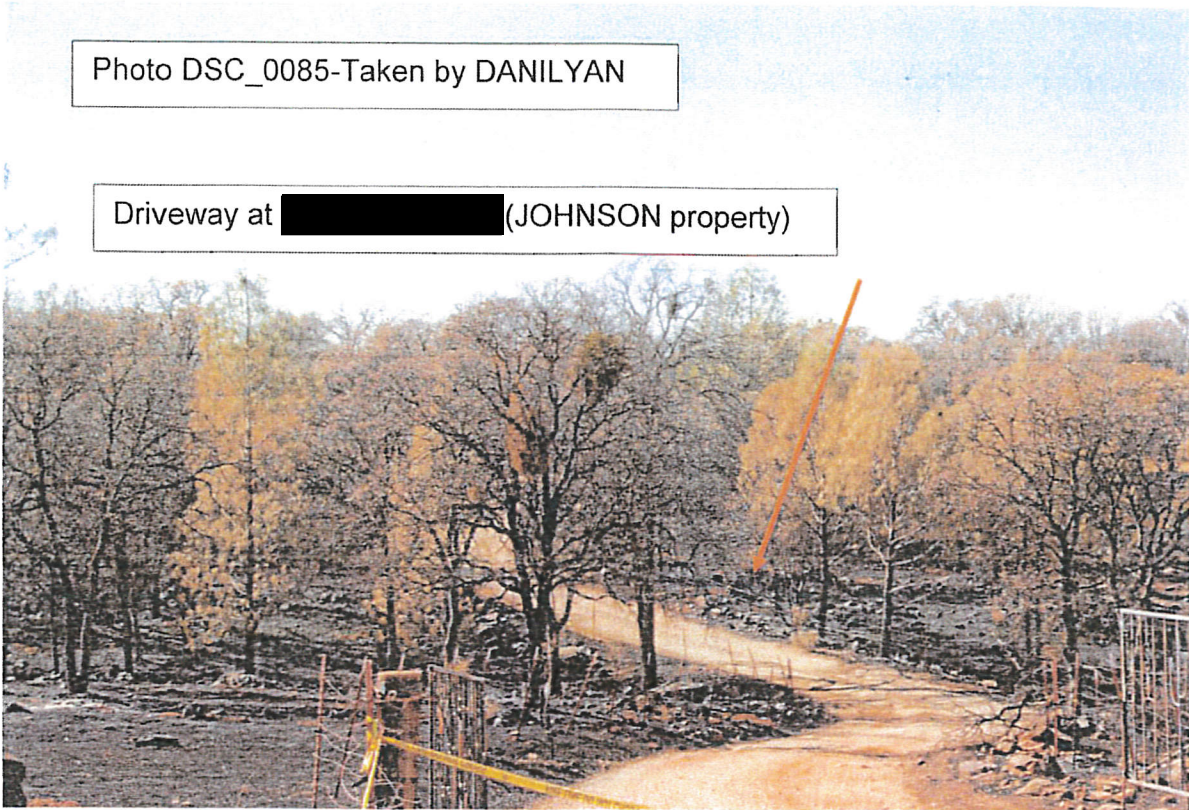
Photo DSC_0085-Taken by DANILYAN

At about 9:20 AM on Saturday October 14, 2017, I interviewed Greg DANILYAN at his residence at [REDACTED] (See Attachment 9) . DANILYAN said the fire was on the north side of the JOHNSON driveway, and had not crossed to the south side of the driveway. DANILYAN said the fire was about 100-200 feet from Cascade Way. DANILYAN did not give a size of the fire, and I asked him if it was windy and his response was “insanely windy”. DANILYAN had to leave but met me again at the property at about 2:00PM. I gave DANILYAN my camera and asked DANILYAN to take a picture of where he saw the fire the night of October 8, 2017 when he was driving out. DANILYAN took a picture of the driveway to Matt and Jennifer JOHNSON’s house. I asked DANILYAN if he drove through smoke on his way out on October 8, 2017 and DANILYAN said “no”. The photo DANILYAN took is DSC_0085, taken from Cascade Way looking west.
