PG&E Responds to CAL FIRE's Report on 2021 Dixie Fire in Butte, Lassen, Plumas, Shasta, and Tehama Counties

CALIFORNIA DEPARTMENT OF FORESTRY AND FIRE PROTECTION

INVESTIGATION REPORT

On Tuesday July 13, 2021 at approximately 5:07 PM, the Dixie Fire was reported in a remote area above the Cresta Dam in Plumas County, CA, near the community of Pulga. The fire ignited below the Pacific Gas and Electric (PG&E) Bucks 1101 12KV distribution circuit, between pole number 120772797 and an unmarked pole approximately 300 feet east. The fire ignited as a result of a 65' tall, damaged and decayed Douglas-Fir tree when it fell and contacted conductors at approximately 6:48 AM. Two of the three fuses blew (opened) upon initial contact with the conductors, but the third fuse remained closed and kept a line energized. The tree being in contact with energized conductors and the ground created a high impedance fault. The high impedance fault energized the tree, which caused heat and arcing to ignite a dry and receptive fuel bed over the course of 10 hours. Because PG&E had an excessively delayed response to the fault, the fire was not discovered until a PG&E troubleman W-1 arrived at scene at app

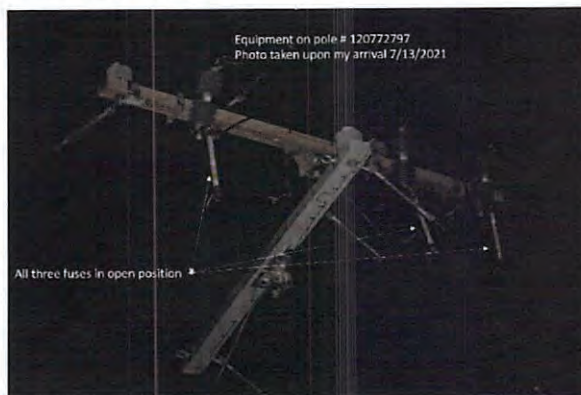
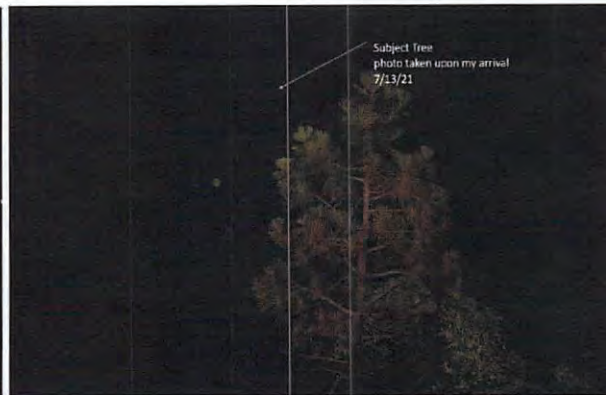
1 preserve the scene for the next day. At approximately 9:53 PM, I noticed increased fire
2 activity located in a steep draw. Within a few minutes the fire increased and made an
3 uphill run as it consumed an area of unburned brush and small trees. I observed a
4 moderate amount of ember cast over Camp Creek Road which threatened the
5 unburned (west) slope. As Magalia Crew 5 (Mag 5) arrived at the fire's edge I
6 expressed my concerns of a possible spot fire to the captain. Mag 5 Captain positioned
7 his crew members along Camp Creek Road to patrol for spot fires. I continued downhill
8 approximately 150 feet along the handline. With my flashlight I observed a pine tree
9 laying across all three conductors. Mag 5 Captain transmitted over the radio that the fire
10 had spotted across Camp Creek Road and was making a run uphill with a moderate
11 rate of spread. I photographed the tree across all three conductors and retreated up the

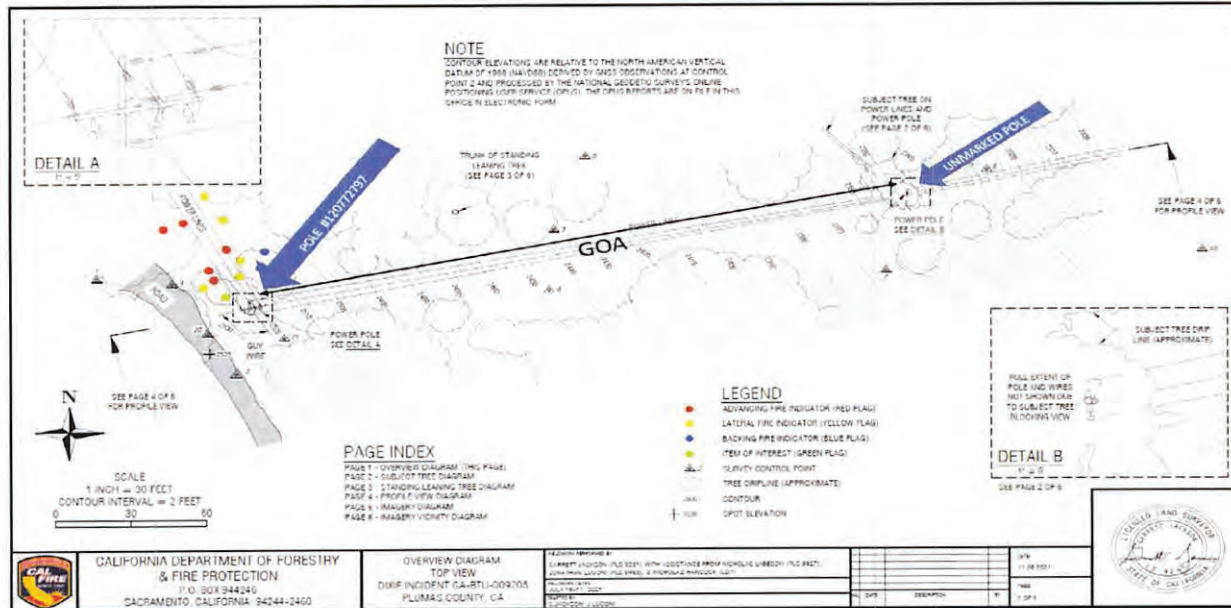
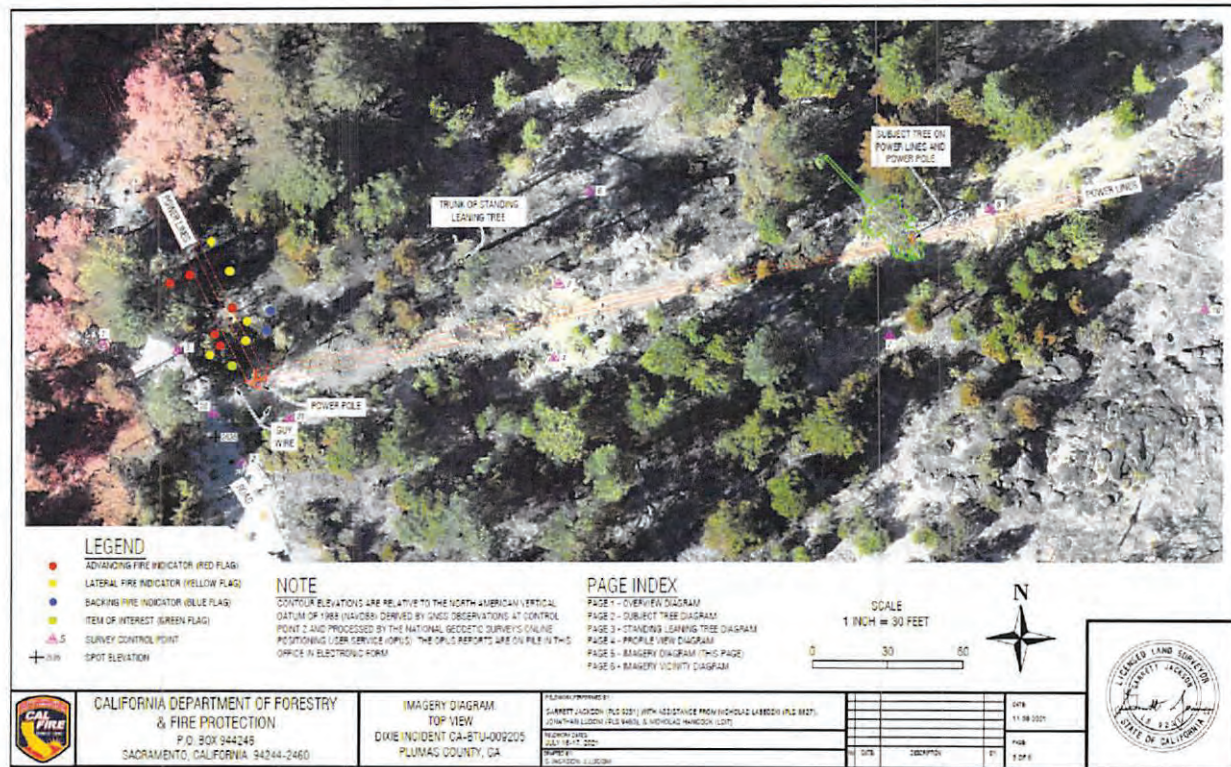
21
22 Based upon these fire pattern indicators and witness statements from [REDACTED] W-1 we
23 determined the SOA was located between pole 120772797 and the unmarked pole. The
24 ignition area, or areas, was located within this SOA. No other sources of ignition

- 1 besides the powerlines and its associated equipment were located within the GOA.

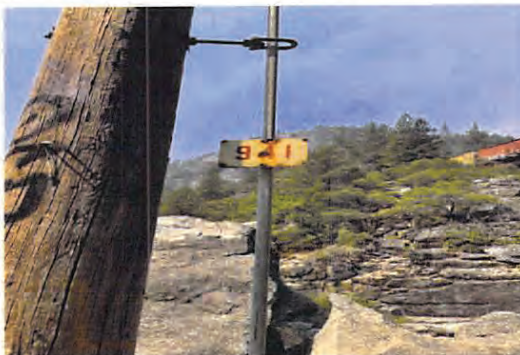
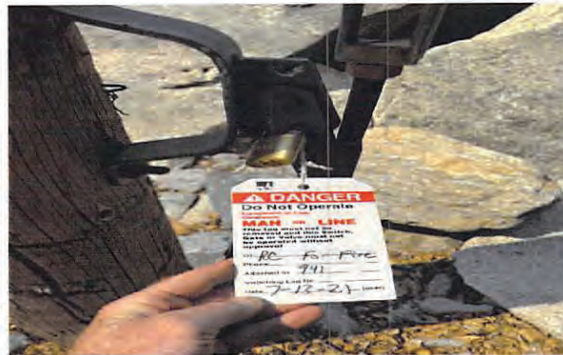
1 members to the origin to complete their LIDAR scan. I took HILTON and B&B to the
2 Cresta Dam to examine the Bucks 1101 circuit from that vantage point. From the area
3 of Cresta dam I was able to see the subject tree laying across the conductors with the
4 naked eye and even more clearly with the use of binoculars. We observed the
5 conductors ran downhill from Camp Creek Road, across the Feather River to the Cresta
6 Dam and a secondary pole which most likely fed the lighting system for the Elephant
7 Butte tunnel. We drove up the Highway 70 canyon for several miles following the
8 conductors looking for the termination point or switch. We traced the conductors to a
9 pole with a switch located off Highway 70 and labeled 941. The switch was locked with
10 a PG&E lock and posted with a "MAN on LINE" tag. The tag read "RC For Fire"
11 attached to 941 and dated 7-13-21. The tag did not have a time referenced. I

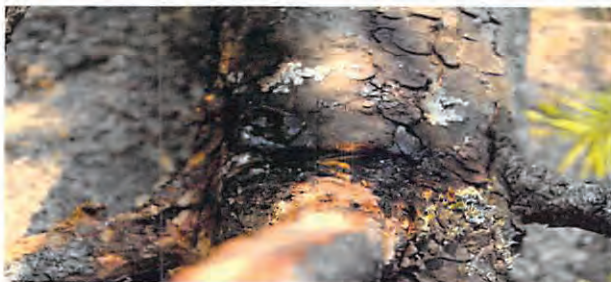
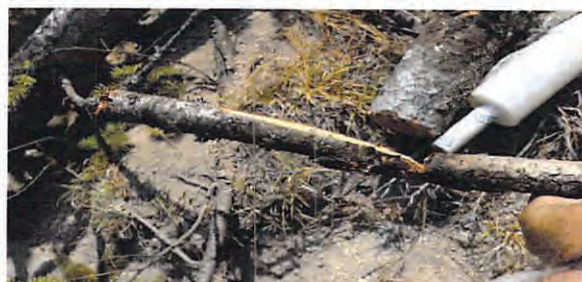
17
18 At approximately 12:30 PM, BERRY accompanied CAL FIRE contract faller Randy
19 SHAULIS down to the subject tree and photographed him while he cut the subject tree
20 free from the conductors. Before the tree was cut, BERRY used orange marking paint to
21 mark the tree's orientation on the trunk. Once the tree was free of the conductors
22 BERRY examined the tree and advised SHAULIS how he wanted it cut for evidence
23 purposes. SHAULIS cut two sections from the top of the tree that had come into contact
24 and rested on the conductors. BERRY photographed and packaged those sections of
25 the trunk as evidence, labeled E-4 and E-5.

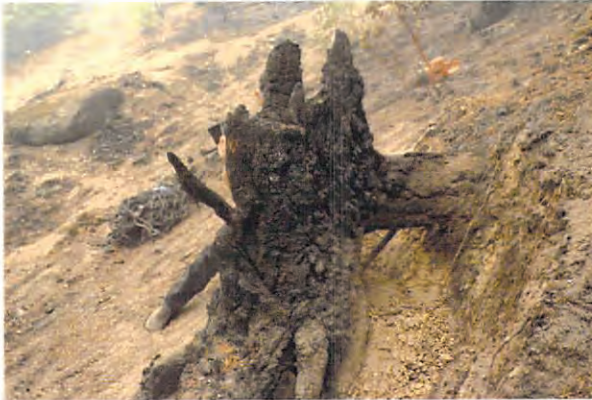
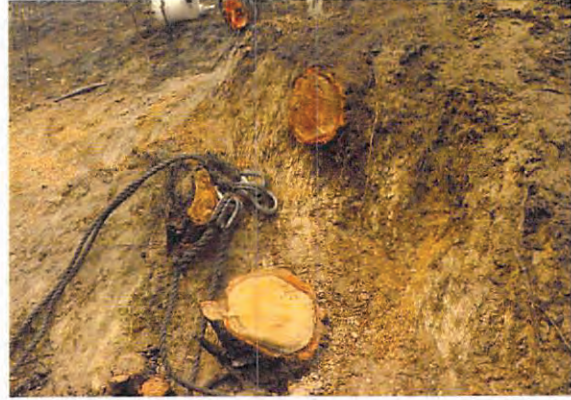
1 and further examination by CAL FIRE contracted arborist MCNEIL. With a digging tool
2 we exposed the soil around the base of the stump to cut the root system below the soil
3 line. This was done to ensure we had all the pertinent pieces of the stump that had been
4 exposed pre and post fire for forensic analysis.
5

6
7 After exposing the root system below the soil level, the stump and a large portion of the
8 root were photographed and cut loose. The stump and root were then packaged in
9 protective bubble wrap and loaded into a cargo net and flown by long line below the
10 Butte County Sheriff's Department helicopter to the Shady Rest Area along Highway 70.
11 The stump and root were then loaded into a CAL FIRE flatbed vehicle and driven to a
12 secure CAL FIRE evidence storage facility. The flatbed was followed by BERRY during
13 transport. The tap root was labeled as E-12 and the stump was labeled as E-13.

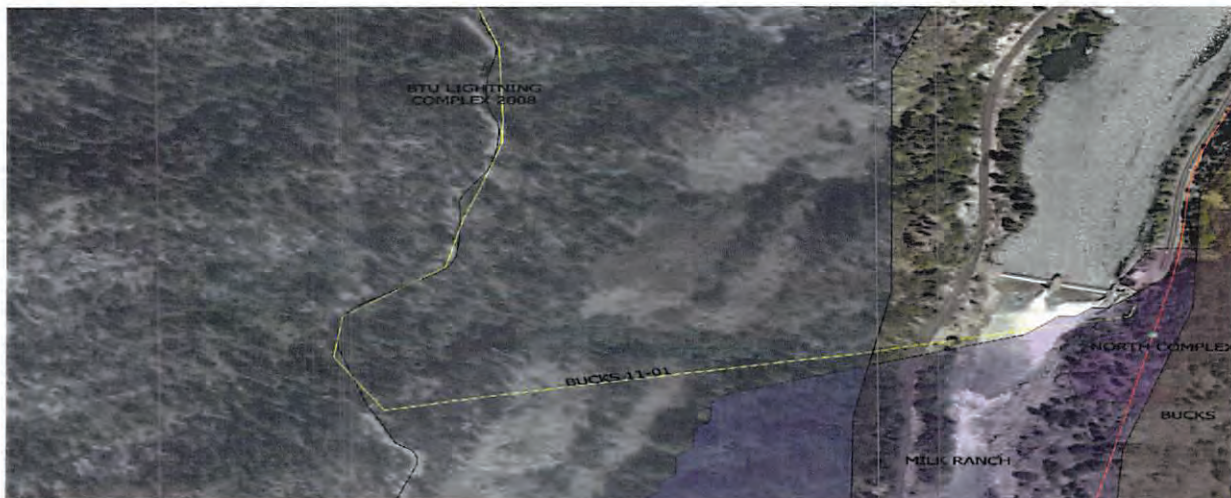
13
14 After MCNEIL's first visit he contacted me by phone and advised me he believed the
15 subject tree was damaged by some sort of event (most likely fire) in 2008 and again in
16 2015 or 2016. MCNEIL asked if I would be able to determine if there had been a fire or
17 other significant event in the area that could have damaged the subject tree. With the
18 use of CAL FIRE archived data and fire history maps, I determined that the 2008 Butte
19 lightning complex fire had burned through the footprint of the Dixie GOA. I was unable
20 to determine what the 2015/2016 event would have been. Based upon that information
21 MCNEIL advised me he would like to return for more samples of the subject tree stump.

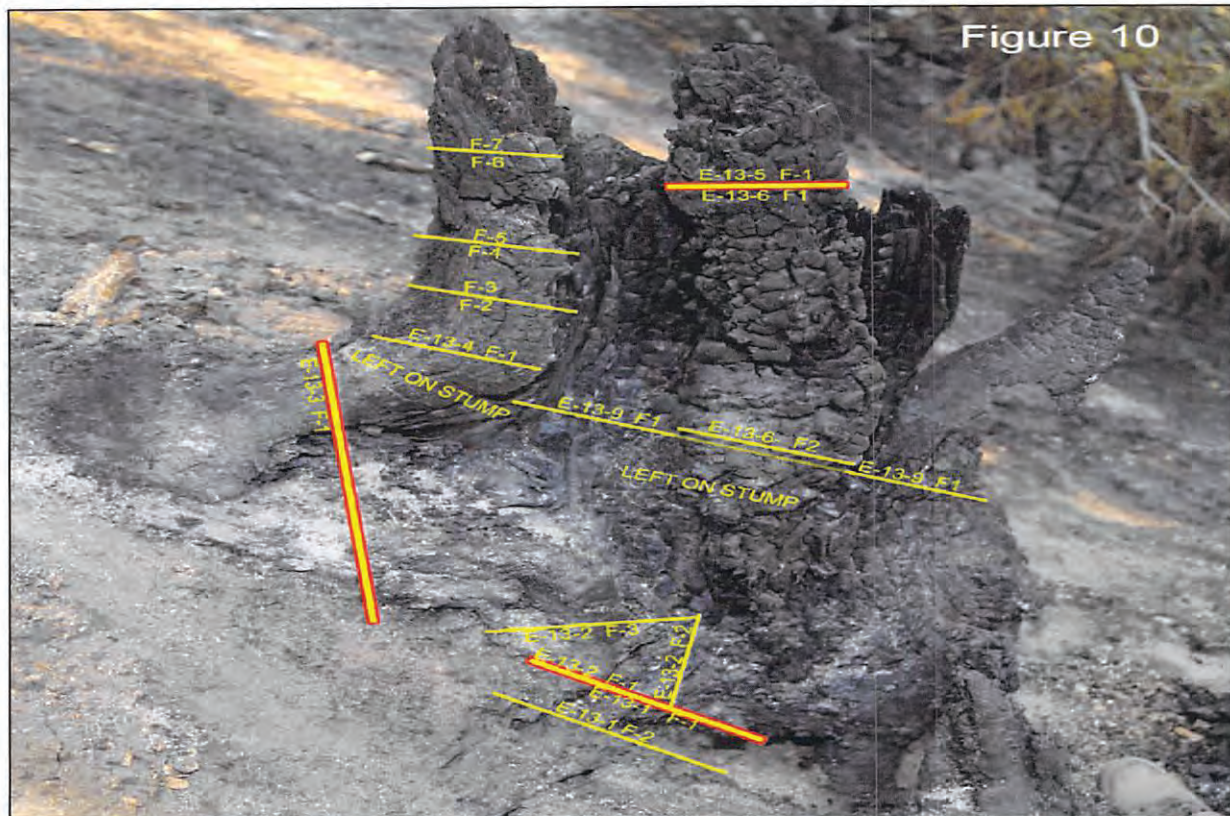
On September 11, 2021, at approximately 11:00 AM, MCNEILL returned and met with CAL FIRE Officer Mark HILLSKOTTER. MCNEIL removed four more pieces of the subject stump for further analysis and testing. Those pieces were labeled as evidence numbers E-13-6, E-13-7, E-13-8, and E-13-9. A chain of custody form was completed and signed by HILLSKOTTER and MCNEIL.

On October 10, 2021, I received MCNEIL's final report. In that report MCNEIL concluded that the subject tree was approximately ninety years old, approximately 15.8 inches in diameter and approximately 65 feet tall. "The tree was growing vertically without a lean" and was "alive and vital at the time of failure".

Based upon MCNEIL's evaluation the tree was likely significantly injured by the Butte Lightning Complex Fire in 2008 and by an unidentified event between 2015 and 2016. These injuries caused the live cambium (growing part of trunk) to be severely damaged.
