KIRKLAND & ELLIS LLP

**PG&E Independent  
Monitor Report of  
November 19, 2021**

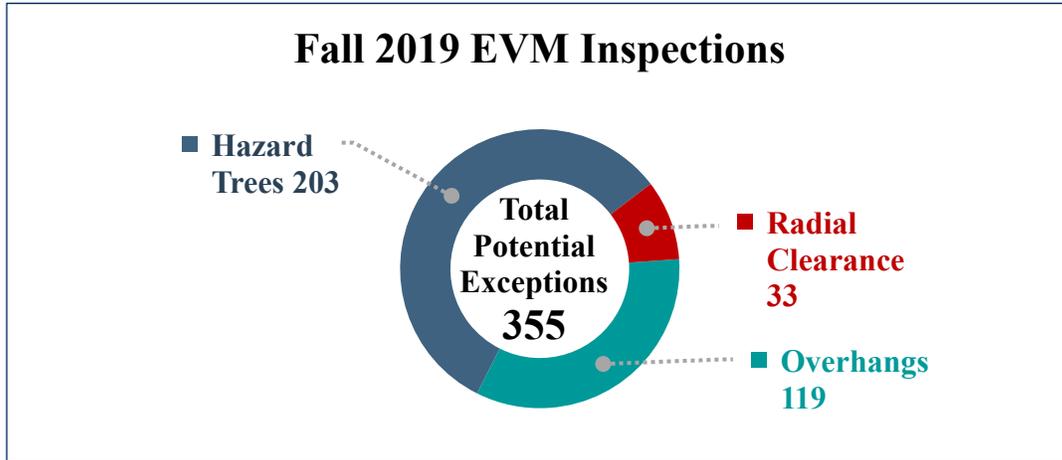
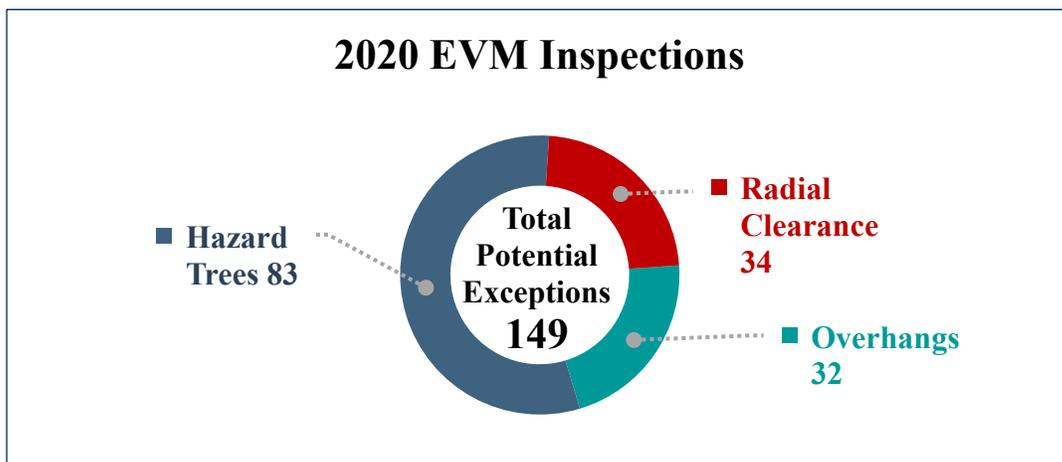
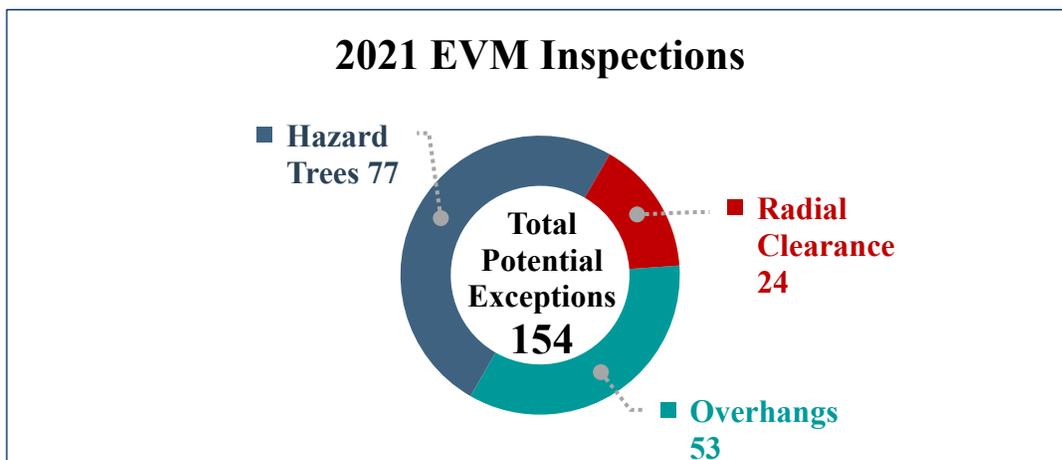
### EXHIBIT 4: EVM INSPECTION STATISTICS

For Monitor team inspections of EVM areas from 2019-2021, the three graphs below show the number of potential exceptions observed.

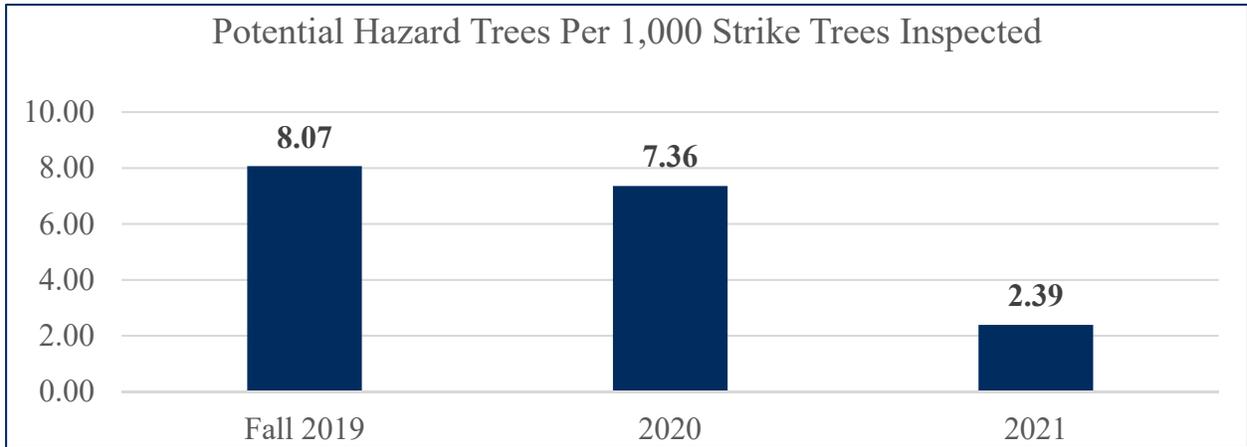
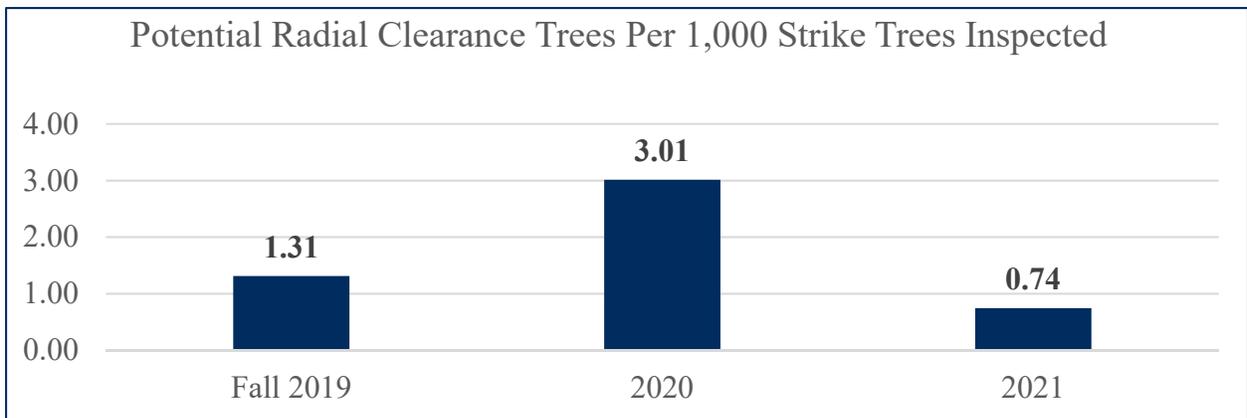
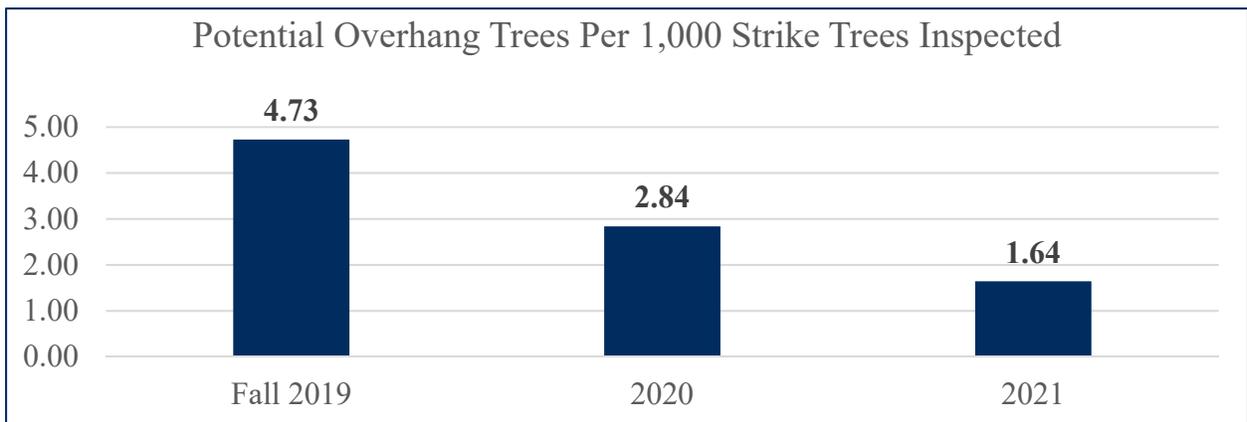
For Monitor team inspections of EVM areas from 2019-2021, the first graph shows the number of potential hazard trees observed per 1,000 strike trees inspected, the second graph shows the number of potential radial clearance issues observed per 1,000 strike trees inspected, and the third graph shows the number of potential overhang trees observed per 1,000 strike trees inspected.

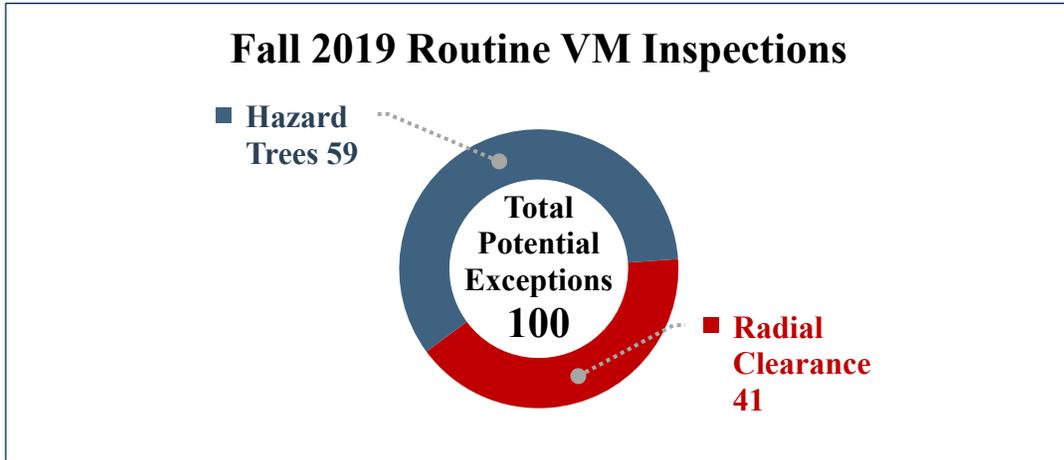
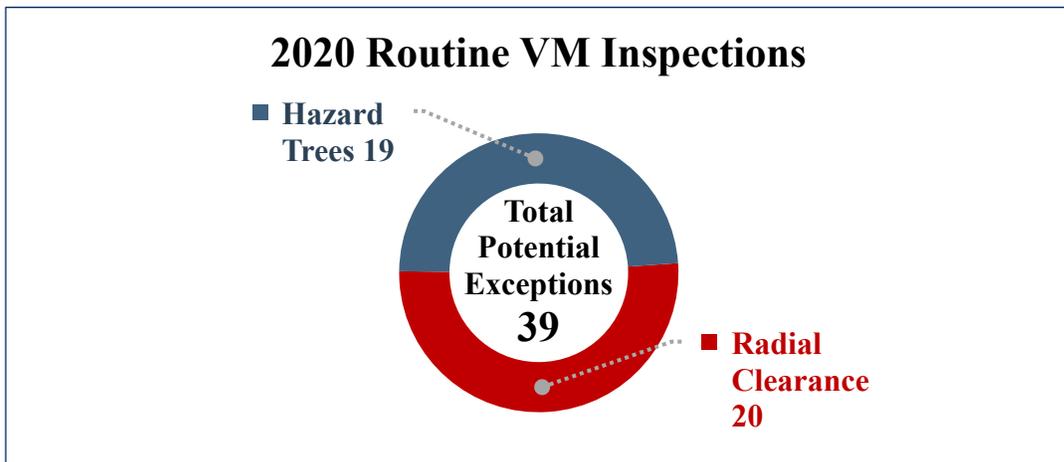
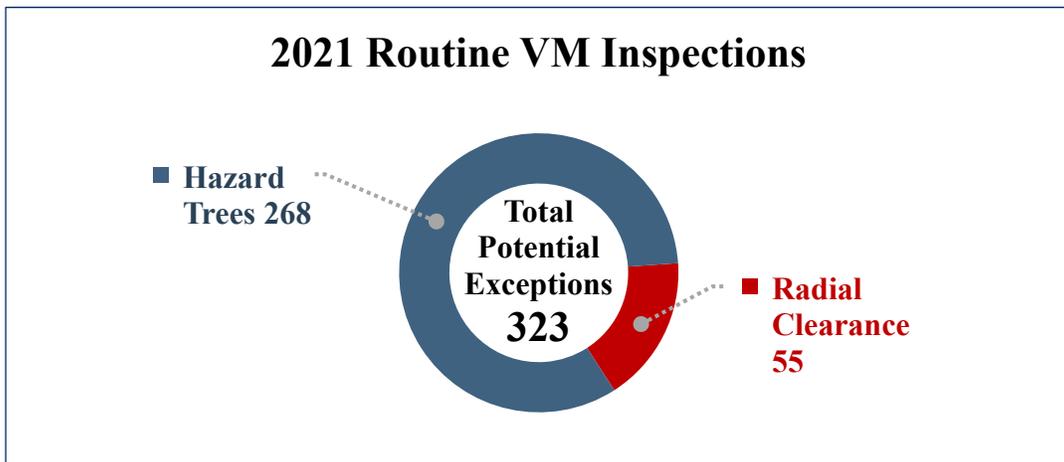
### EXHIBIT 5: ROUTINE VM INSPECTION STATISTICS

For Monitor team inspections of Routine VM areas from 2019-2021, the three graphs below show the number of potential exceptions observed.

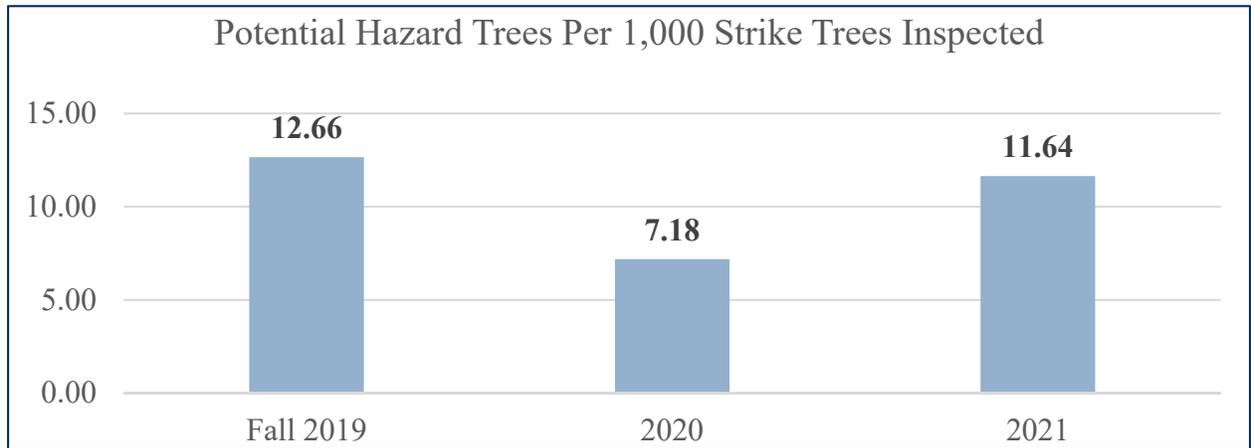
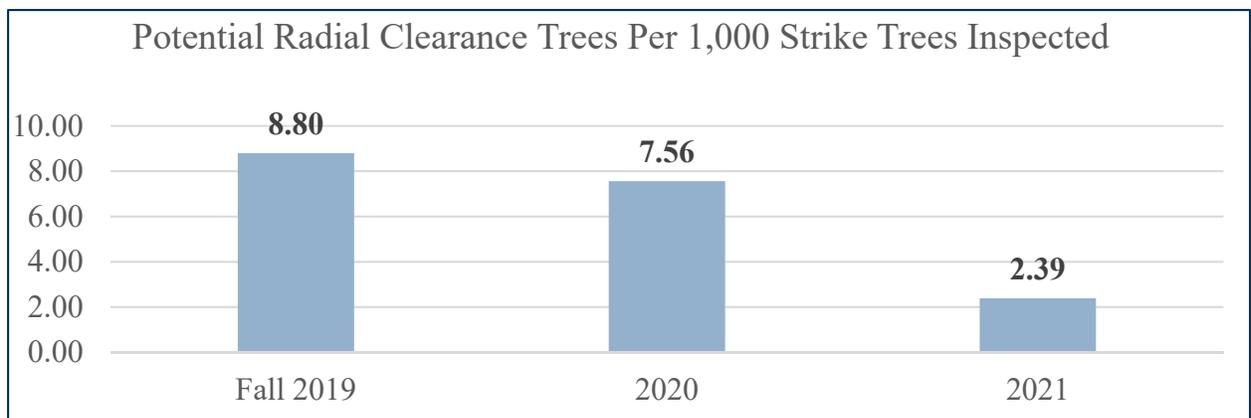
For Monitor team inspections of Routine VM areas from 2019-2021, the first graph shows the number of potential hazard trees observed per 1,000 strike trees inspected, and the second graph shows the number of potential radial clearance issues observed per 1,000 strike trees inspected.

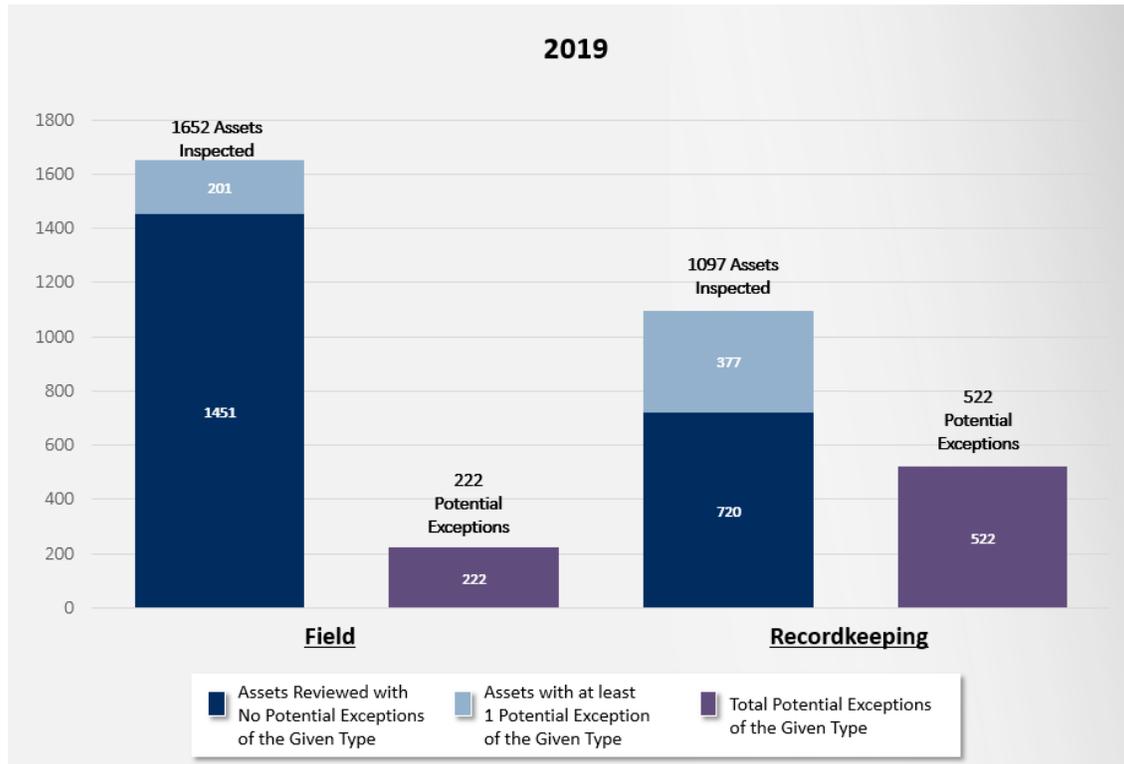
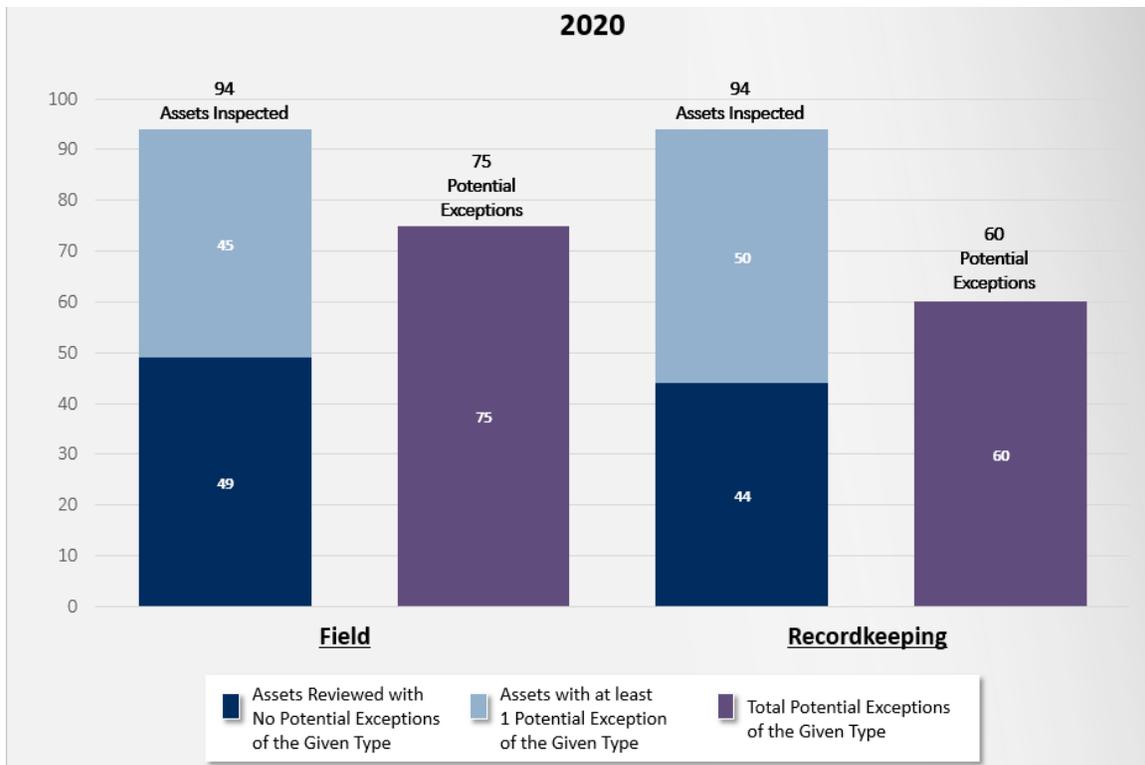
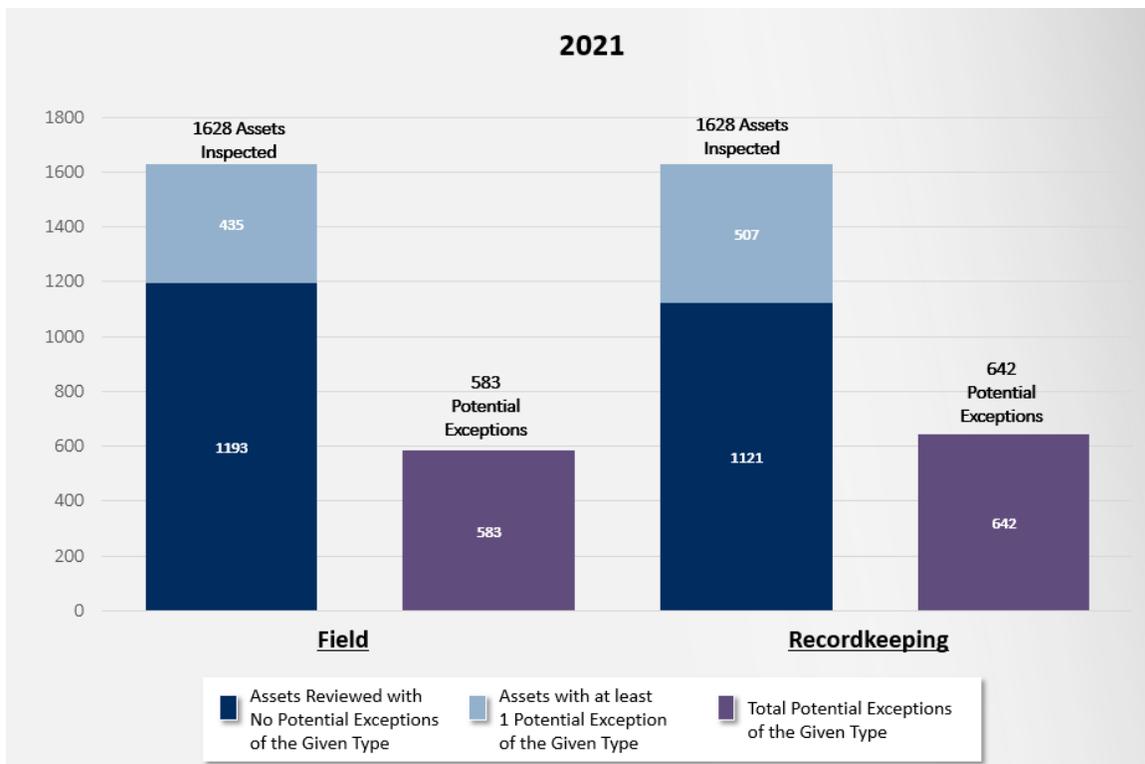
**EXHIBIT 10: REVIEW OF DISTRIBUTION INSPECTION FINDINGS (2019 - 2021)**

The graphics below show the number of distribution inspections reviewed by the Monitor team each year, as well as the number of potential exceptions recorded.

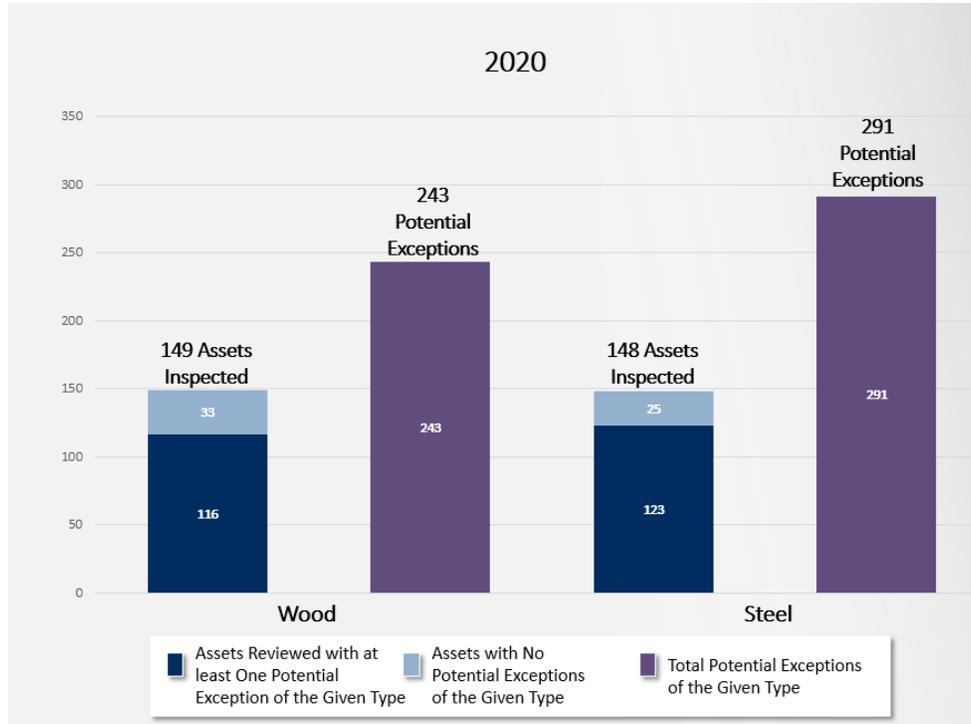
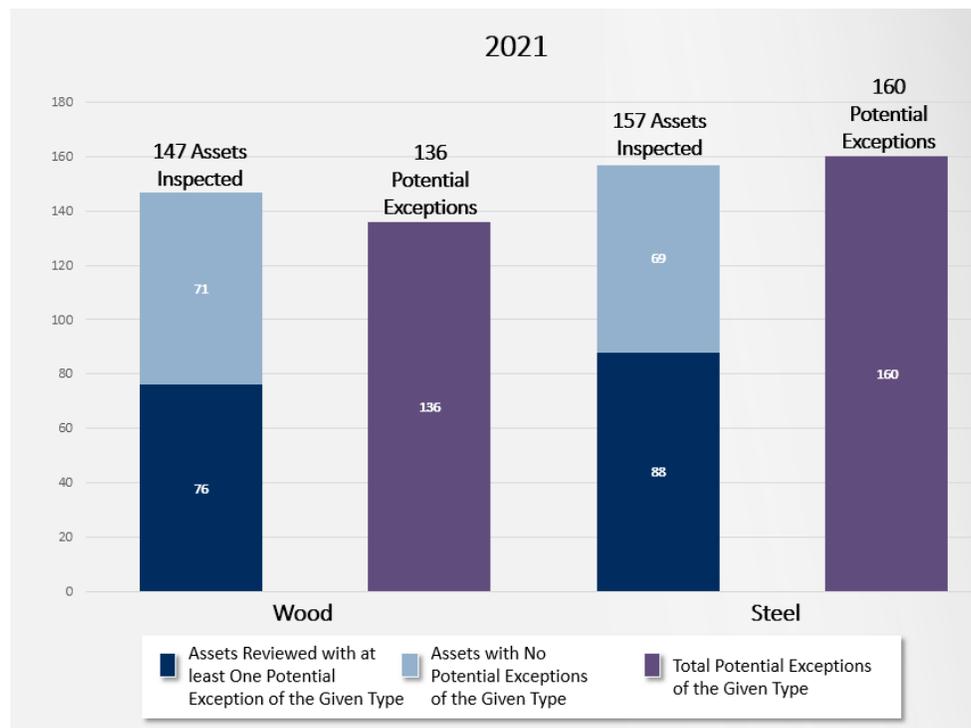
**EXHIBIT 11: REVIEW OF TRANSMISSION INSPECTION FINDINGS (2020 - 2021)**

The graphic below shows the number of transmission inspections reviewed by the Monitor team each year, as well as the number of potential exceptions recorded.

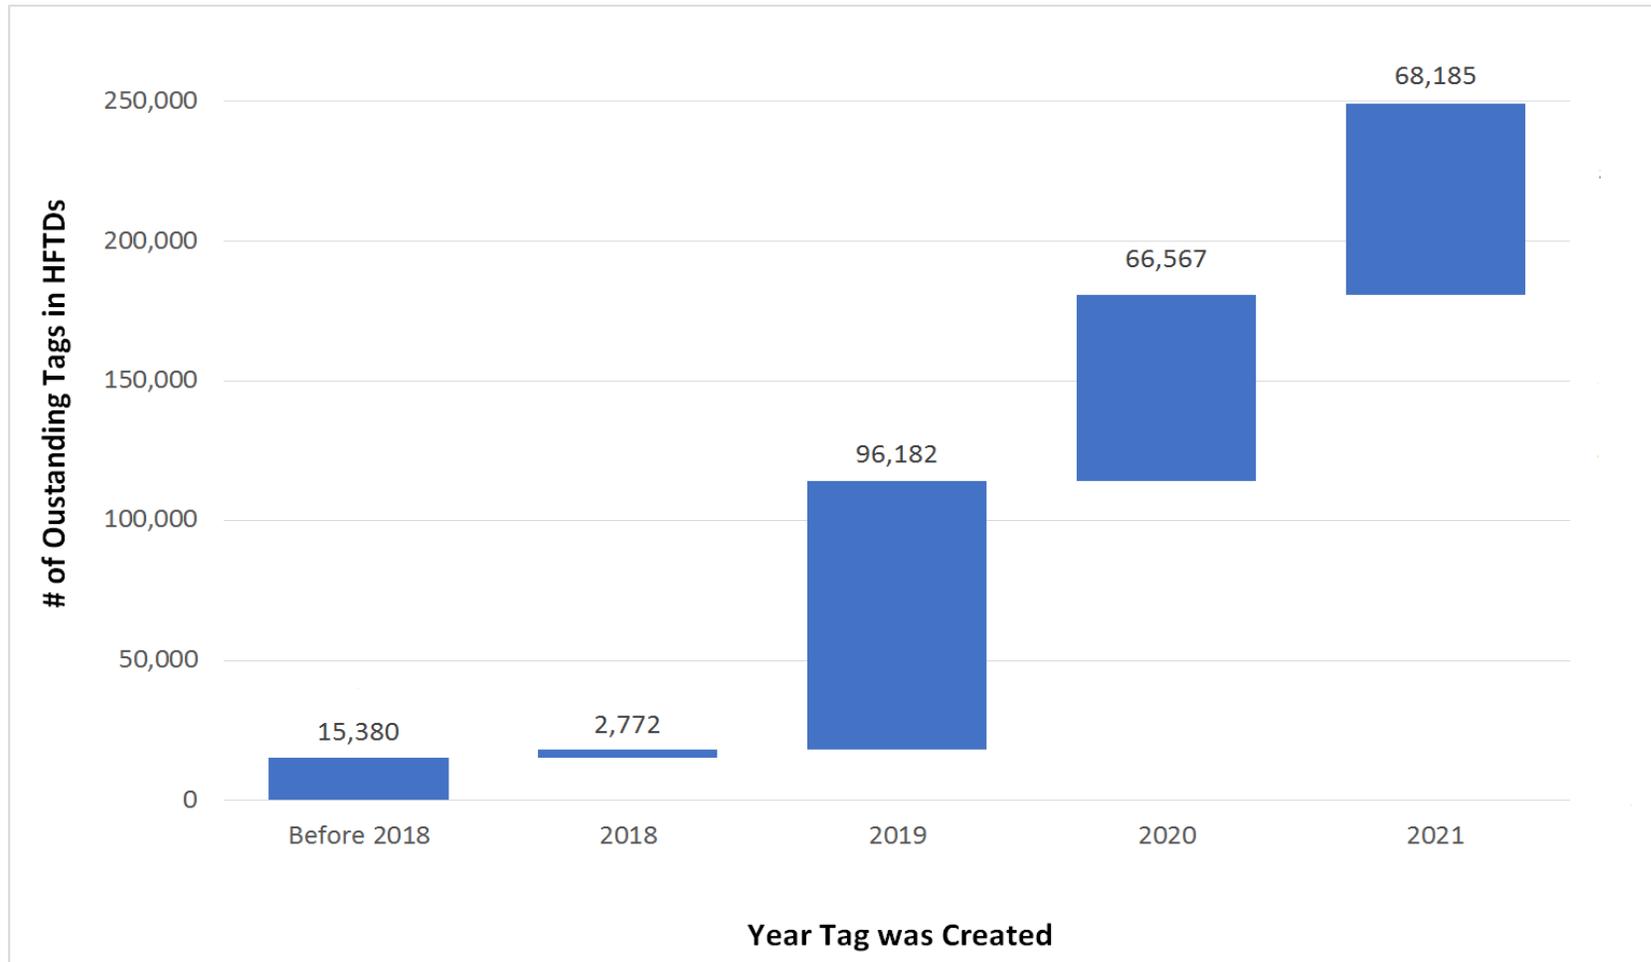
**EXHIBIT 12: INCREASING BACKLOG OF INFRASTRUCTURE-RELATED REMEDIATION WORK**

This graphic shows the increasing backlog of outstanding transmission and distribution tags through June 2021.
