**CALIFORNIA DEPARTMENT OF FORESTRY AND FIRE PROTECTION
NEVADA-YUBA-PLACER UNIT**

INVESTIGATION REPORT

INCIDENT NUMBER: 17-CA-NEU-026269

CASE NAME: CASCADE

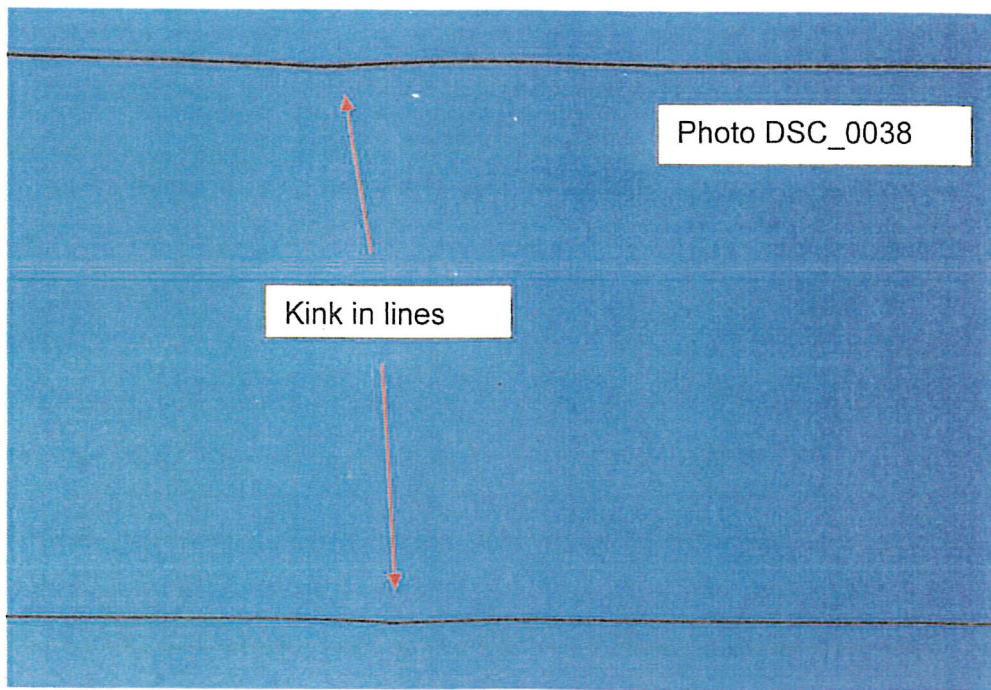
5 I arrived back at the scene at about 5:00PM on October 9, 2017, and VILLALOBOS
6 had been on Cascade way since about 12:00 PM. Assisted by VILLALOBOS, I started
7 searching along Cascade Way for a fire cause and origin. Fire pattern indicators along
8 Cascade Way identified the spread of the fire coming from the area of the RIDDLE or
9 JOHNSON properties advancing east toward Cascade Way. Advancing indicators were
10 also observed on the east side of Cascade Way moving east, from Cascade Way along the
11 east side of the roadway. I checked the powerlines along east side of Cascade Way looking
12 for any damage to the lines or equipment. I did not observe downed lines or any branches
13 or vegetation in contact with powerlines along Cascade Way. VILLALOBOS showed me
14 the powerlines on the RIDDLE property she observed earlier in the day. Using binoculars, I
15 was able to see a mark on the east and west leg conductors. I was not able to identify what

16 the mark was from the ground, but the marks looked in very close proximity to each other,
17 and the conductors also appeared to have a kink in the line and line sag. I advised
18 VILLALOBOS the lines were something we would need to rule out, and we continued
19 looking at microscale and macroscale fire pattern indicators on the RIDDLE and JOHNSON
20 Properties. At about 10:00 PM VILLALOBOS left the scene. I decided we would need to
21 maintain scene security on a 24-hour basis until we were done with the origin and cause
22 investigation. I remained at the scene overnight for scene security along Cascade Way at
23 [REDACTED].

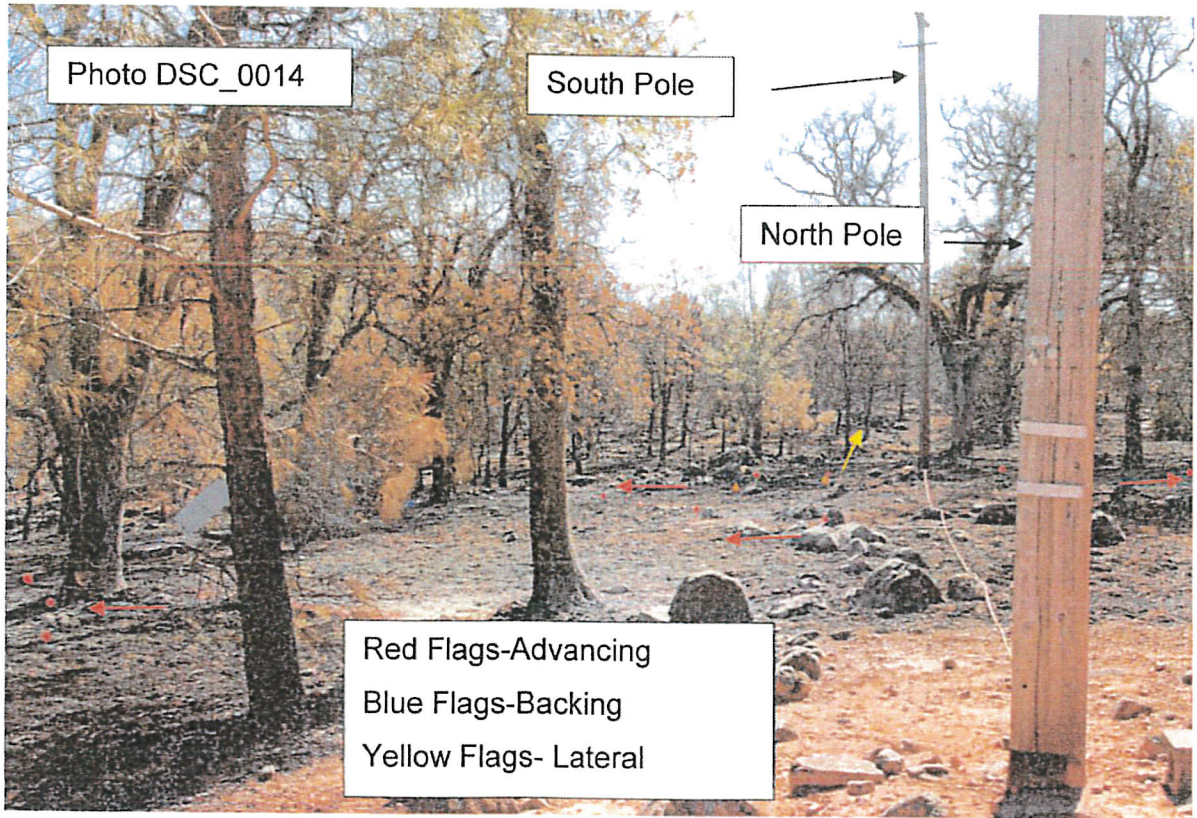
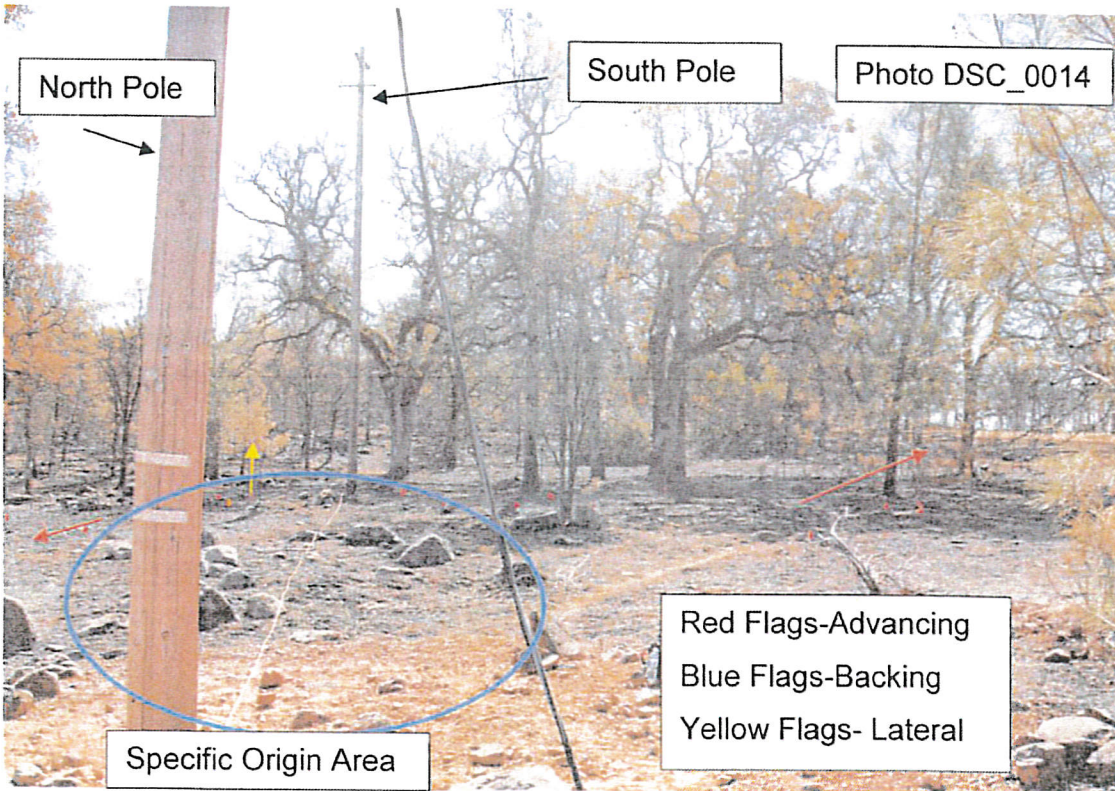
9 On Friday October 13, 2017 at 10:15 AM I arrived with Jim NOLT (J H Nolt
10 Associates Electrical, Mechanical, and Corrosions Engineers) and BARCKLAY at 13916
11 Cascade Way. I continued adding fire pattern indicator flags, and verified the fire pattern
12 indicator flags VILLALOBOS and MONROE had placed indicating the GOA. The fire
13 pattern indicator flags underneath the north and south utility poles on the RIDDLE
14 property showed advancing fire indicators going away from the area below the
15 conductors in the dead and dry annual grasses. This area was identified as the Specific
16 Origin Area (SOA).

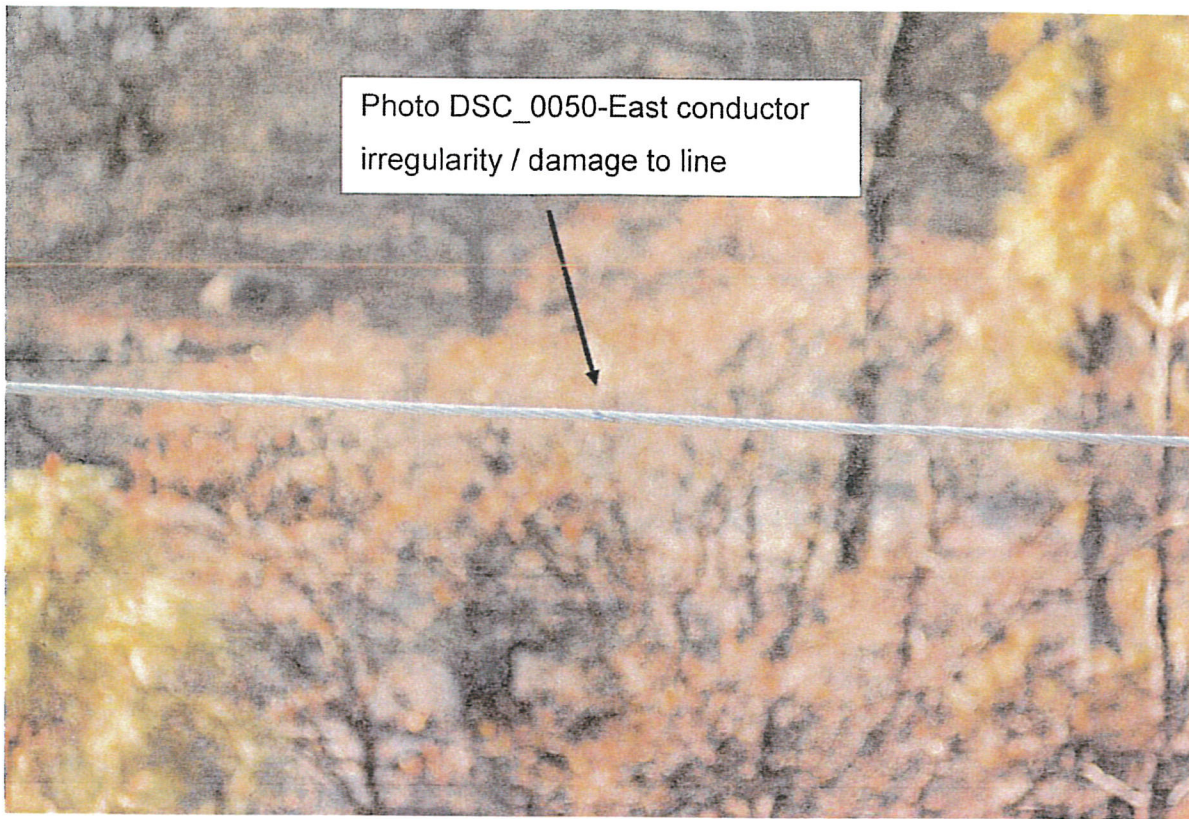
1 From the bucket truck, I observed and photographed an irregularity on both the east
2 and west conductors. The irregularities appeared to be damage to the lines. The
3 damage appeared to be close to the same distance between the north and south utility
4 poles. Jim NOLT completed an independent report of the electrical equipment at the
5 scene (Attachment -7).

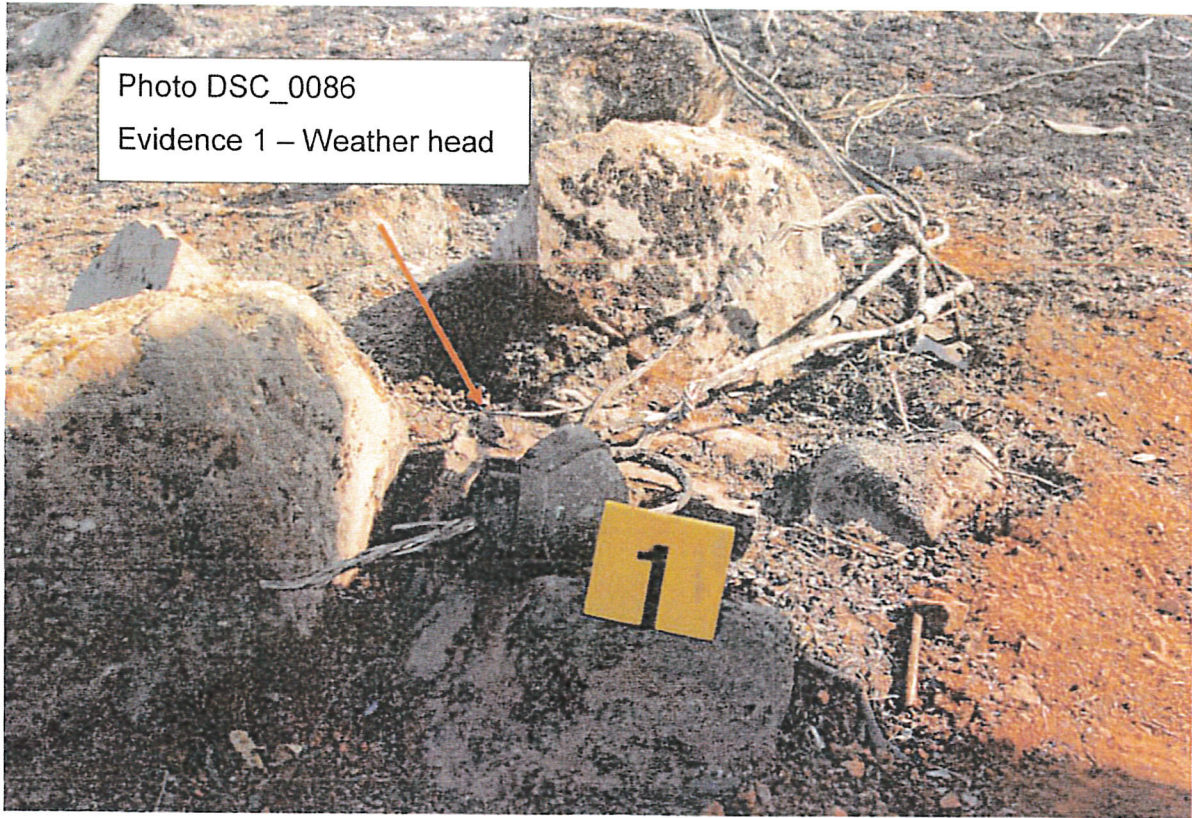
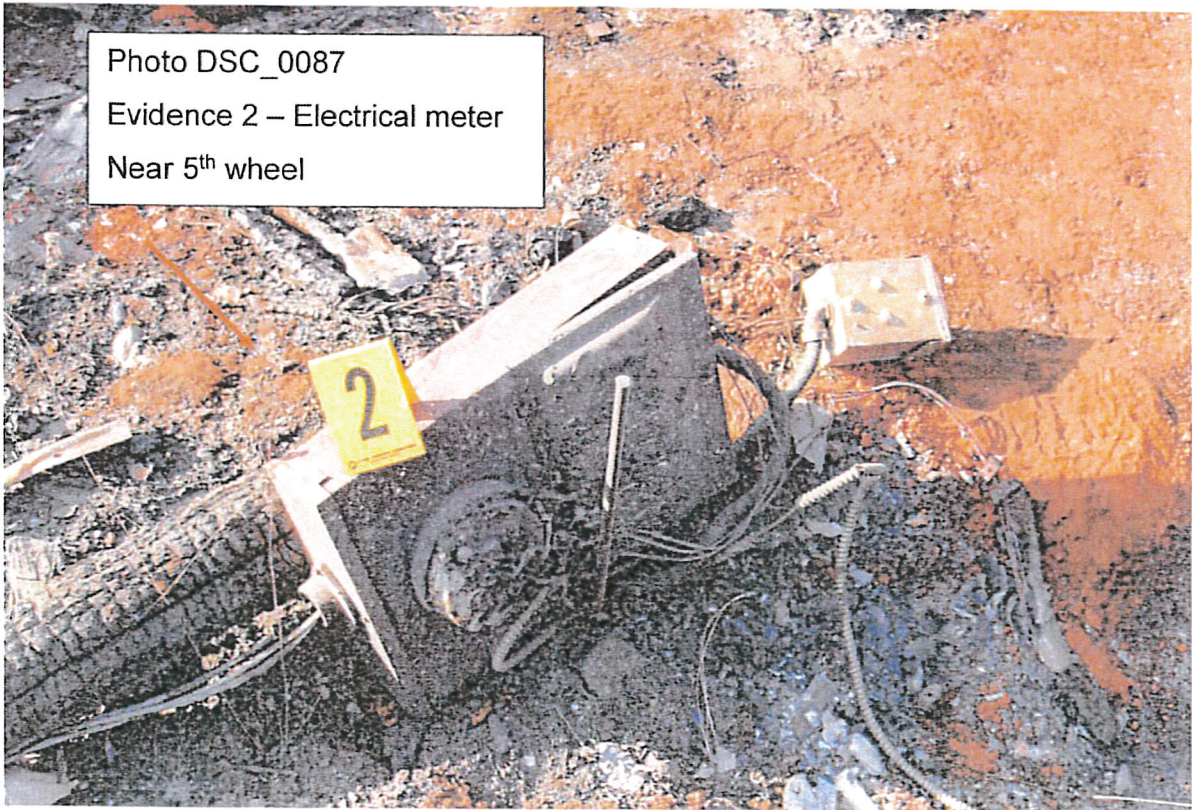
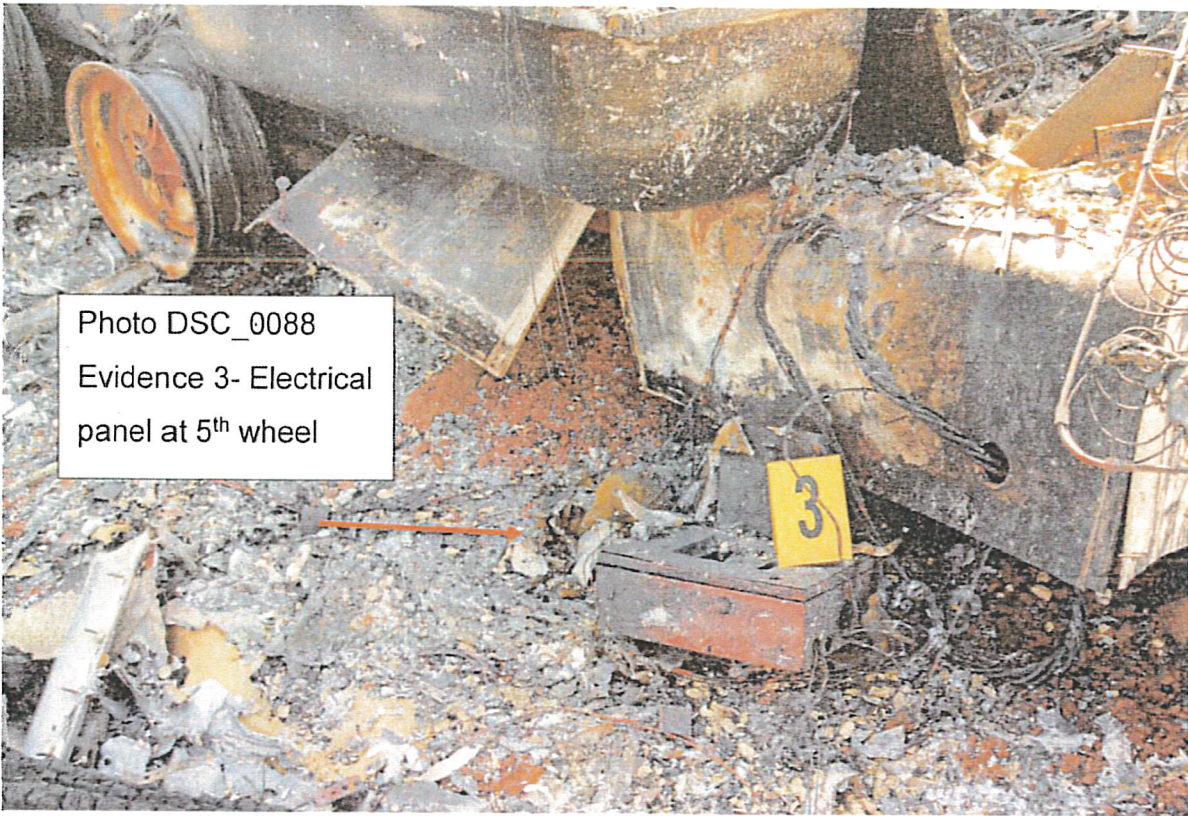
I was unable to locate any tree branches on the drop line which would suggest the tree caused the drop line to contact the ground. I was unable to locate any limb damage, charring, pitting, or staining on the tree which would have been indicative of a live conductor making contact with the tree. The weatherhead, electrical meter, and electrical panel to the 5th wheel trailer were collected as evidence and sent to Anamet Inc. for further laboratory testing due to the extent of fire damage to the equipment. NOLT also looked at this equipment for analysis (See NOLT report - Attachment 7).
