**PACIFIC GAS AND ELECTRIC
COMPANY'S RESPONSE TO
REQUEST FOR INFORMATION**

Electric Transmission Overhead Steel Structure Strategy Overview

STRUCTURES

**Prepared for: Pacific Gas & Electric
Version 4.0**

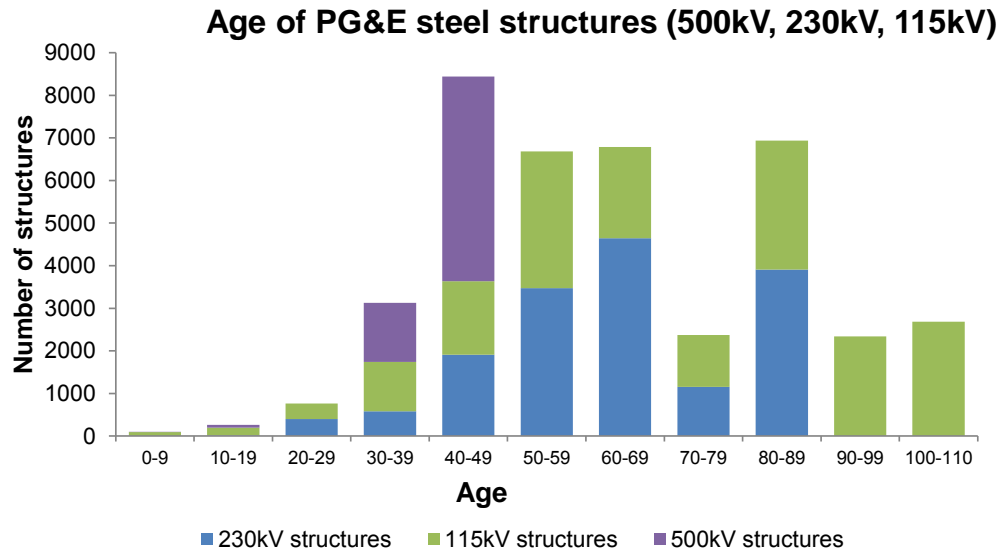
Asset Base – Steel Structure In Service

- Oldest structures are 108 years old, average age is 68
- Mean Life Expectancy is 65 years
 - Max Coastal: 80 years
 - Max Valley: 100+ years
- Poor age data on 60 and 70 kV structures
- Structures age data/life expectancy is from a year 2010 Quanta Technology Study

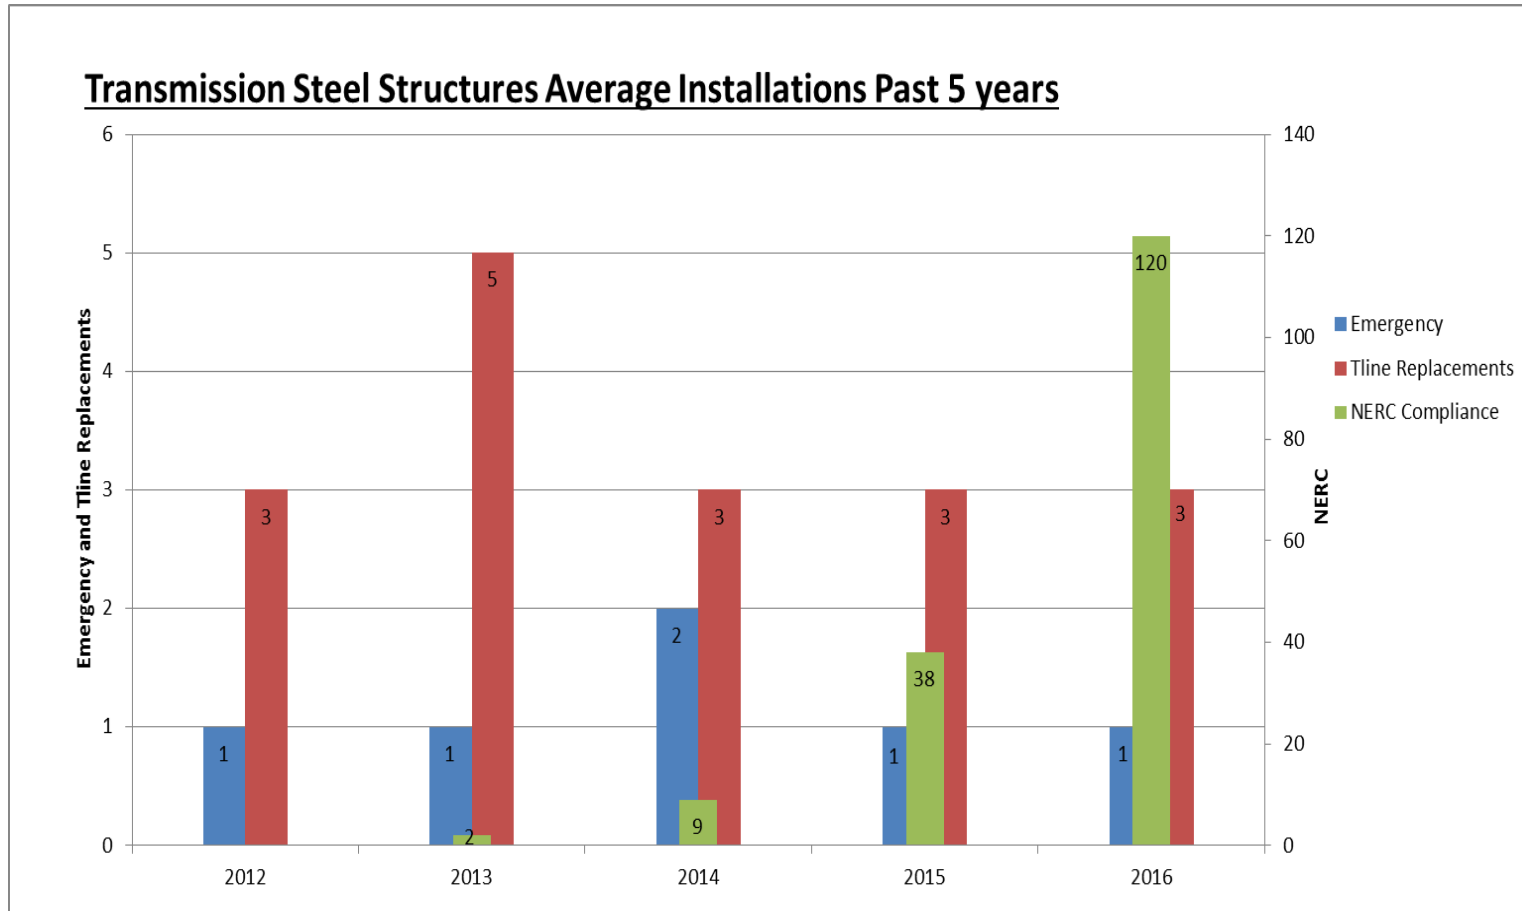
Capital Investment Plan – Steel Structure Replacement

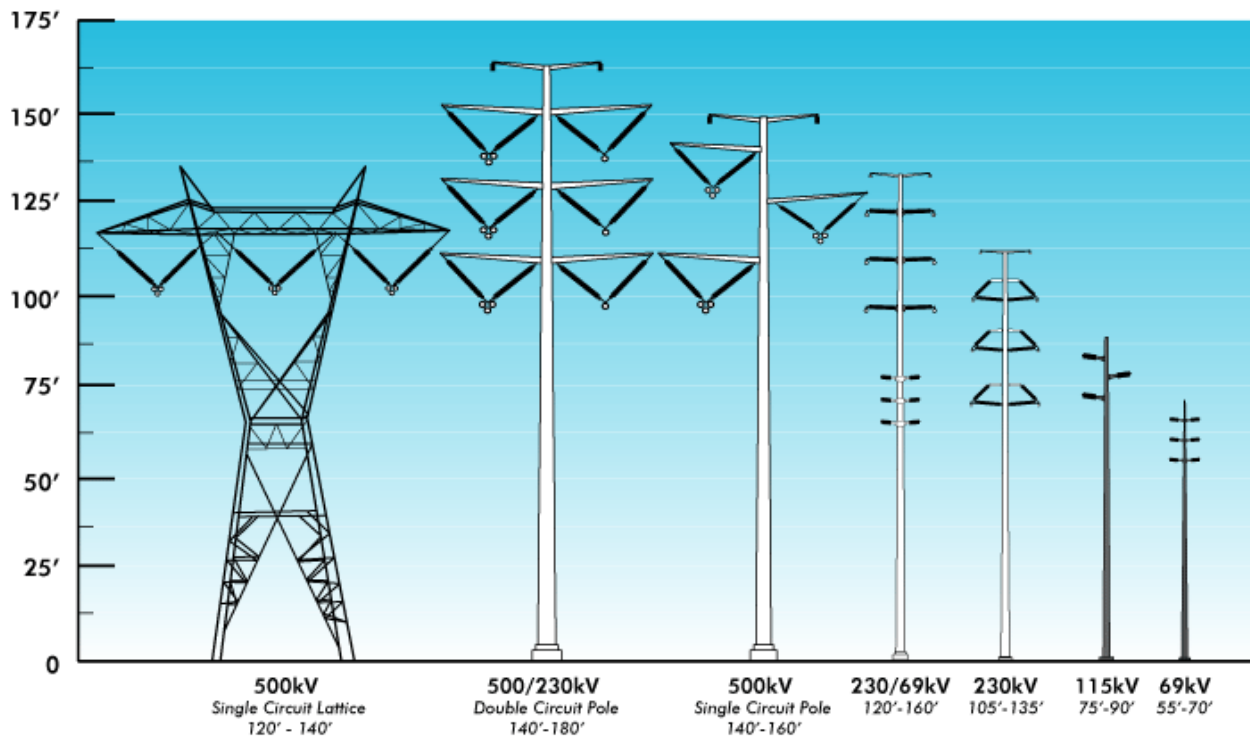
Figure 3-1. Typical industry tower types and heights by voltage class.

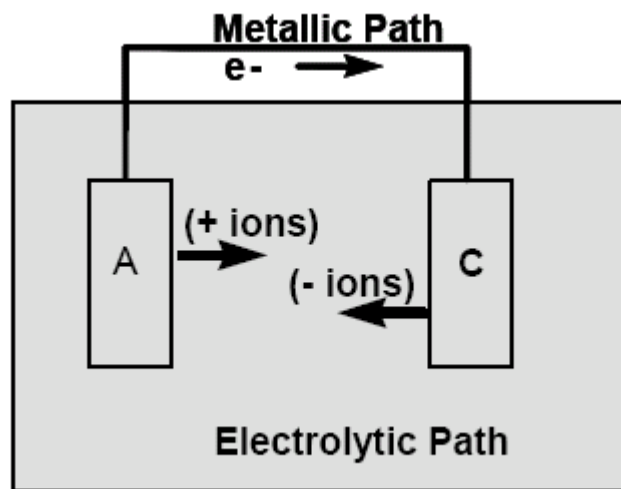
Figure 4-1. Typical Corrosion Cell

In a corrosion cell, electrons migrate from the anode to the cathode leaving a surplus of positively charged ions that combine with negatively charged hydroxyl ions in the solution to produce corrosion oxides. A typical corrosion cell is shown in Figure 4-1.

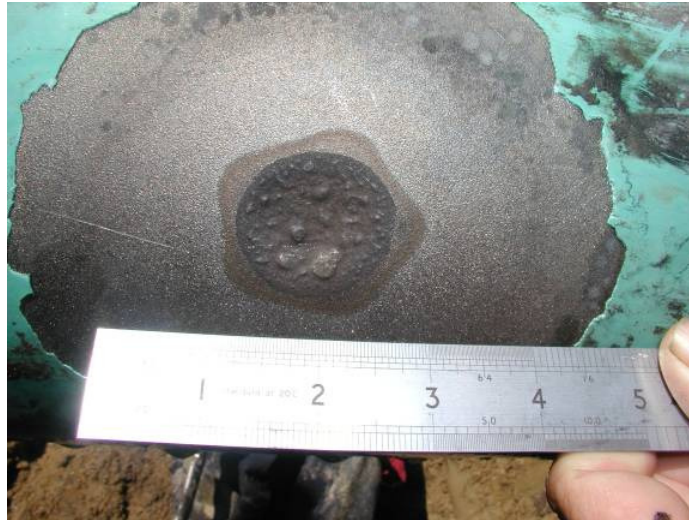
Figure 4-4. Corrosion Cause by Stray A-C

corrosion requiring pinhole defects in coatings to concentrate the current density. An example of the corrosion morphology associated with AC interference current is shown in Figure 4-4.

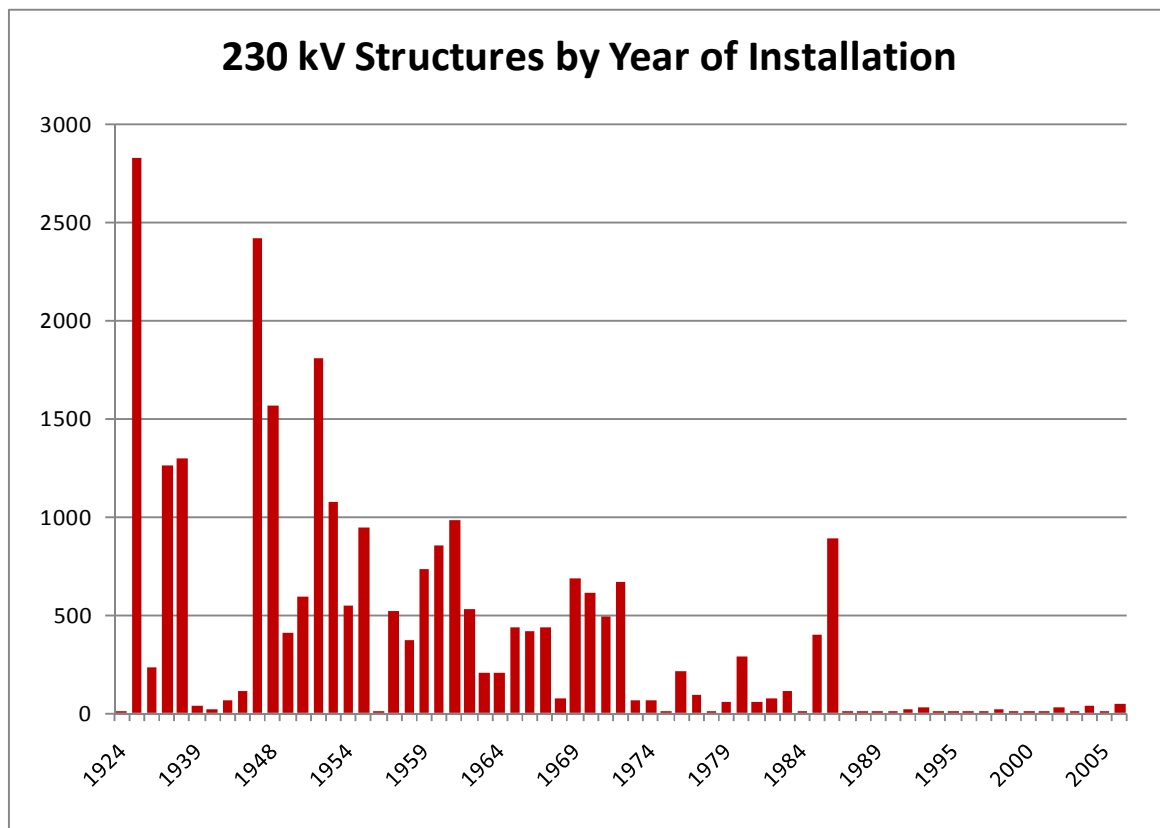
Figure 9-3. 230 kV structures by year installed

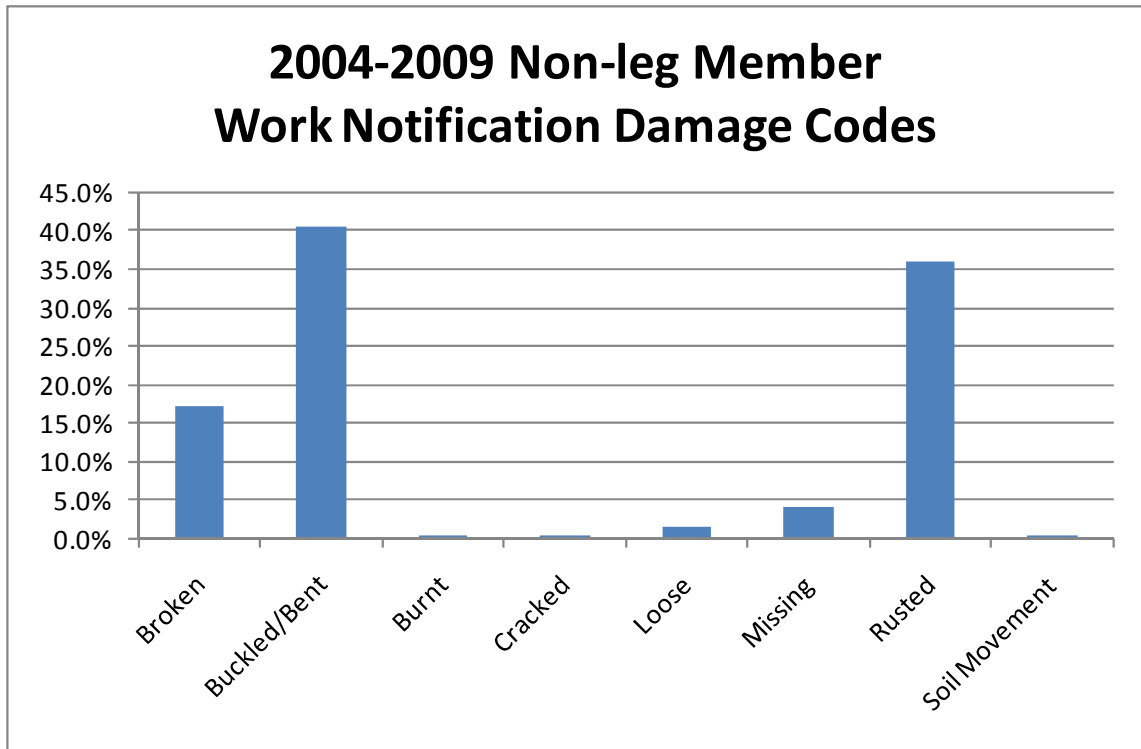
Figure 9-7. Non-leg member damage reports

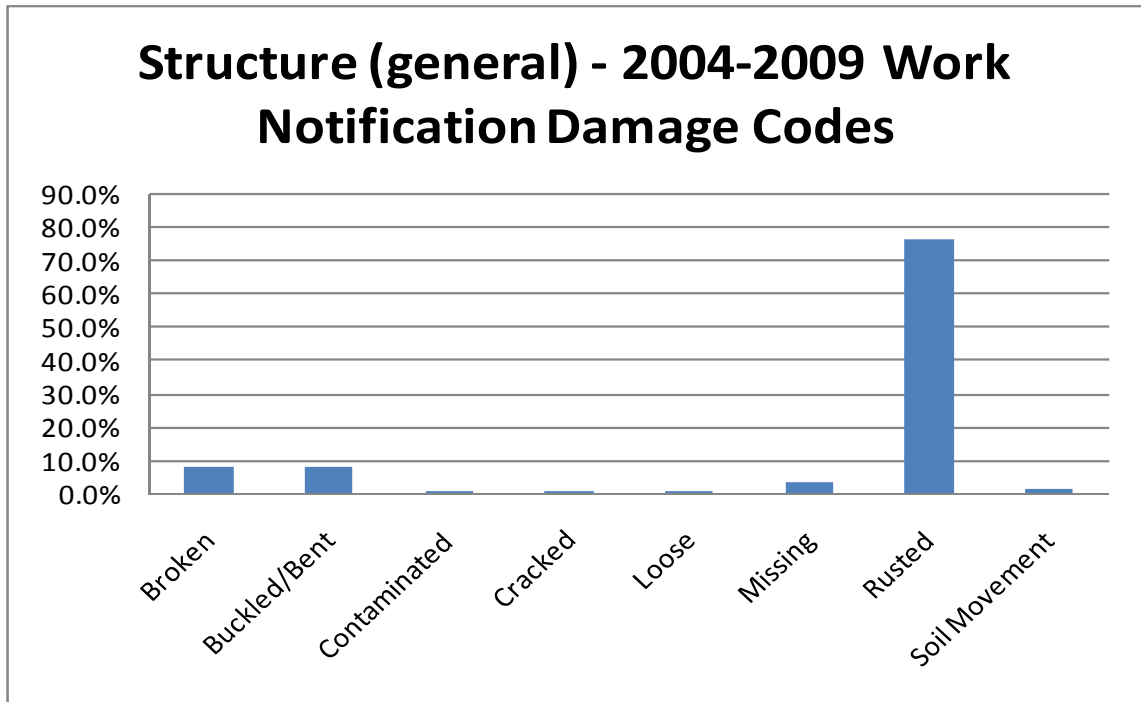
Figure 9-8. Structure (general, incl. bolts) damage reports

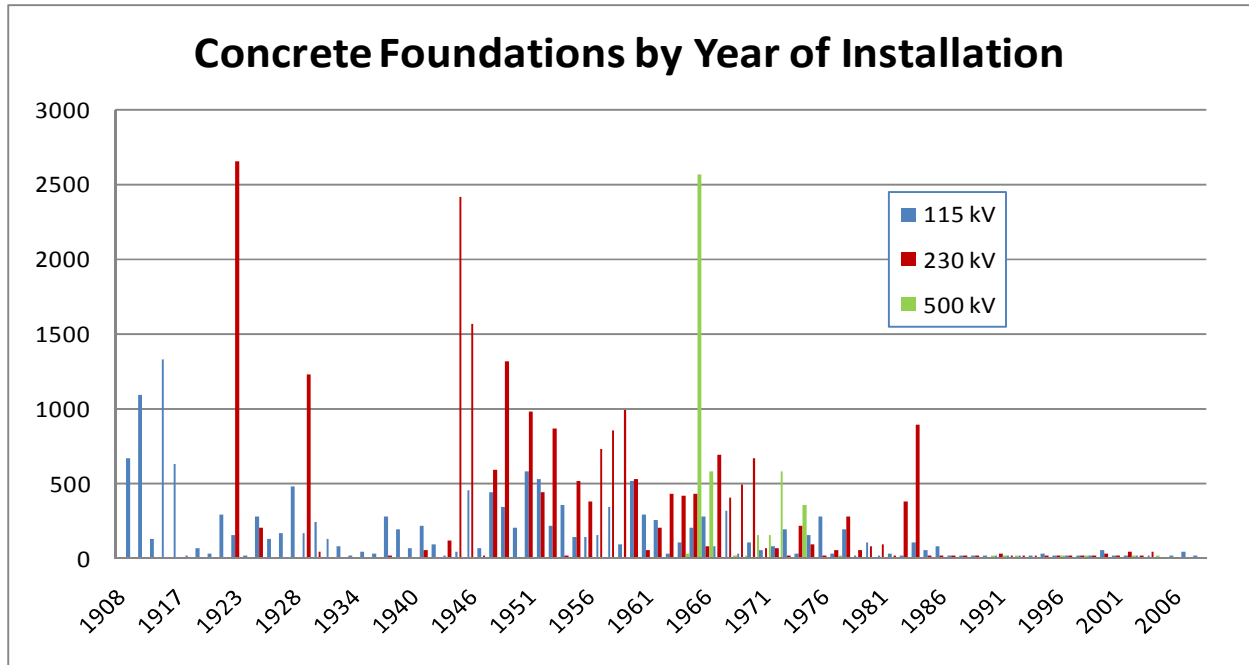
Figure 9-9. Concrete foundations

The following graphs display the age distribution of foundations, by type. The total numbers represented are as follows: Concrete 42,330; Earth 5,072; Pile 1,978.

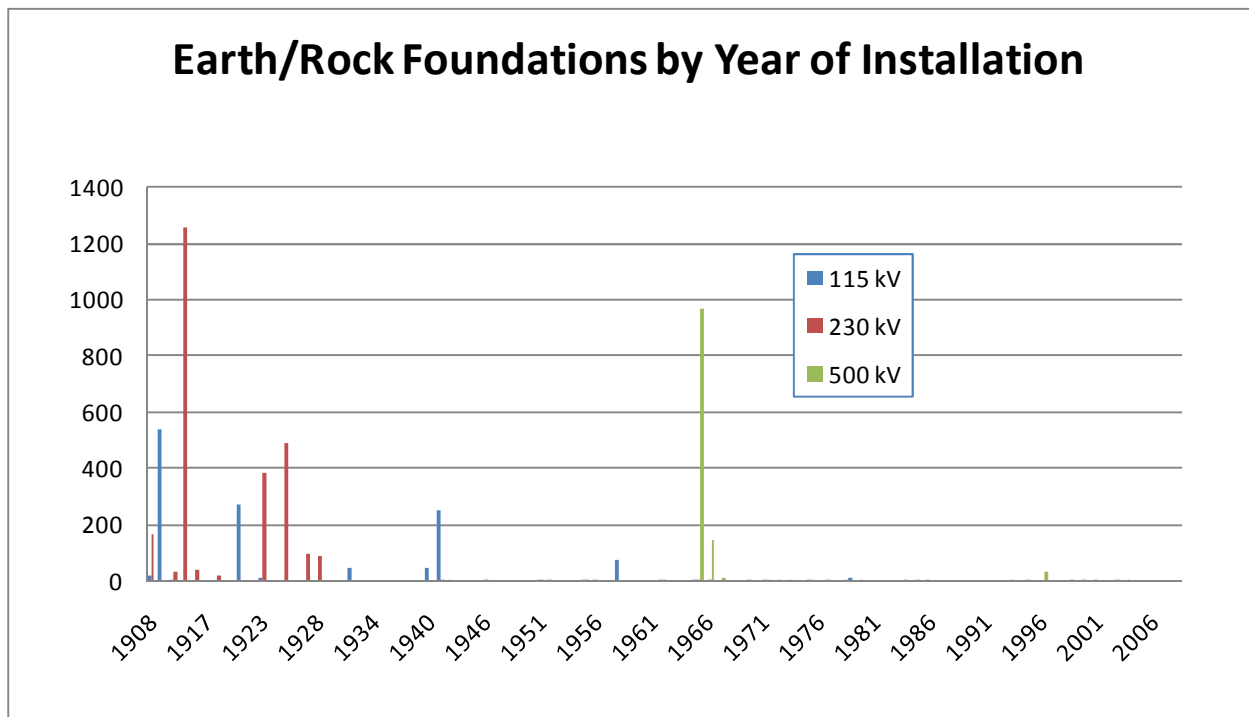
Figure 9-10. Earth and rock foundations

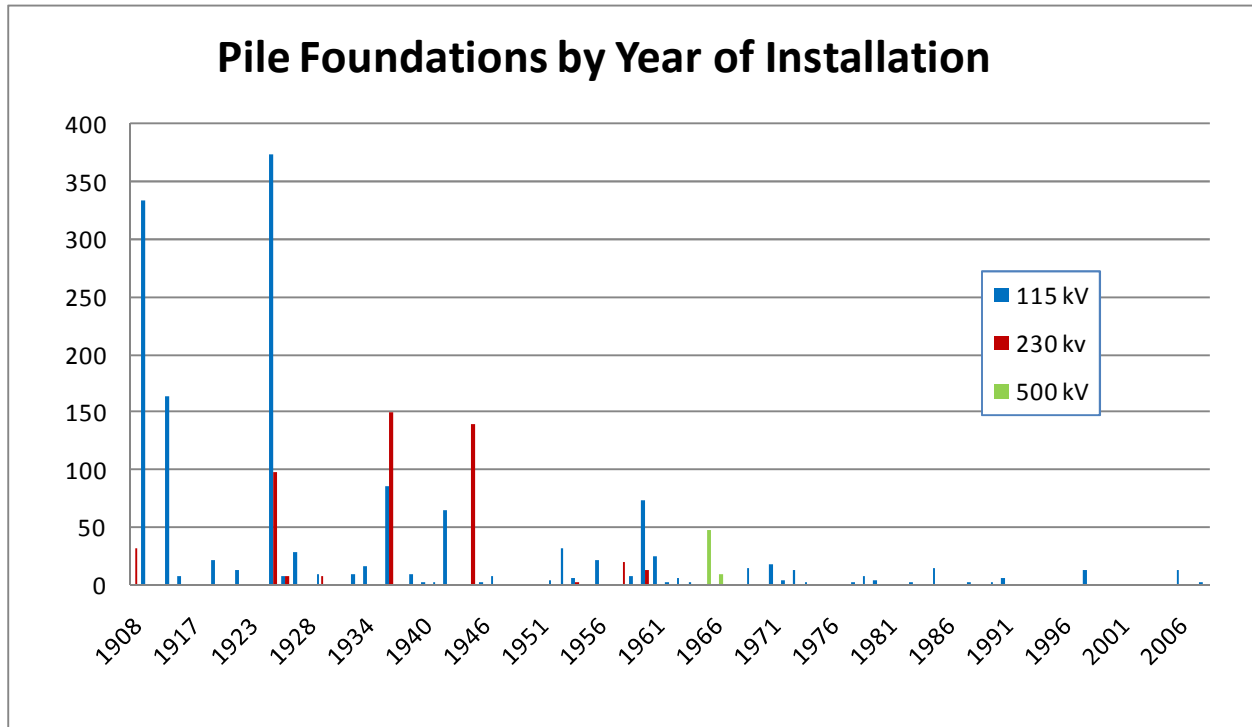
Figure 9-11. Pile foundations

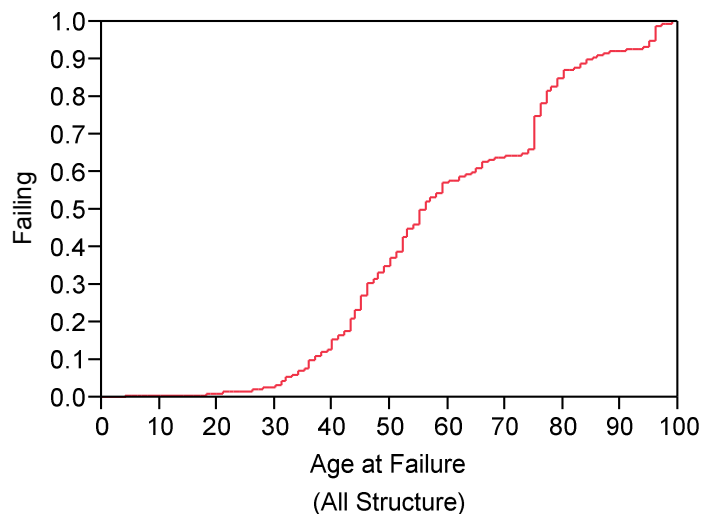
Figure 10-1. The Kaplan Meier plot of all structure failure data

The Kaplan Meier plot is shown in Figure 10-1, this plot can be treated as a cumulative distribution function based on actual data instead of a fitted probability distribution function. Considering only the set of structures that have experienced a major failure from 2004 to 2008, the plot describes the probability that these failures have occurred before or at the time t .

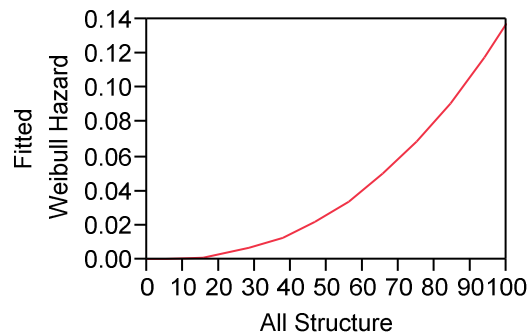
Figure 10-3. Fitted Weibull hazard function for structures

As shown in Figure 10-3, the typical failure rate of a structure increases with its age. Based on the fitted Weibull distribution, the typical failure rate of a structure of age 90 is around 0.11.

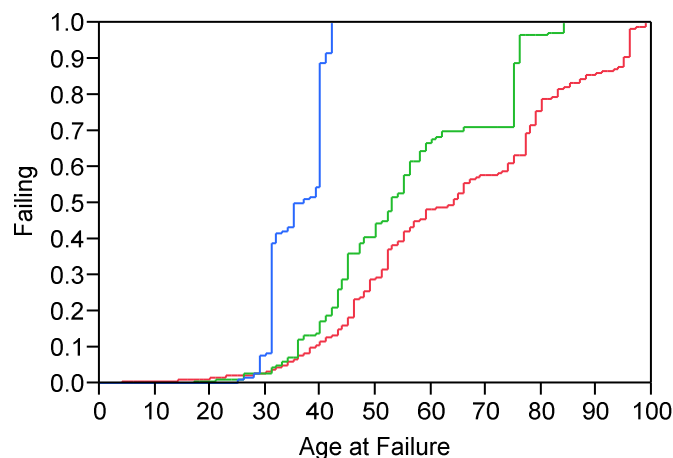
Figure 10-4. The Kaplan Meier plots of structures at different voltage levels

The Kaplan Meier plots for structures in three different voltage levels are shown in Figure 10-4

The Kaplan Meier plot for 500kV shows that all the work notifications of structures in 500kV systems are for those failed before the age of 42. From the Inventory database, the earliest installation year for 500kV structures is 1965. All the 500kV structures are installed

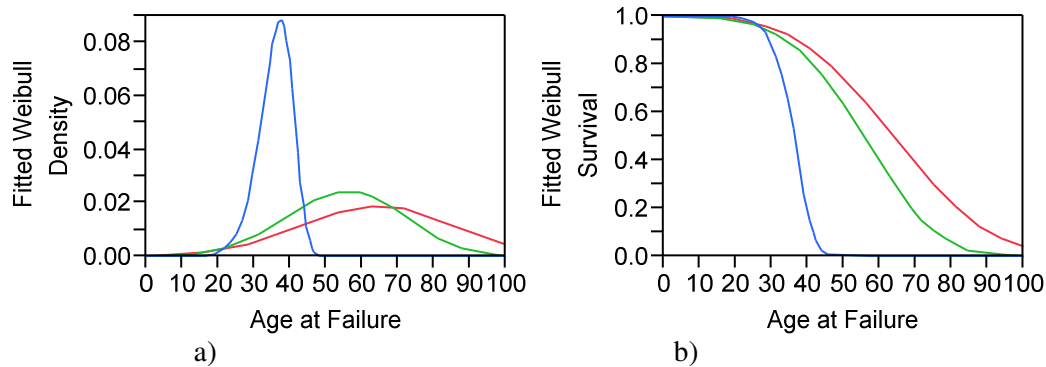
Figure 10-5. Fitted Weibull probability density functions and survival curves for structures at different voltage levels

The fitted Weibull probability density functions for structures at different voltage levels and their corresponding survive curves are shown in Figure 10-5a and 10-5b, respectively.

Between the structures of 115kV system and 230kV systems, it is shown in Figure 10-5 that the structures in 115kV systems tend to fail at a later age than 230kV systems; and it is shown in Figure 10-6 that beyond age 40, the failure rates of 230kV structures is roughly twice as high as 115kV structures.

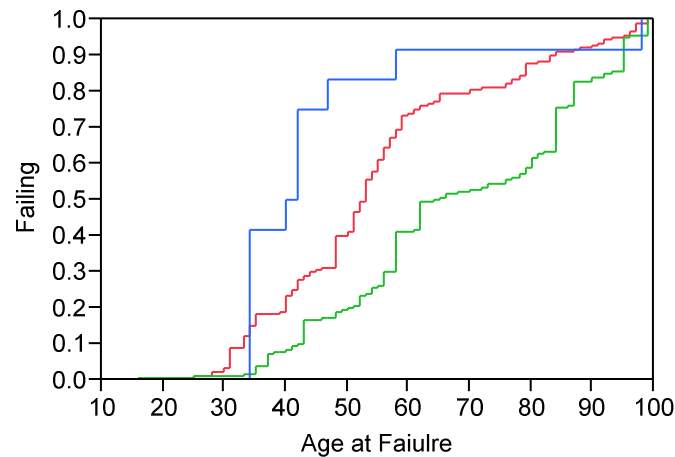
Figure 10-7. The Kaplan Meier plots of structures of different damage types

The Kaplan Meier plots for structures of different damage types are shown in Figure 10-7.

Due to the limited quantity of records related with structures damaged due to Worn/Aged, its curve in the Kaplan Meier plot has several obvious step-functions like zigzags. It can be a discrete version of a smooth curve, or it can be a biased curve due to biased data sample. Without additional information, the true underlying curve is not able to be identified. Therefore, special attentions should be taken to understand the results from this analysis related with the category of “Worn/Aged”.

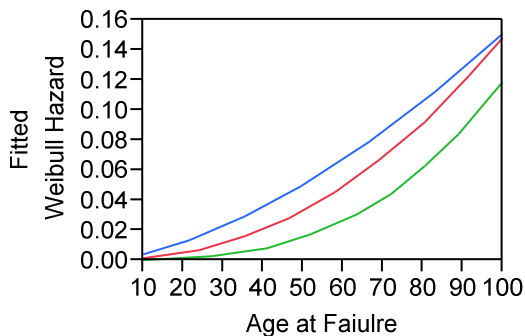
Figure 10-9. Fitted Weibull hazard function for structures with different damage types.

As shown in Figure 10- 9, the failure rate of structures due to “Worn/Aged” is constantly higher than the other two damage types; the failure rate of structures due to “Buckled/Bent” is slightly smaller than worn structures and the difference gets smaller at older ages. The failure rate of structures due to “Rusted” is smaller than the other two damage categories at all ages.

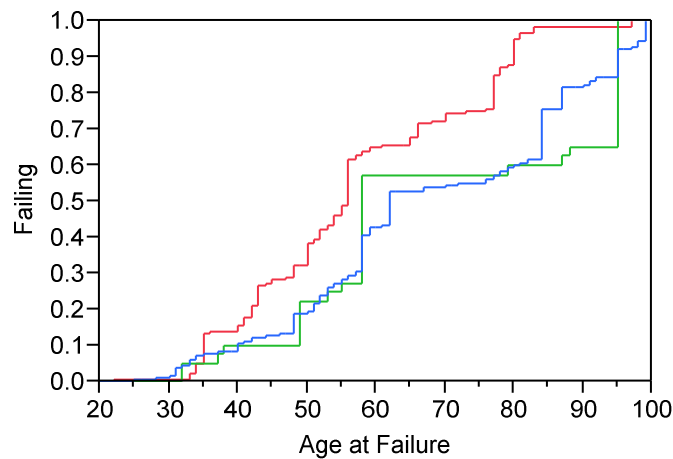
Figure 10-10. The Kaplan Meier plots of structures in different locations

Even though only 40 records of structure failure in the mountain region are suitable for this particular regional analysis, the failure age of structures in the mountain region spreads out basically the same age range as the other two regions, the representativeness of results for the mountain area structure can be considered as sufficient regardless its limited historical data.

The Kaplan Meier plots for structures of different types are shown in Figure 10-10.

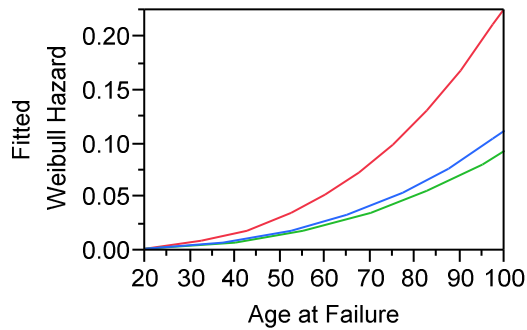
Figure 10-12. Fitted Weibull hazard function for structures in different locations.

As shown in Figure 10-12, the failure rate of structures in the coastal region is significantly higher than the failure rates of structures in the valley and mountain regions, with a rough ratio of 2:1. The structure failure rates in the valley and mountain regions are similar until the age of around 55; and then the failure rate of structures in the valley region are slightly higher than that of structures in the mountain region.

Structures in the Coastal region experienced failures earlier in life (peaking before 60) than in the other two regions and also had about twice the failure rate at all ages. The ages of failures for the Valley and Mountain regions (peaking around 70) as well as their failure rates were fairly similar to each other.
