**GOLDEN STAR**

WASSA MINE DRILL RESULTS  
02.16

# WASSA Q1 2016 DRILL RESULTS

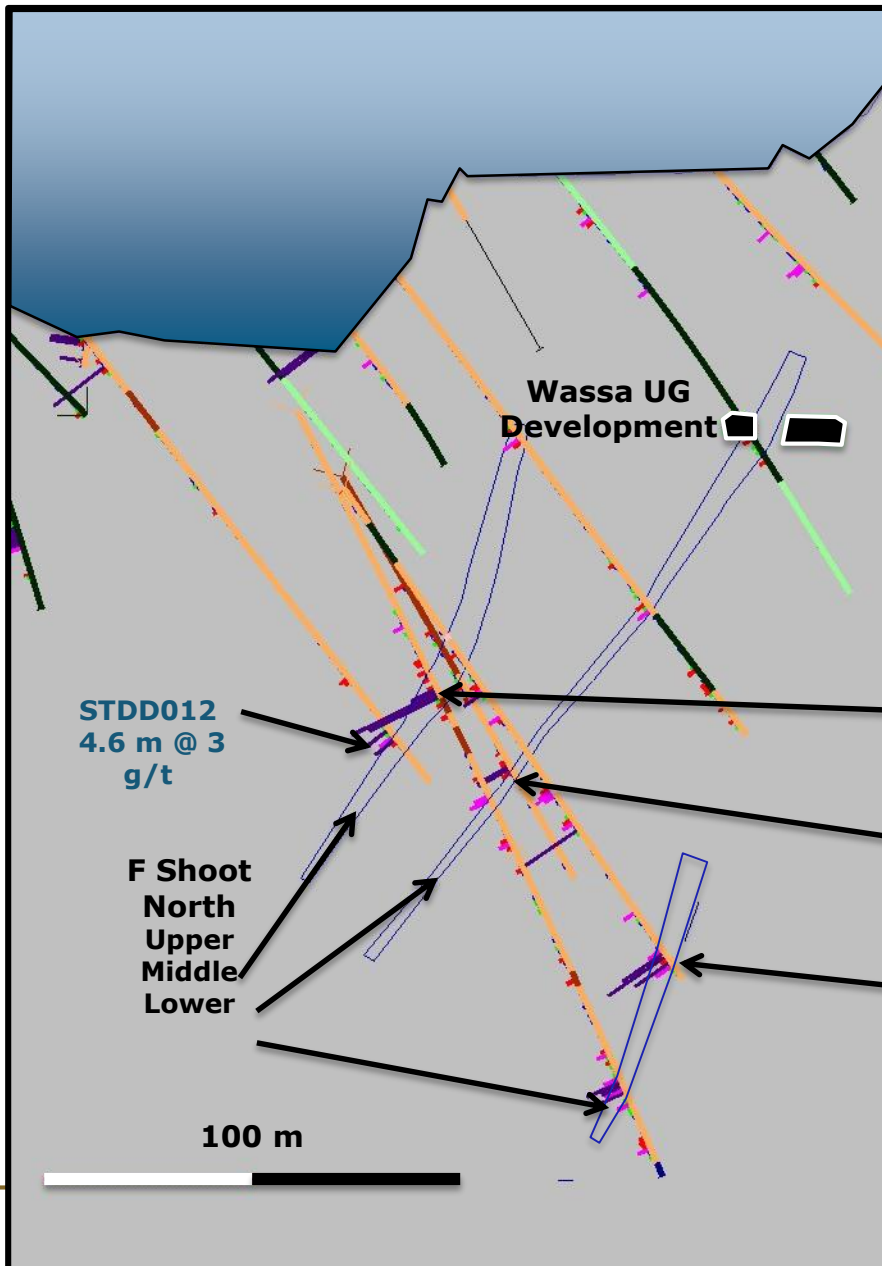
# WASSA UNDERGROUND F SHOOT NORTH TARGET – DRILL X SECTION 20350 N

FSDD011 8.4 m @ 5.6 g/t  
Including 3.2 m @ 12.7 g/t

FSDD009A 5.4 m @ 2.9 g/t

STDD019 6.1 m @ 5.8 g/t

Drill hole  
grades g/t
